**MARYLAND HISTORICAL TRUST
DETERMINATION OF ELIGIBILITY FORM**

Property Name: Montjoy Farm Inventory Number: HO-145
 Address: 9097 Executive Park Drive City: Ellicott City Zip Code: 21042
 County: Howard USGS Topographic Map: Savage
 Owner: Estate of M.L. Dawson Lee, Jr. Is the property being evaluated a district? yes
 Tax Parcel Number: 260 Tax Map Number: 30 Tax Account ID Number: 243105
 Project: Montjoy Complex Agency: _____

Description of Property and Eligibility Determination: (Use continuation sheet if necessary and attach map and photo)
CAPSULE SUMMARY

Prepared by: Ward Bucher Architects

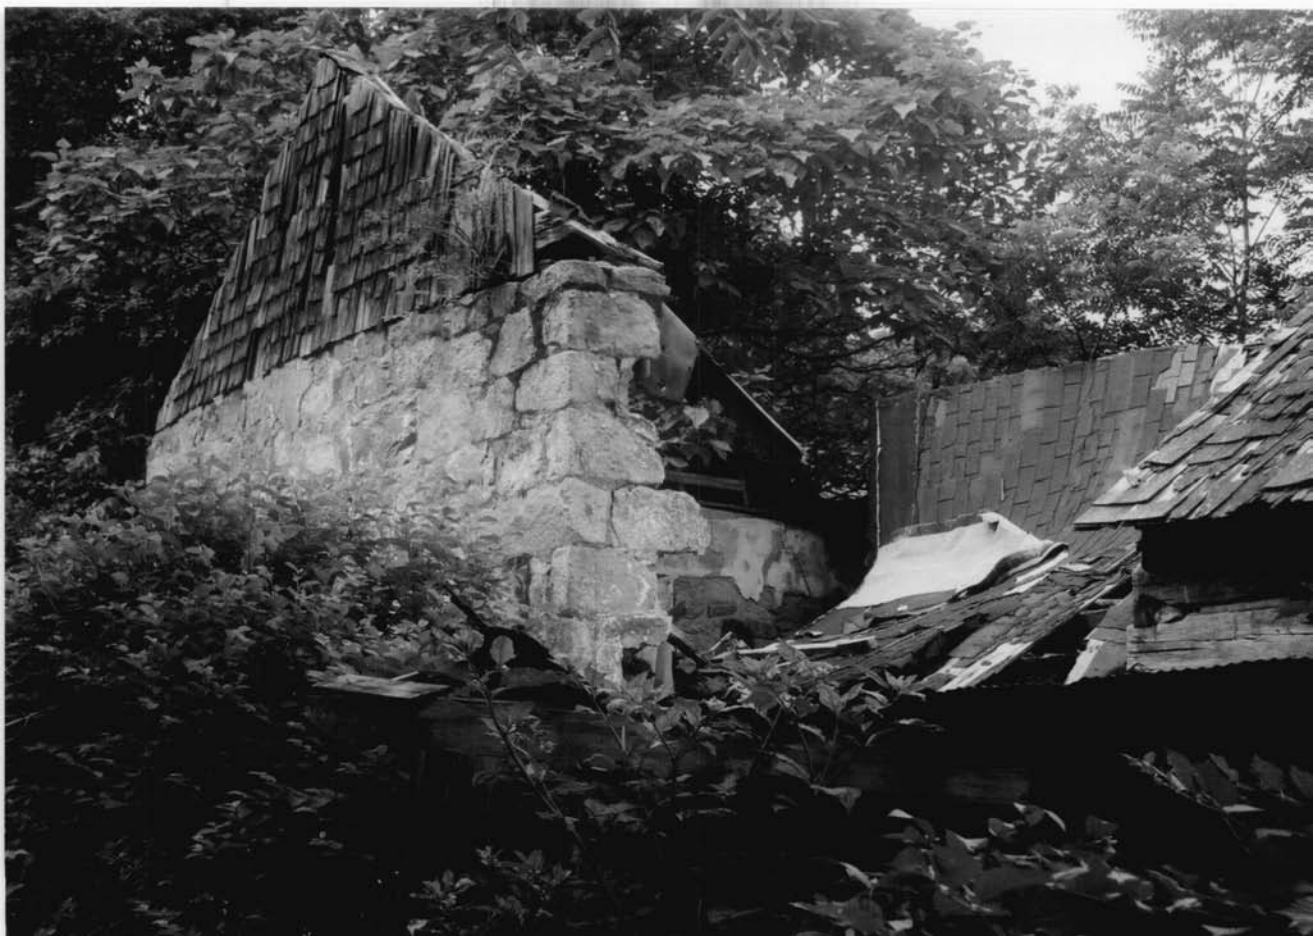
①

"Unfortunately, during the winter of 2002-2003 the side gabled roof and the north wall collapsed, taking down the second floor and making the structure extremely unstable and unsafe. There is a large crack and pronounced bow in the east wall. According to photographs taken prior to the collapse, the north wall had a door on the first story and a window on the second story. A large kitchen hearth, with an internal brick chimney, occupies the east wall. Unfortunately, the interior of the structure was not documented before it collapsed and now it is not possible to gather evidence to determine the construction date or use of the second floor. The first floor was certainly used as a kitchen as is clear from the presence of the large cooking fireplace on the east wall; ... Lath and plaster finishing is visible in the second-story ruins, and furnishings are present, indicating use as living space at some point in time. The date of the building is unclear. Its orientation suggests that it was part of the planned domestic complex consisting of house, kitchen, and smokehouse, and it probably at least dates to the early 1850s and the construction of the house."(5)

KITCHEN HOUSE
HOWARD COUNTY, MD

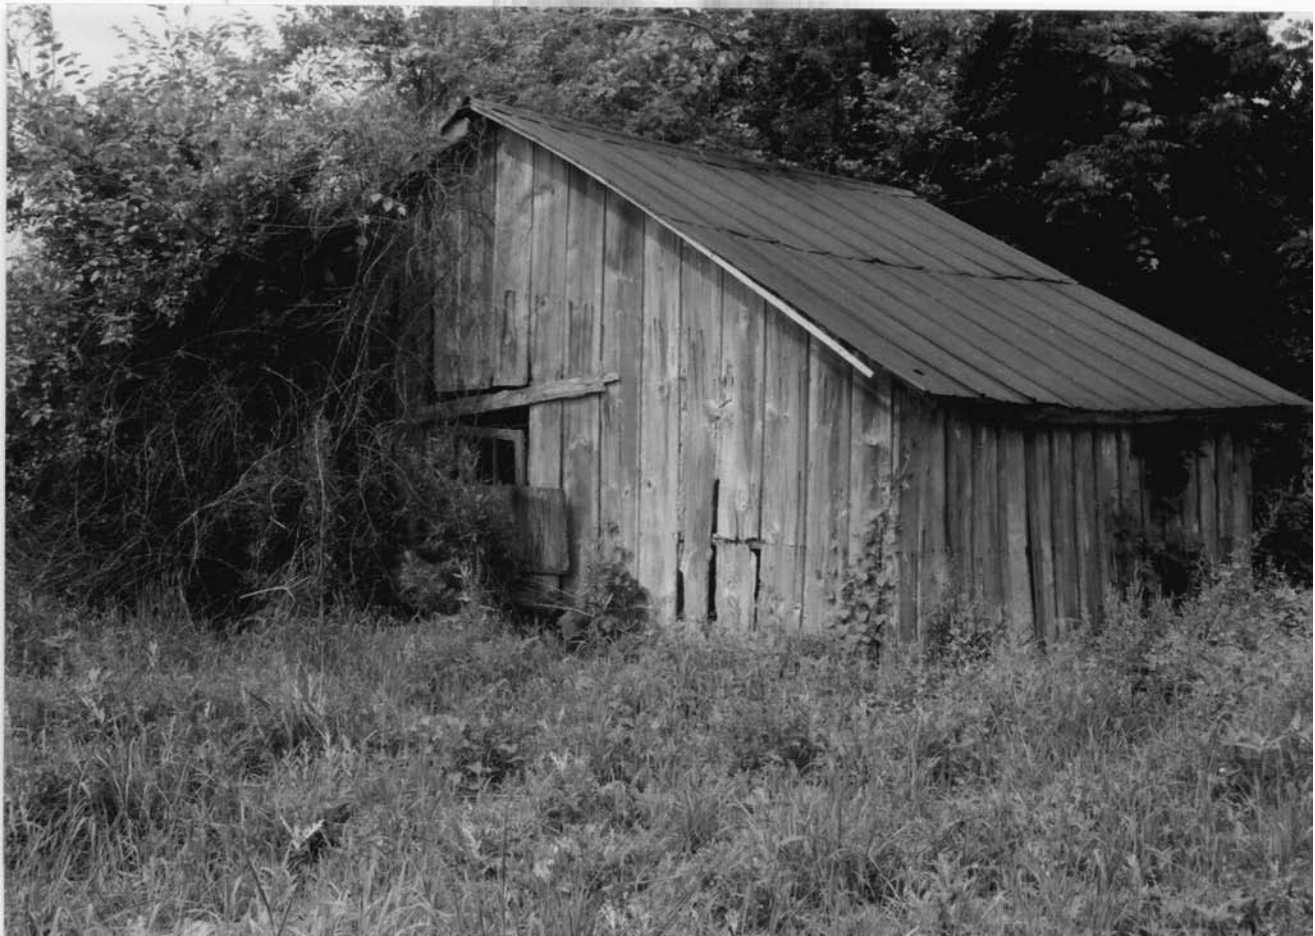
4

Settlement has caused cracks in the foundation and the slight dipping of the north wall. Wire nails tie the circular-sawn wood framing together. Remnants of white paint is evident on the exterior cladding, and faded white paint coats all interior wood, including the diagonally suspended wood-pole perches spanning the northern interior wall that indicate the previous agricultural function of the now unused structure.

The general condition of the building is fair due to missing wall elements and foundation settlement.

CHICKEN COOP
HOWARD COUNTY, MD

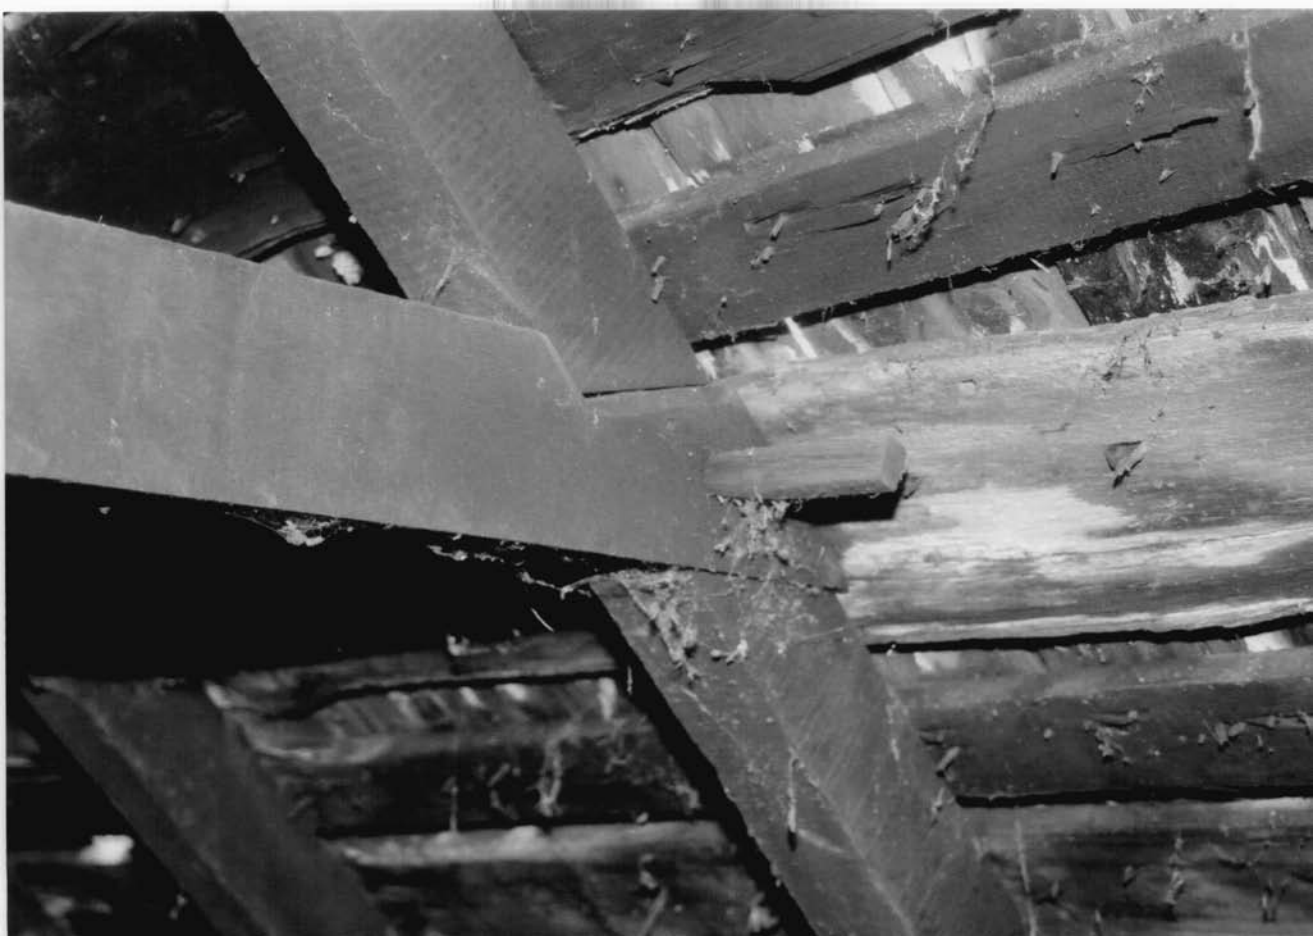
10

The building is in generally poor condition, with the roofing shingles in very poor condition with numerous holes, racked rafter pairs and rotten log top and bottom plates. Winchester Homes plans to maintain the exterior of the building along with the Montjoy house and the kitchen house ruin as part of the history of the site.

LOG SMOKEHOUSE
HOWARD COUNTY, MD

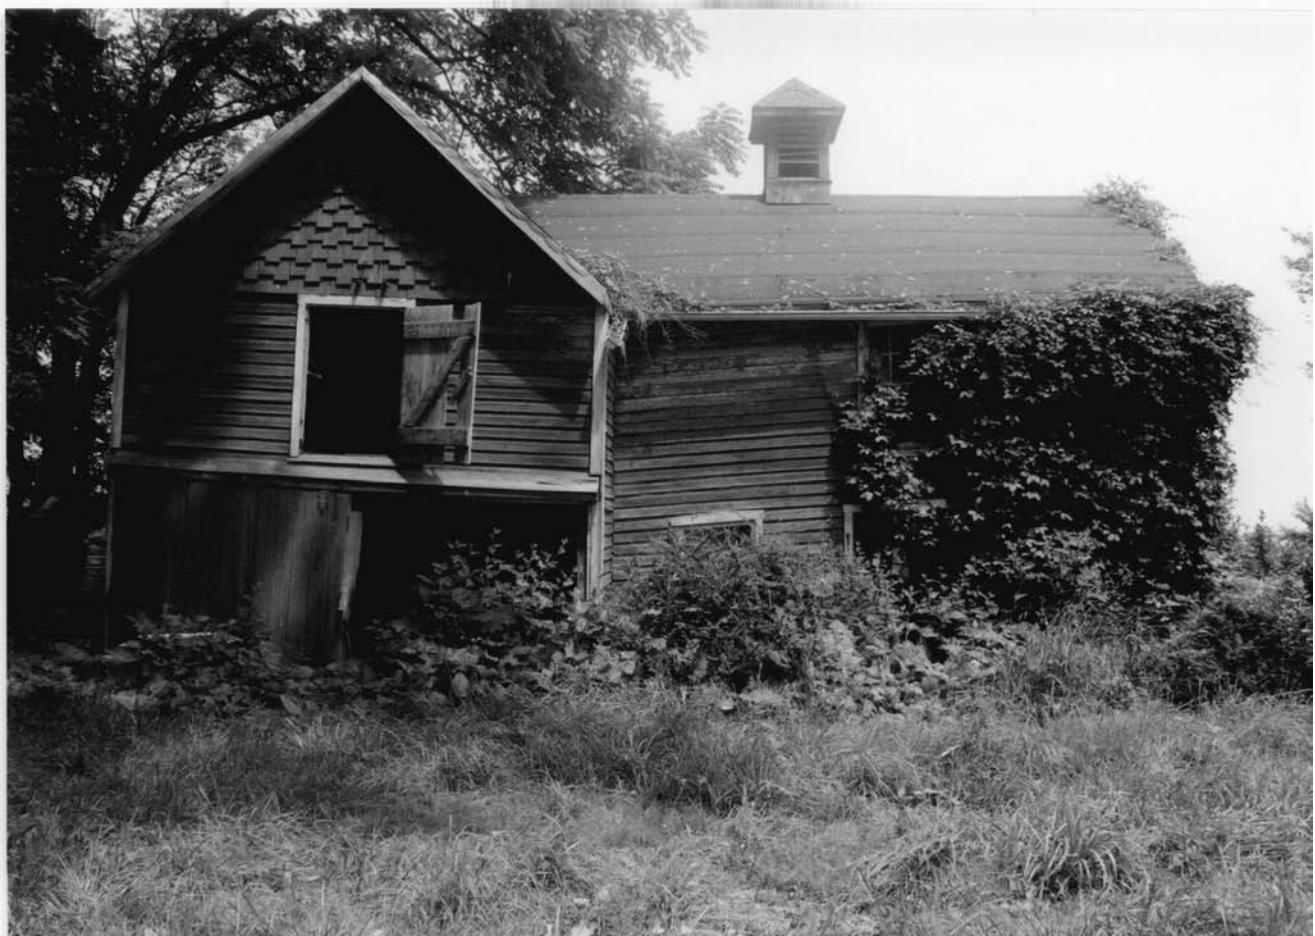
(11)

The structure has rolled roofing on 1x sheathing and, in some locations, plywood supported by 2x rafters. The open rafter ends are covered by a face board. "Due to sloping ground level, the foundation is visible on the east, north and west sides, but is below ground on the south side."(8) The northeast corner of the building has become detached from its foundation and its wood framed wall and some of the foundations stones have slid north down the hill, causing the corner walls and roof to sag drastically. There is a cellar beneath the garage portion once accessible by a below grade opening beneath the western exterior wall. The cellar stair is filled with trash and its southern rubble stone retaining wall has collapsed into the opening.

The general condition of the building is poor, with a compromised foundation and unstable envelope. Winchester Homes proposes to demolish the building.

GARAGE/WORKSHOP
HOWARD COUNTY, MD

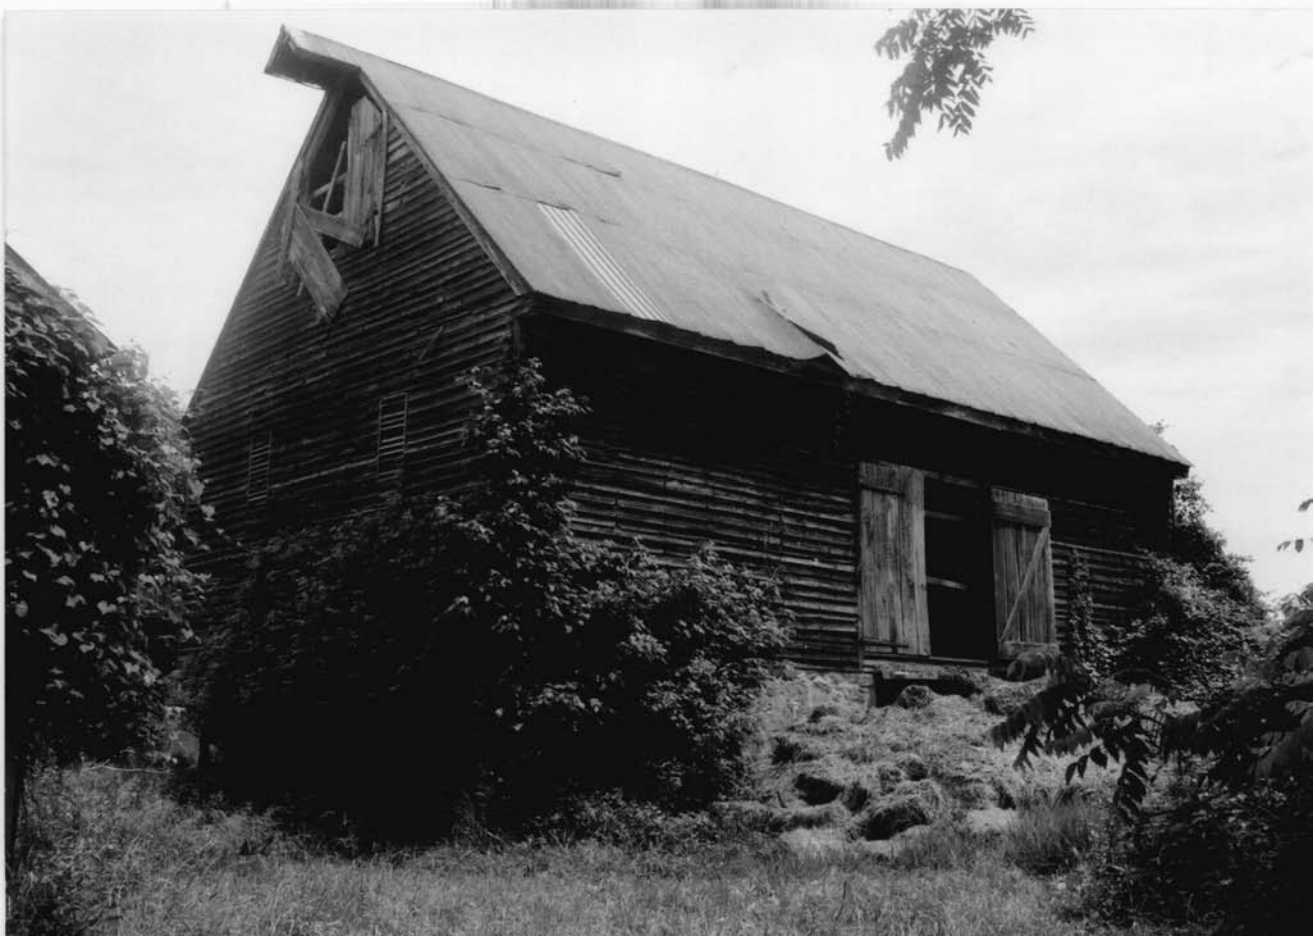
(14)

The general condition of the barn is good despite minor deterioration to the exterior, such as missing clapboard cladding at the peak of the west gable end. Winchester Homes proposes to give the barn to the Howard County Conservancy (HCC) for disassembly and reconstruction on the grounds of the HCC.

ENGLISH BARN
HOWARD COUNTY, MD

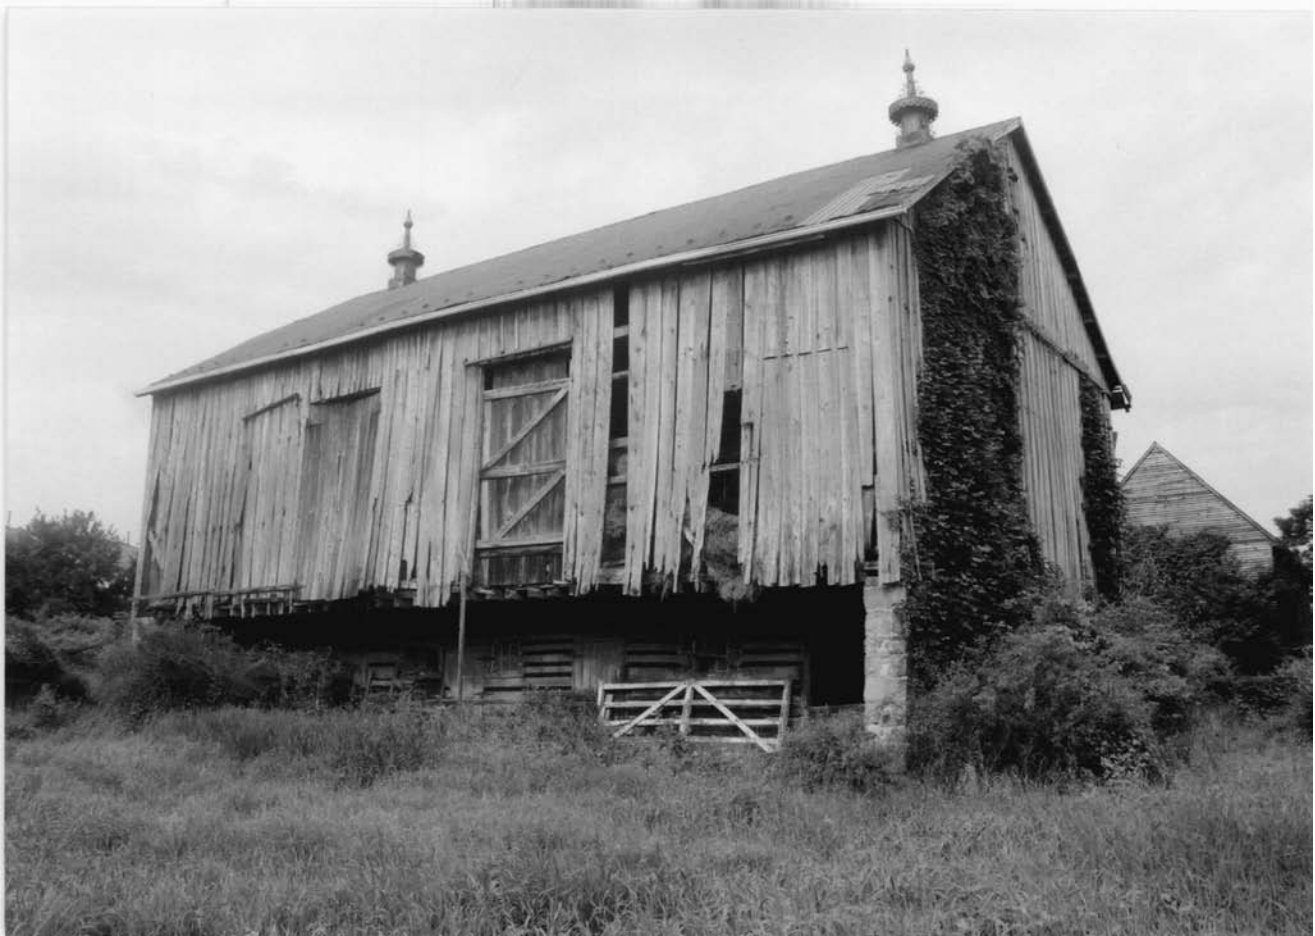
(19)

The general condition of the barn is good. Winchester Homes currently proposes to demolish the building. However, Winchester Homes has had initial discussions with the HCC about the possibility of the HCC utilizing the bank barn.

BANK BARN
HOWARD COUNTY, MD

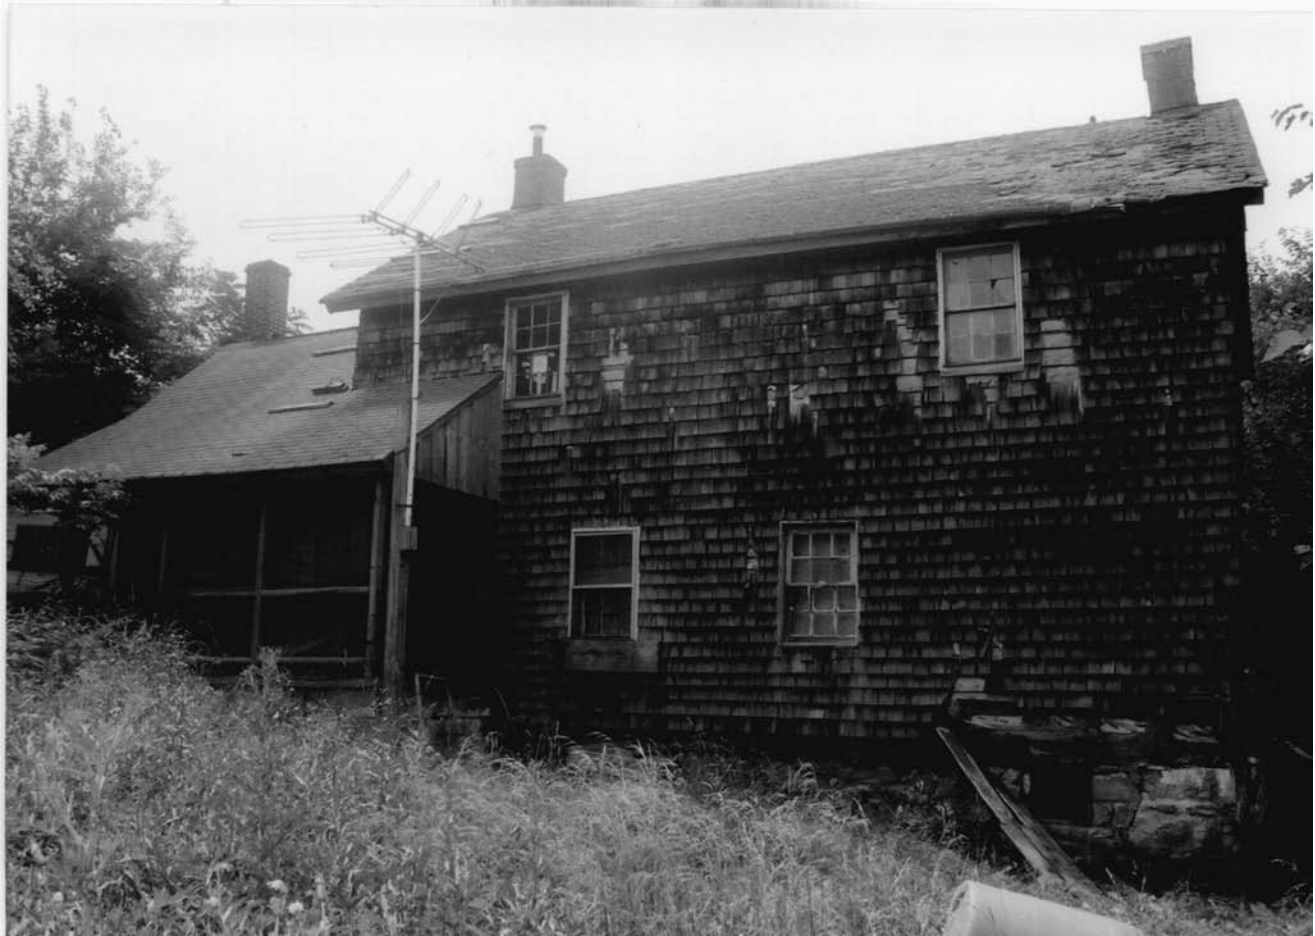
24

The partial basement is largely filled by a pile of stone rubble that is the remains of the west chimney base. The corners of the chimney base are visible. The western foundation wall has substantial cracks and bulges outwardly significantly on the exterior side of the chimney base, destabilized by its collapse.

The building is generally in poor condition. The west foundation and chimney are collapsing and water damage to the ceiling and flooring in the southwest corners of both second floor rooms indicate major roof leaks. Winchester Homes proposes to demolish the building.

TENANT HOUSE #1
HOWARD COUNTY, MD
