Maryland Inventory of Historic Properties number: HO-666

Name: Old Montgomery Rd. over Little Patuxent River

Maryland Inventory of Historic Properties
Historic Bridge Inventory
Maryland State Highway Administration
Maryland Historical Trust

Name and SHA No. Old Montgomery Road over Little Patuxent River/HO55

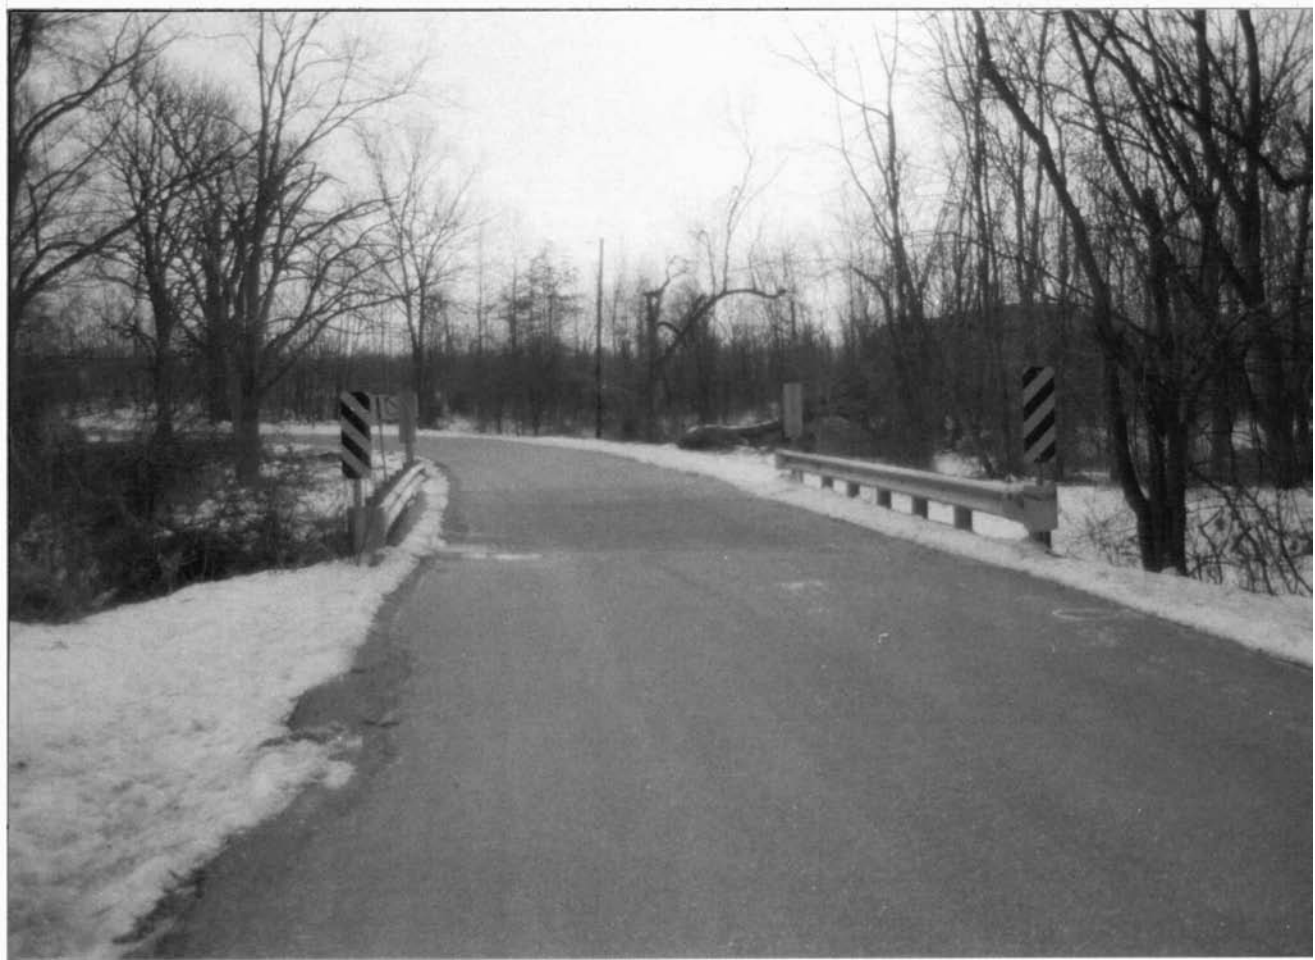
Number 1 of 4
13 of 16

Description WEST APPROACH

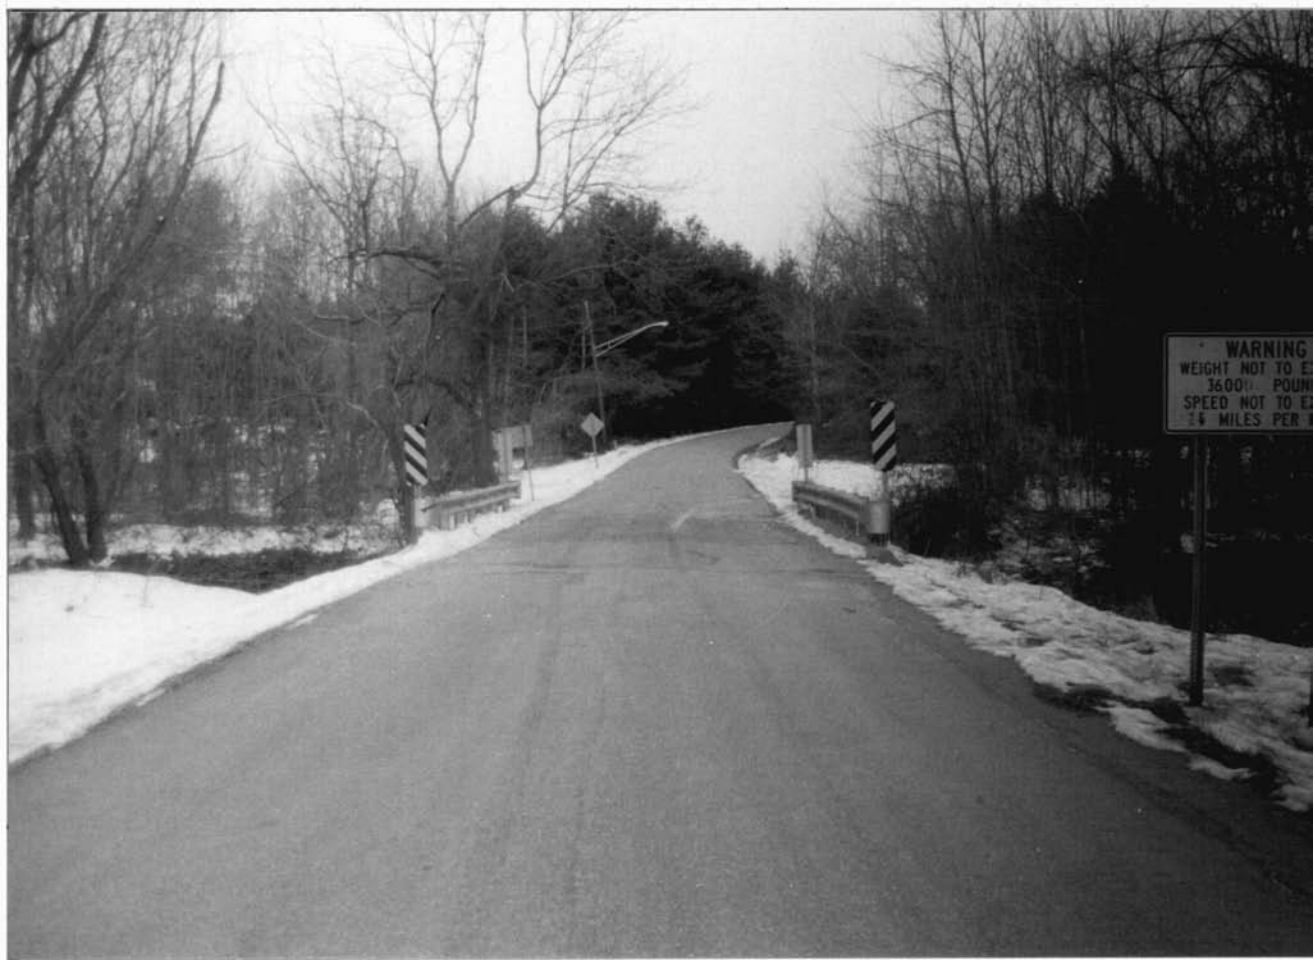
Number 2 of 4
11 of 10

Description EAST APPROACH

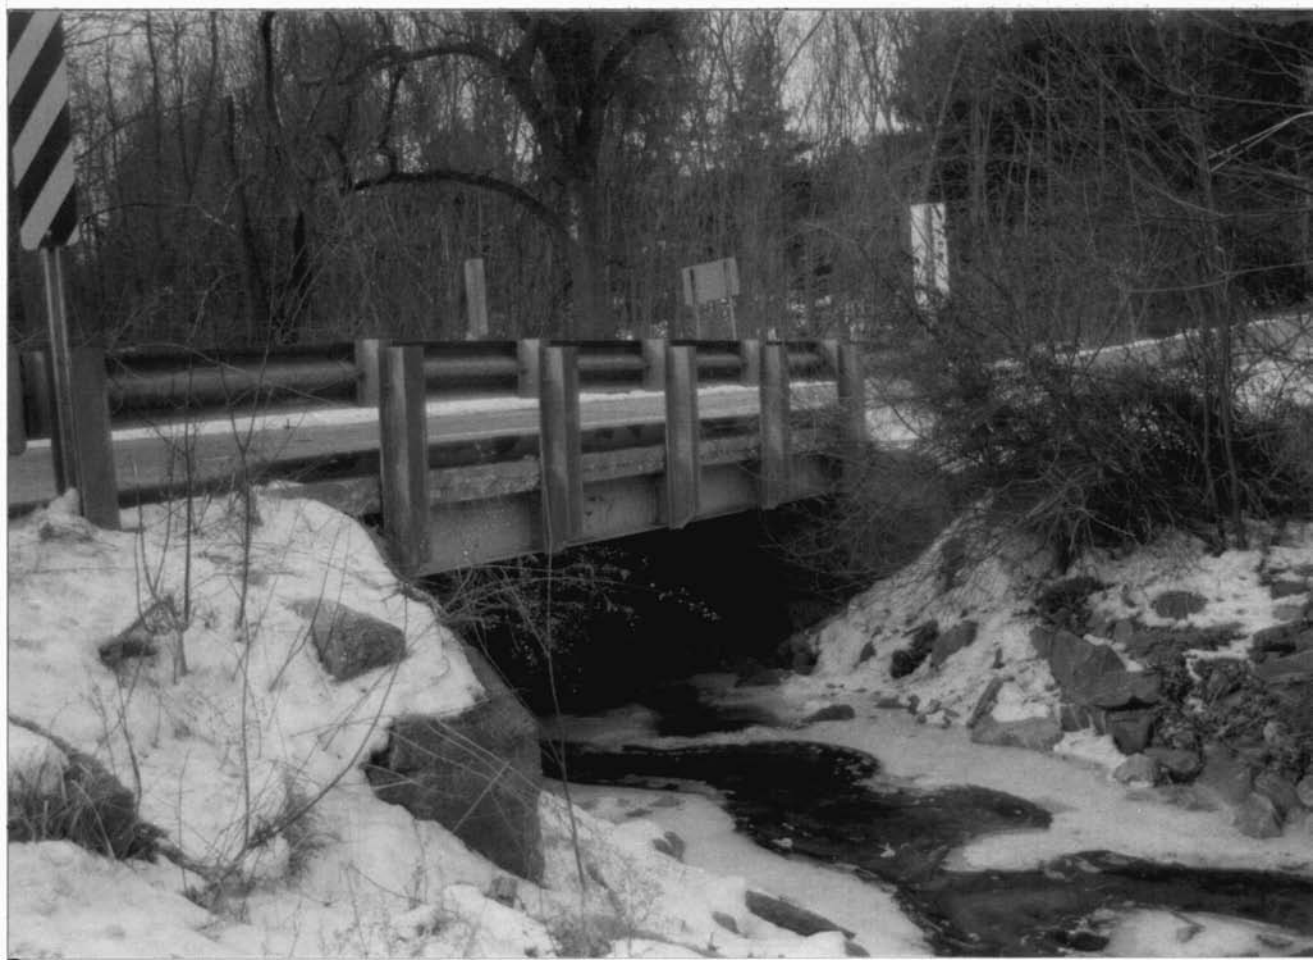
Number 3 of 4

Description NORTH ELEVATION

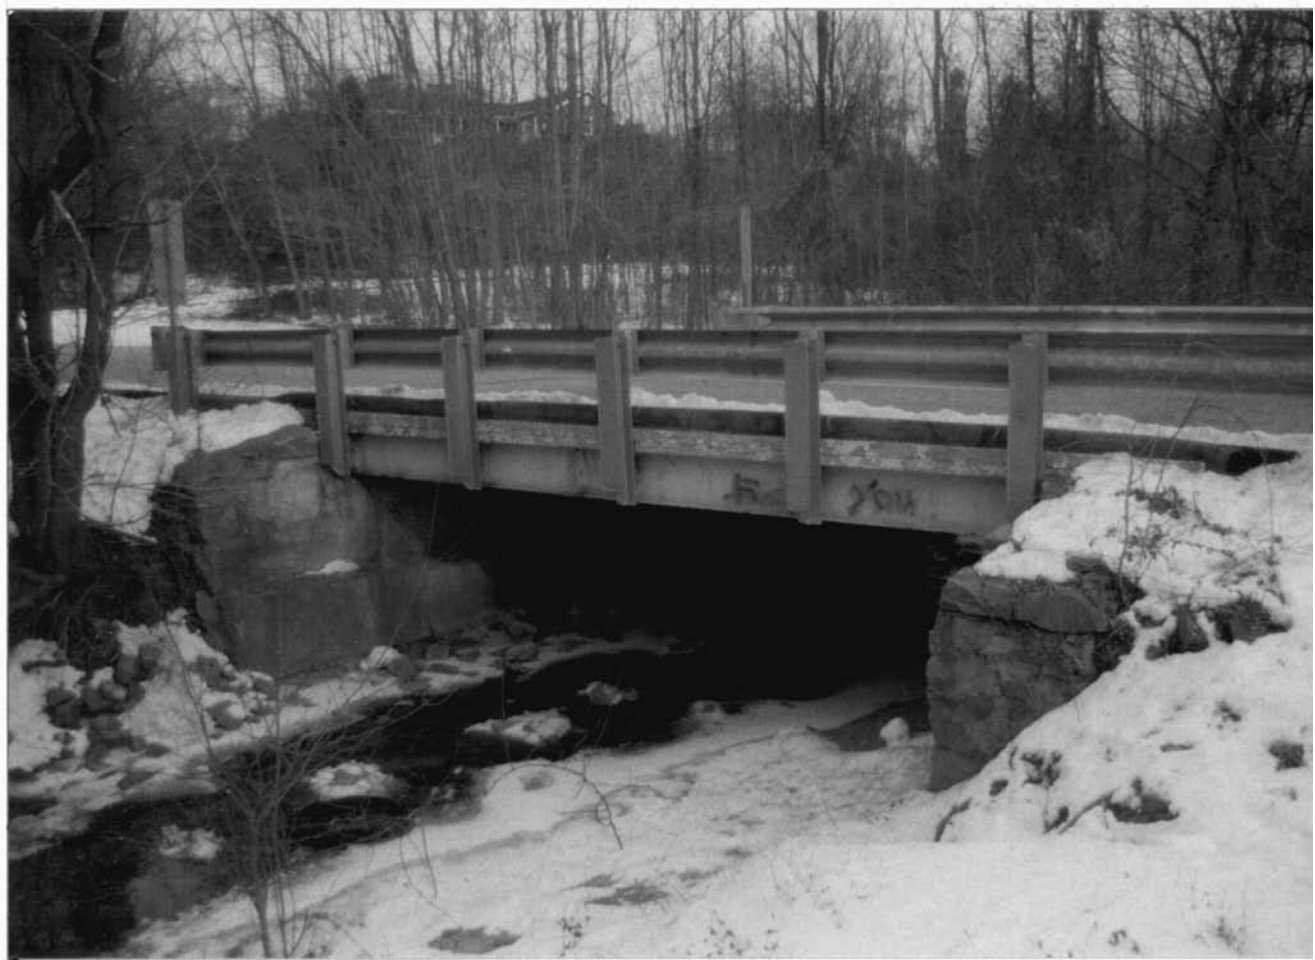
Number 4 of 4

Description SOUTH ELEVATION
