HO-842, House
12400 Route 108/Clarksville Pike, Clarksville
Howard County
Ca. 1900
Private

Maryland Inventory of Historic Properties Form

Inventory No. HO-842

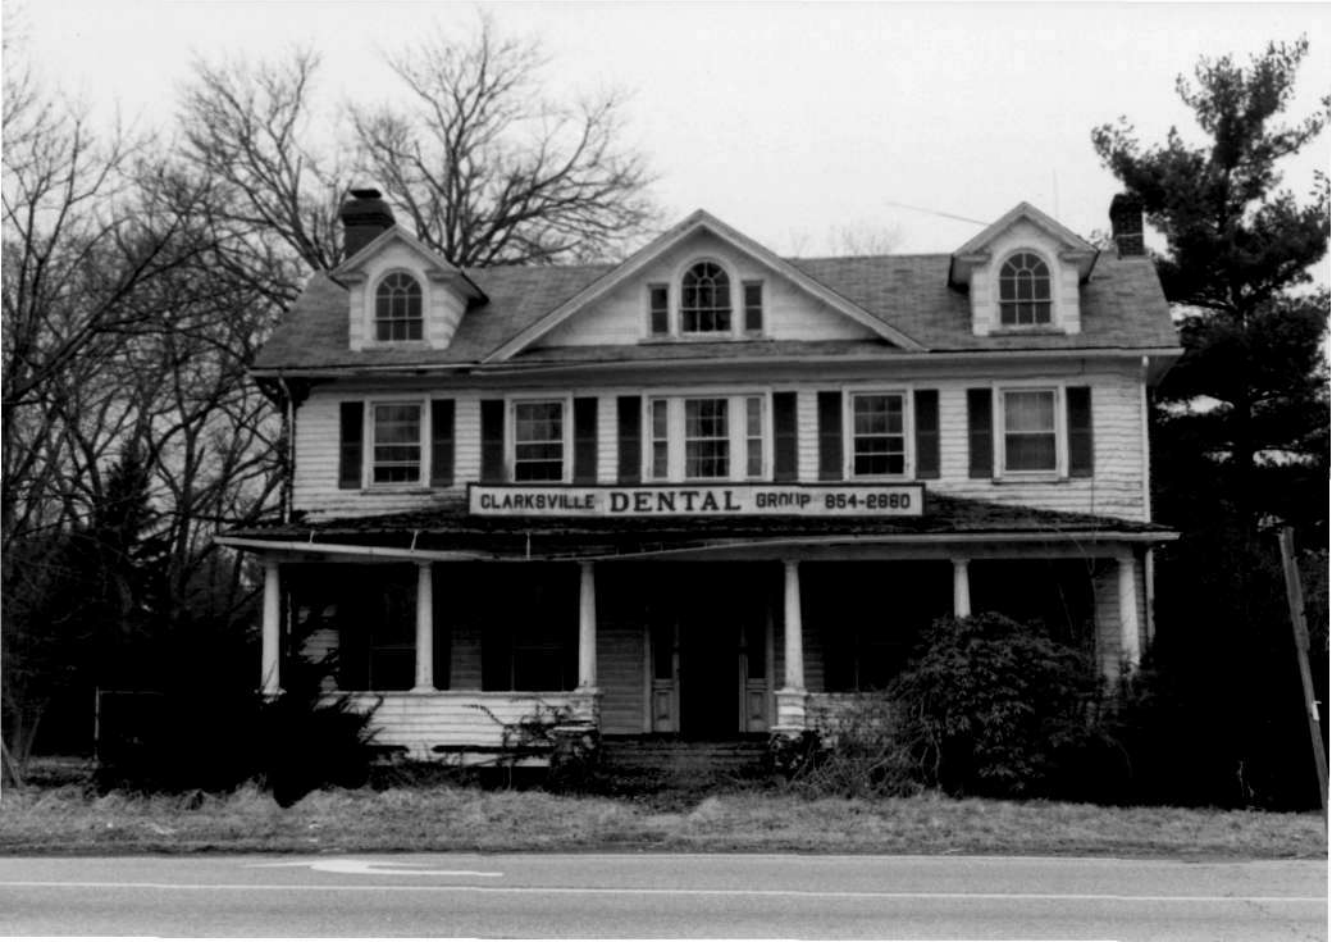
1/9

The front (east) façade is five bays wide with a central entry. The front door (now boarded over) is capped by a six-light transom and flanked by 3-light sidelights. On either side of the door there are two floor-to-ceiling 9/9 double hung wood windows. The second story features a three-part window in the center bay (a regular size 6/6 double hung window flanked by narrow 2/2 windows). The four other second story windows are double hung 6/6 sash. The second story openings are vertically aligned above the first story openings. The front slope of the roof features a central cross gable flanked by two gabled dormers. The cross gable is shingled and contains another three part window. On either side of the cross gable is a gabled dormer. Each dormer has cornice returns and holds an arched window. A full width front porch spans the front façade. The solid balustrade is covered with wood clapboards and six Doric columns rest on top of the balustrade and support the hipped roof.

Front (east) facade

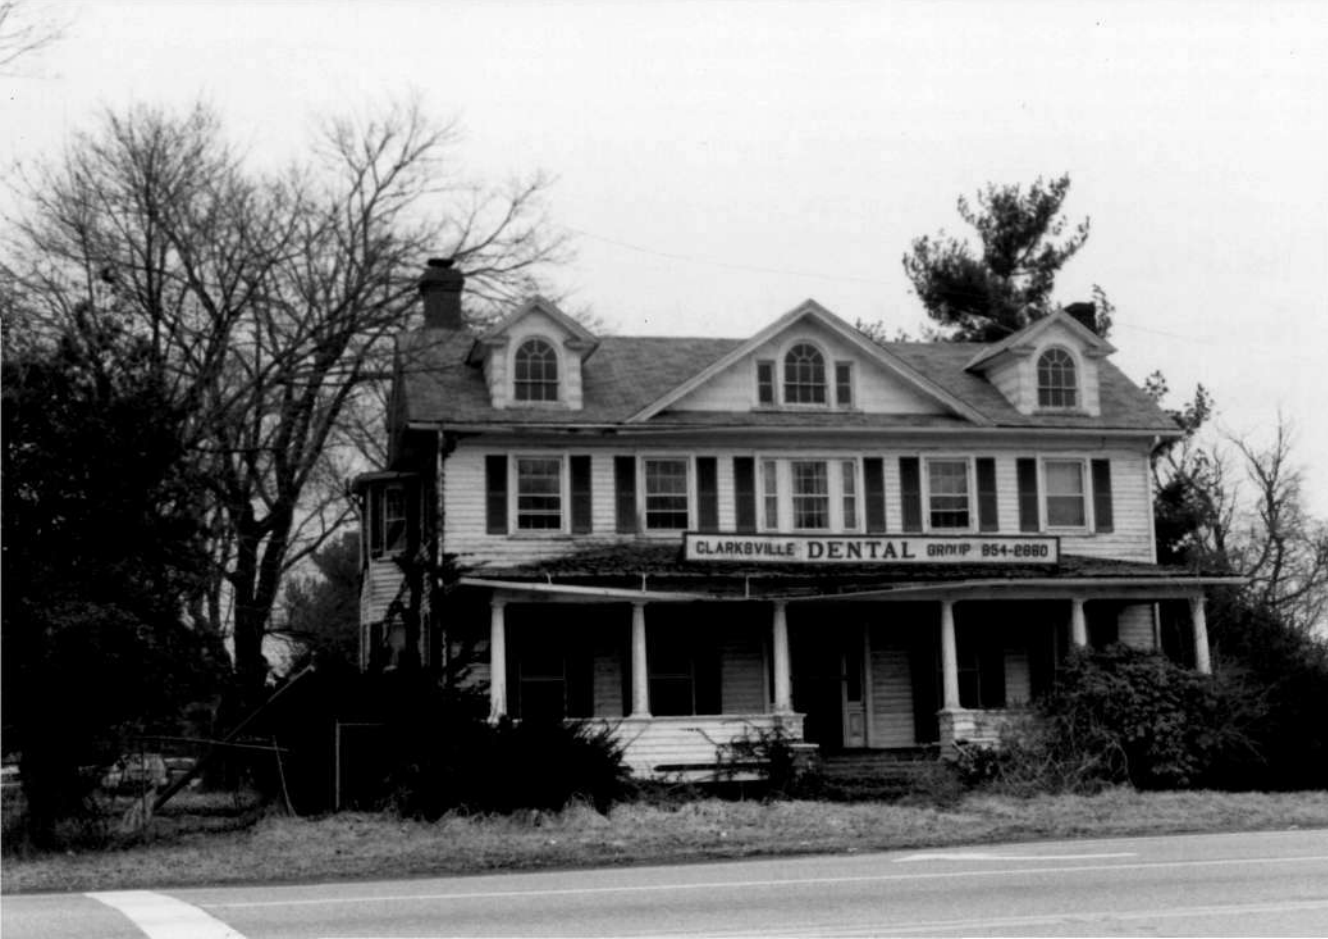
2/9

East elevation

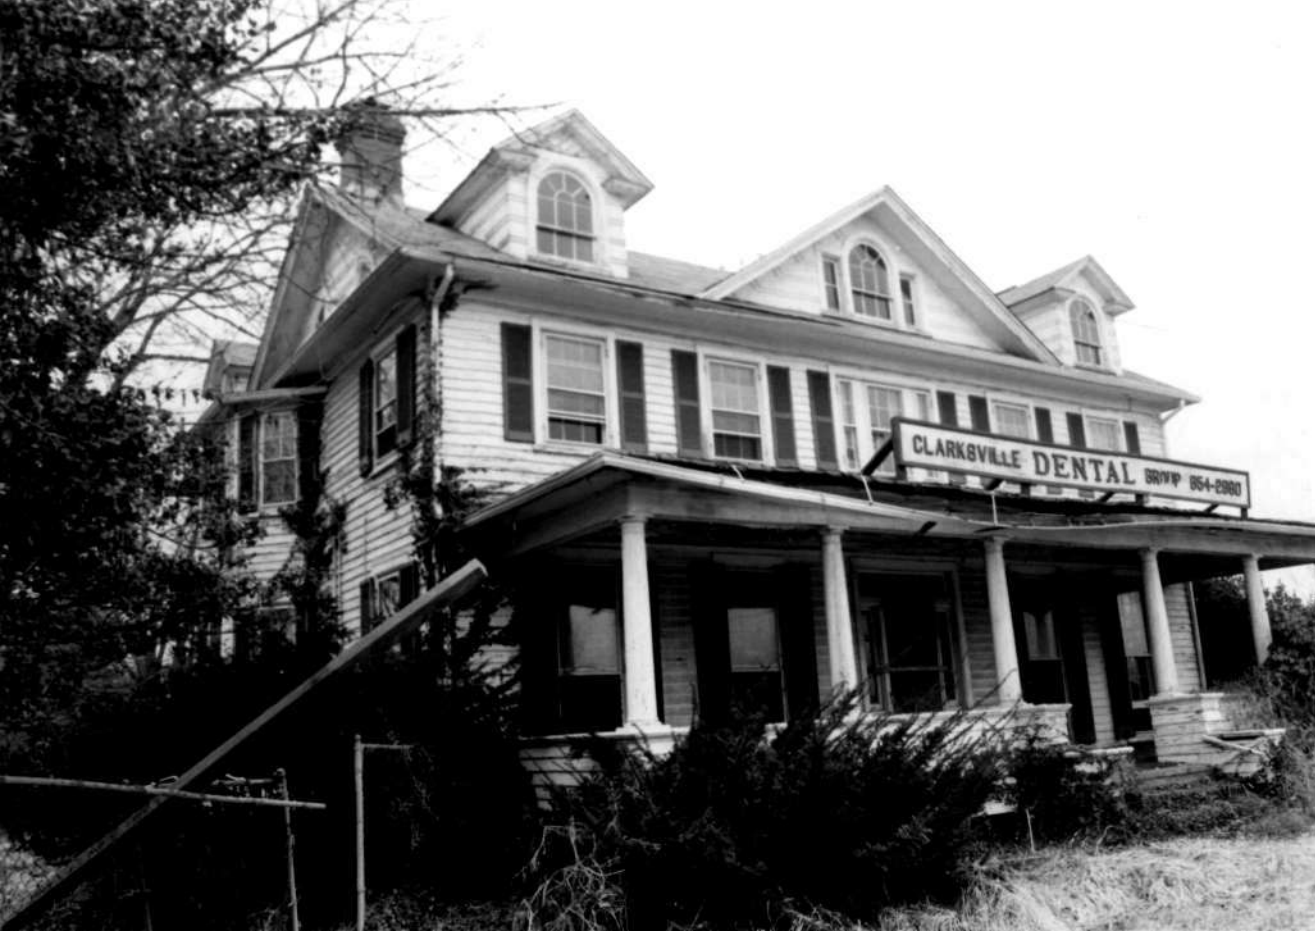
4/9

Front (east) elevation

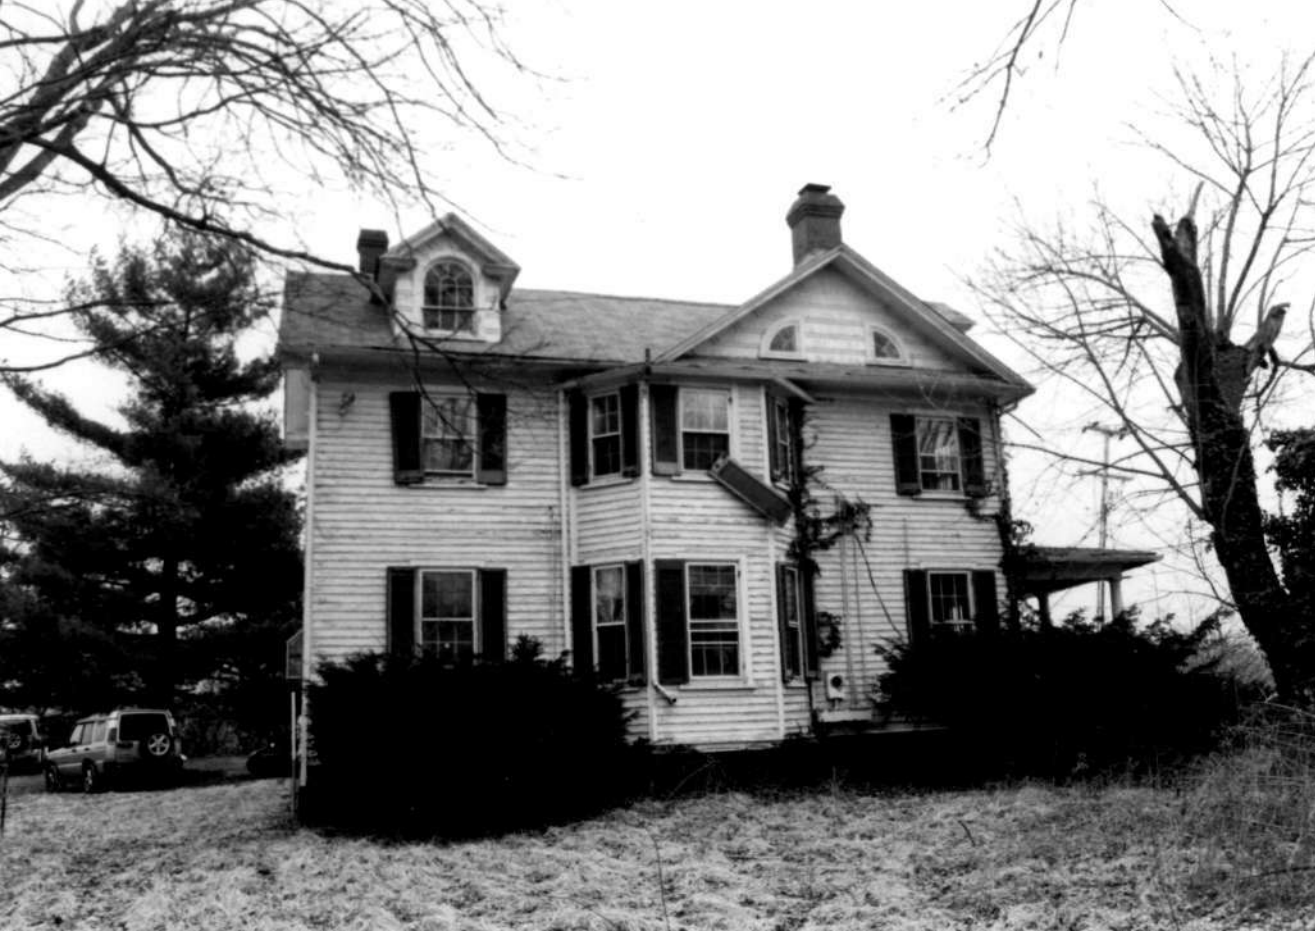
5/9

The south side façade of the house features a three sided, two story bay window centered on the wall. The sides of the bay window hold 4/4 double hung wood windows while the center bay holds 6/6 double hung windows on each story. In front of the bay window, there is one 6/6 double hung window on each story and towards the rear of the house, behind the bay window, there are two more 6/6 windows, one on each story. The gable end of the side gabled section is pedimented and shingled and holds two half fanlights flanking the chimney stack. The west slope of the roof of the rear wing holds another dormer window. The dormer holds an arched window matching the ones on the front façade.

South elevation

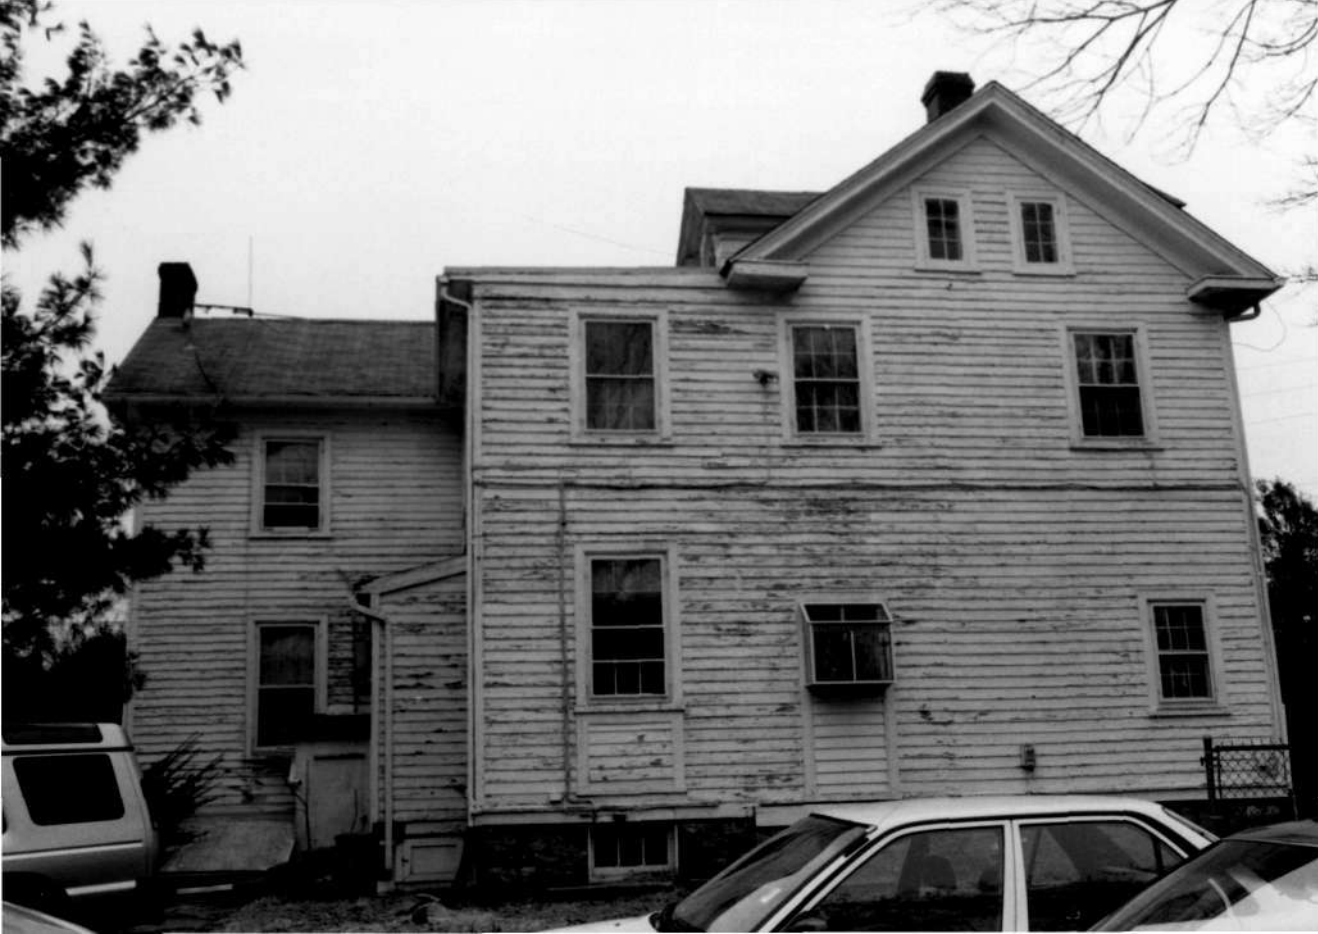
6/9

On the rear façade, the gabled roof of the rear wing covers the two south most bays and a nearly flat shed roof covers the single north bay. At first glance, this two story, shed roofed section on the north side of the rear wing appears to be an addition, but the stone foundation shows no evidence of a seam. The rear façade of the gabled wing and the shed roofed section has three windows across the second story, all of which are 6/6 double hung wood windows. The first story has seen several alterations and the middle bay on the first story was originally occupied by a door and an entry portico. Now that bay holds a small greenhouse-type window and the porch has been removed. The left most bay on the first story also appears to have originally held a door that has since been replaced by a 6/6 window. The right-most bay on the first story holds a small 6/6 window. The gable end of the rear wing has cornice returns and two six-light casement windows. One three-light window is located in the foundation. The rear wing does not span the full width of the side gabled section and the portion of the rear façade of that section that is visible holds one 6/6 window on each story.

Rear (west) elevation

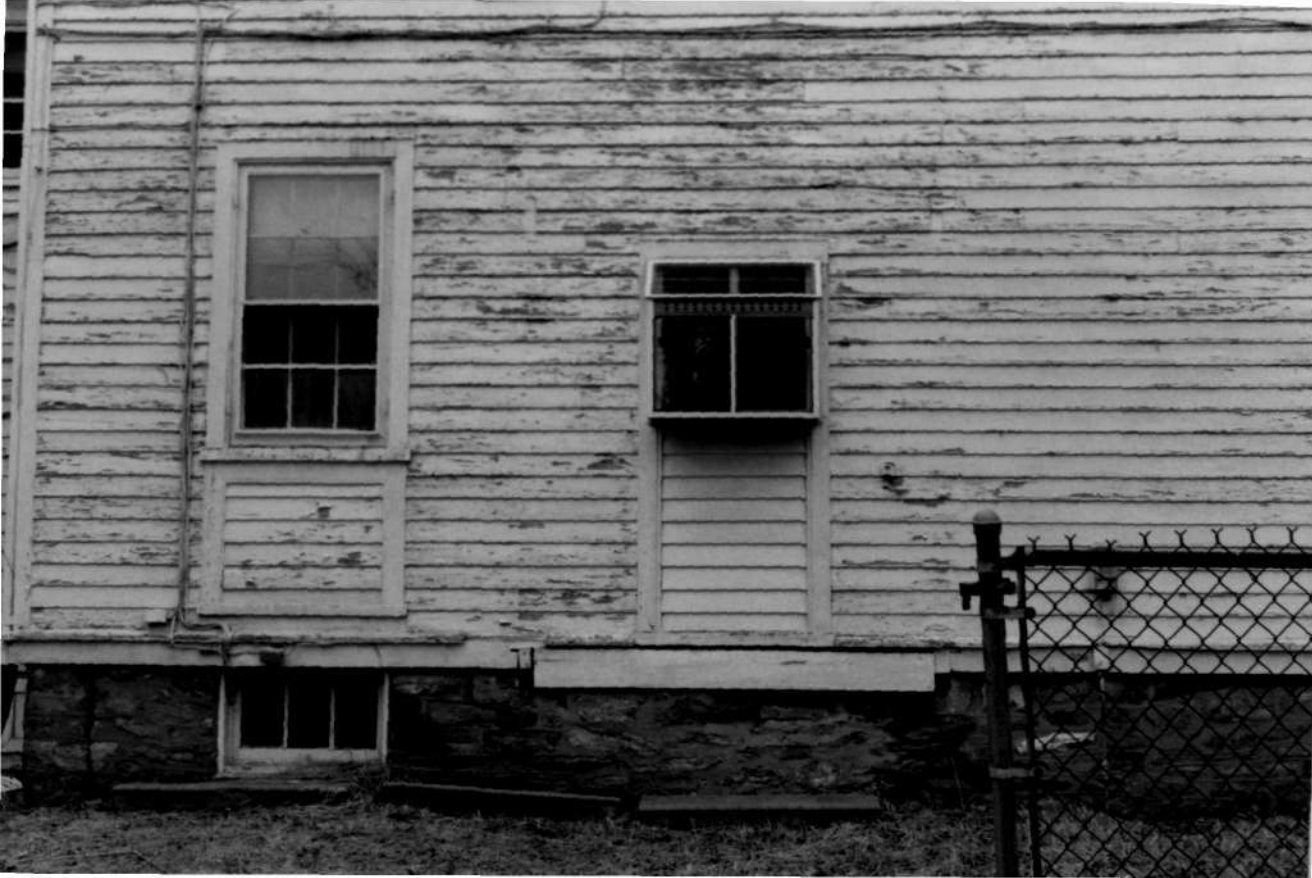
7/9

detail of closed doorways + removed portico on
west (rear) facade

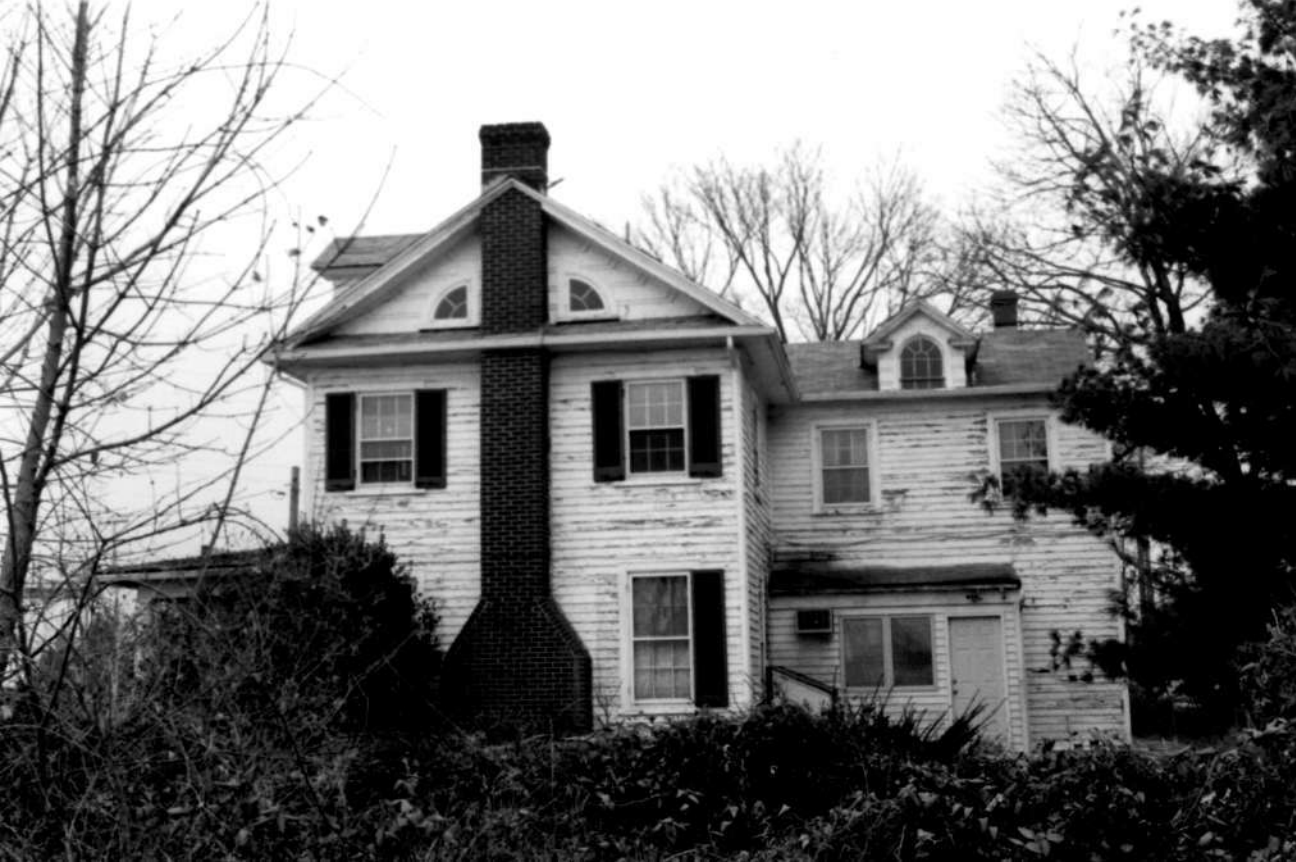
8/9

The north side façade of the front, side gabled section holds two 6/6 double hung windows on the second floor vertically aligned above two more 6/6 windows on the first floor. The windows flank the exterior brick chimney that is centered on this wall. Two half fanlight windows located in the pedimented, shingled gable also flank the chimney, as do two three-light windows located in the foundation. The north elevation of the rear wing features two 6/6 windows on the second floor and a gabled dormer matching the others in the house is found on the north slope of the gabled part of the rear wing. The first story of the north façade of the wing is covered by an enclosed porch with a recent aluminum door.

North facade

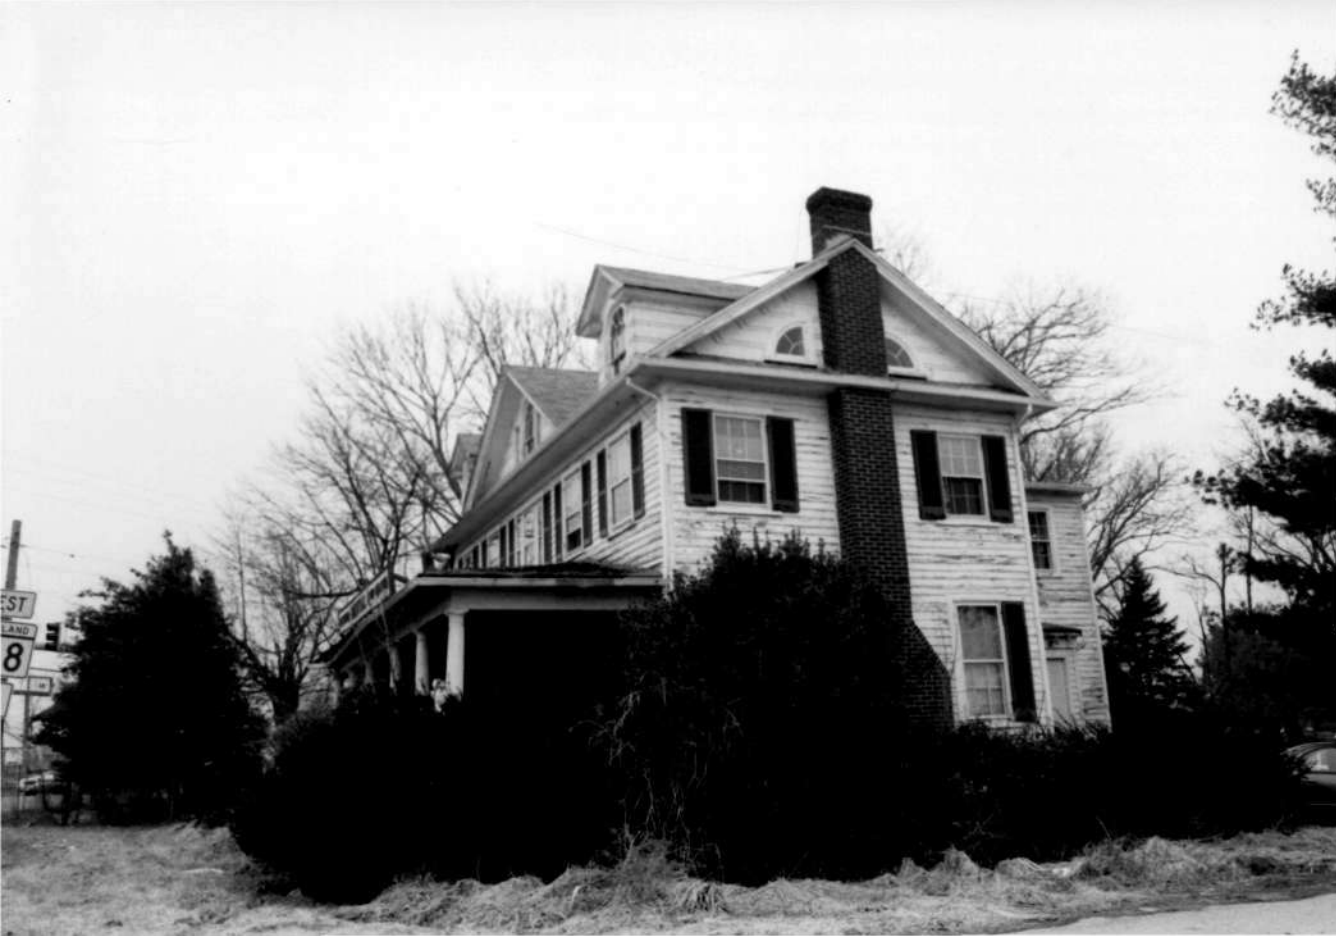
9/9

NE elevation
