1. Name of Property (indicate preferred name) historic other 2. Location 10730 Scaggsville Road street and number not for publication Scaggsville city, town X vicinity county Howard 3. Owner of Property (give names and mailing addresses of all owners) Stephen & Barbara Forney name 3368 Brantly Ct 410-977-1328 street and number telephone Glenwood MD 21738 city, town state zip code 4. Location of Legal Description courthouse, registry of deeds, etc. Howard County Courthouse liber 8809 folio 407 Ellicott City tax map 46 tax parcel 12 tax ID number city, town

Inventory No. HO-995

Maryland Historical Trust Maryland Inventory of Historic Properties Form

10730 Scaggsville Road Howard County, Maryland Ken Short, photographer

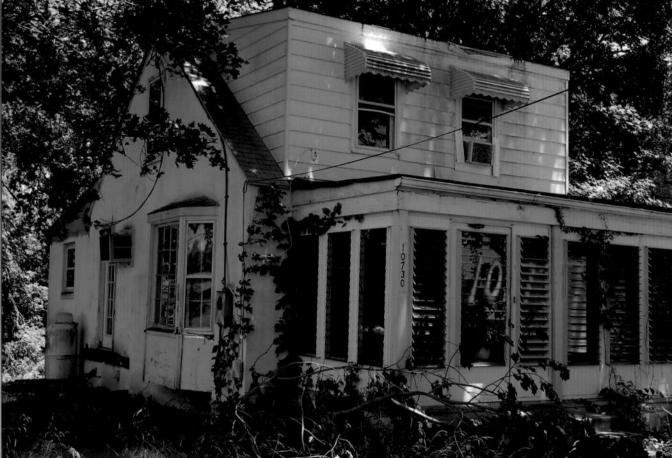
HO-0995_2009-07-08_01 Northwest & southwest elevations

HO-995 10730 Scaggsville Read Howard County, MD. Ken Short July 8, 2009 MD SHPO Northwest & Southwest Elevations

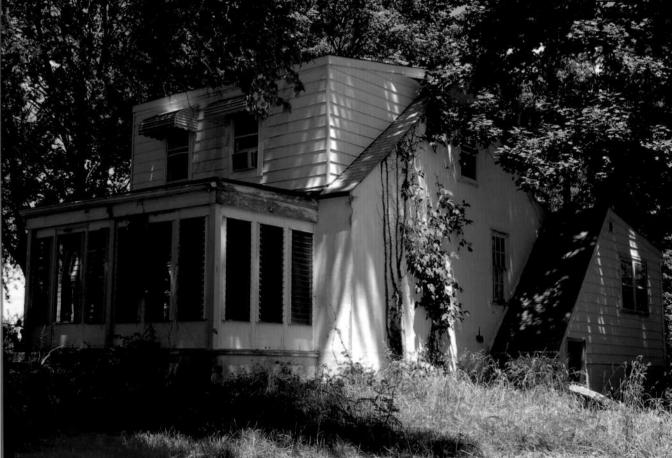
HO-0995_2009-07-08_02 Southwest & southeast elevations

40-995 10730 Scaggsville Road Howard County, MD Ken Short July 8, 2009 MD SHPO Southinest's Southeast Elevations

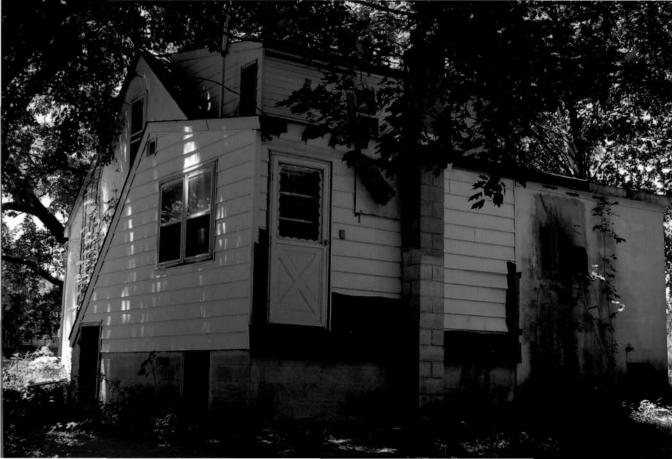
HO-0995_2009-07-08_03 Southeast & northeast elevations

HO-995 10730 Scaggsville Rocal Howard County, MD Ken Short July 8,2009 MD SHPO Southeast & Northeast Elevations

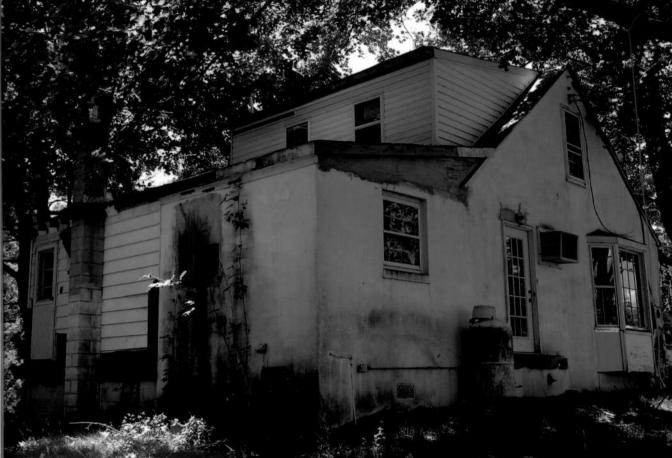
HO-0995_2009-07-08_04 Northeast & northwest elevations

40-995 10730 Scaggsville Rd Howard County, MD Ken Short July 8,2009 MD SHPO Northeast & Northwest Elevations
