HOWARD COUNTY: PIPE BREAKS - FIELD DATA

DAY: 7/26/2011
 TIME: _____
 TIME OF BREAK: _____
 ENGINEER: Chuck Garrett

LOCATION: _____
 GPS LOCATION: 3830 Spring meadow Dr

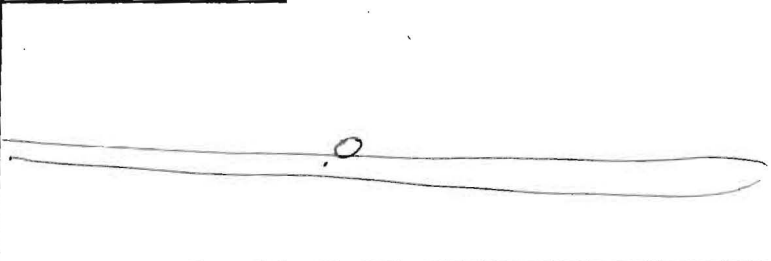
<div data-bbox="167 1648 451 1690" data-label="Section-Header"> <p>SKETCH OF SITE</p> </div>

3" Hole in Pipe

Repair Method: 6" Clamp ___ Weld ___ Cut ___ Other
