# HOWARD COUNTY: PIPE BREAKS - FIELD DATA

LOCATION:  
 GPS LOCATION: 5503 Eaglebeak Row

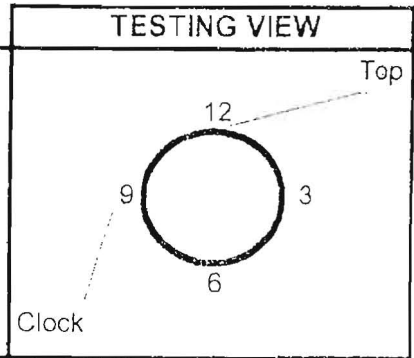
SKETCH OF SITE

6" split
