HOWARD COUNTY: PIPE BREAKS - FIELD DATA

DAY: November 2, 2010
 TIME: 9:20 pm
 TIME OF BREAK: 3:15 pm
 ENGINEER: D. Bozzell M. Tuda

LOCATION: _____
 GPS LOCATION: 8622 Bali Road

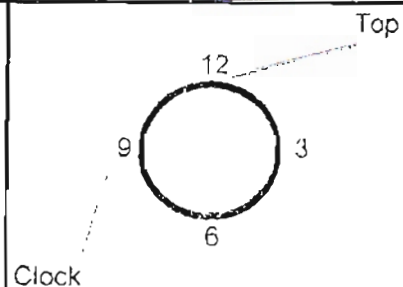
TESTING VIEW

DETAILS: 1 1/2 inches East of WMC for 8622 Bali Rd

DETAILS: 6x12 with 3/4" collar 009
