HOWARD COUNTY: PIPE BREAKS - FIELD DATA

LOCATION:
GPS LOCATION: 6680 Birch way

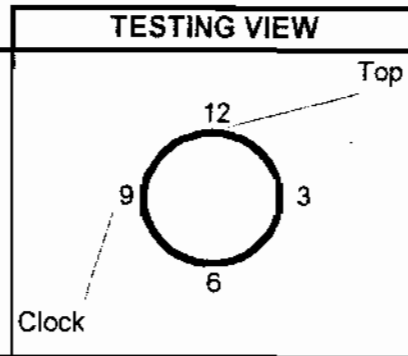
SKETCH OF SITE

DETAILS: Hole in Bottom of pipe.
