**HOWARD COUNTY DEPARTMENT OF PUBLIC WORKS
CORROSION CONTROL TEST STATION
FIELD DATA SURVEY FORM**

Location: 06+40 Date Surveyed: 06/20/2007
 T/S #: 4 Surveyed by: AS/MJ
 T/S Type: St w/Anode Contract #: 44-4227
 Pipe Size: 48"
 Was the T/S located? YES / NO YES

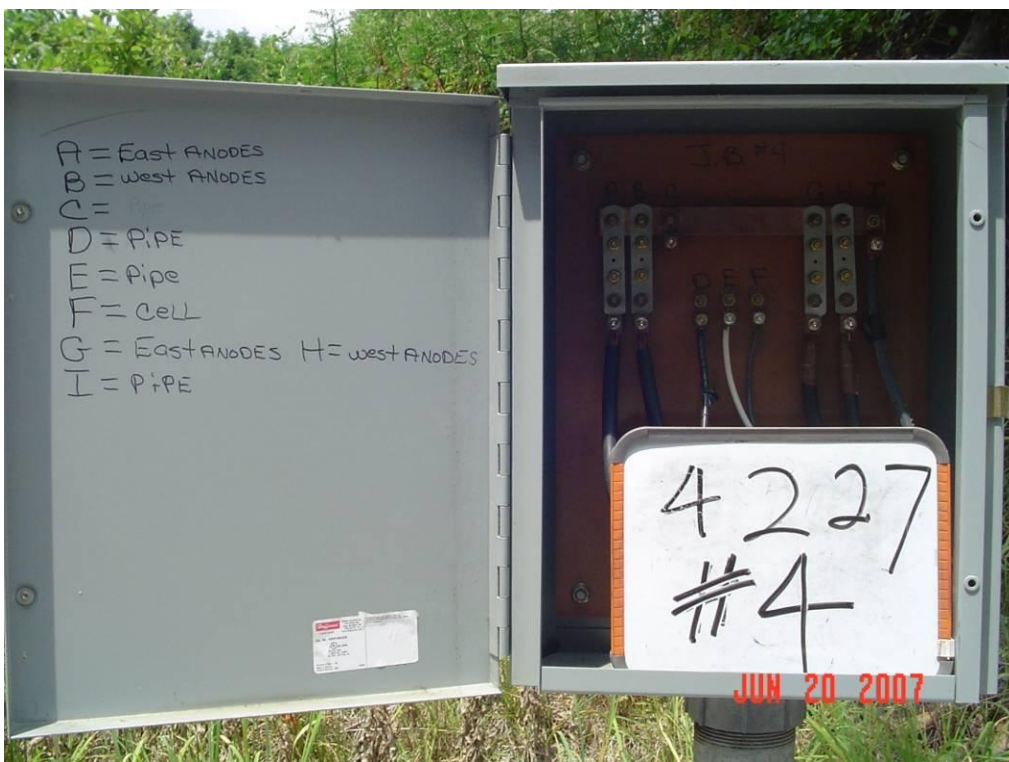
Figure 237 - Test Station 4227-4 close-up

Test Box: Above ground
 Terminal Board: 7 terminals in good condition
 Wires: Good
 Other: _____

Test Box: _____
 Terminal Board: _____
 Wires: _____
 Other: _____
 Comments/Recommendations: It appears wire connected to terminal (I) is broken underground.
