**HOWARD COUNTY DEPARTMENT OF PUBLIC WORKS
CORROSION CONTROL TEST STATION
FIELD DATA SURVEY FORM**

Location: 38+24 Date Surveyed: 06/20/2007
 T/S #: 7 Surveyed by: AS/MJ
 T/S Type: IJ w/Anode Contract #: 44-4227
 Pipe Size: 48"
 Was the T/S located? YES / NO YES

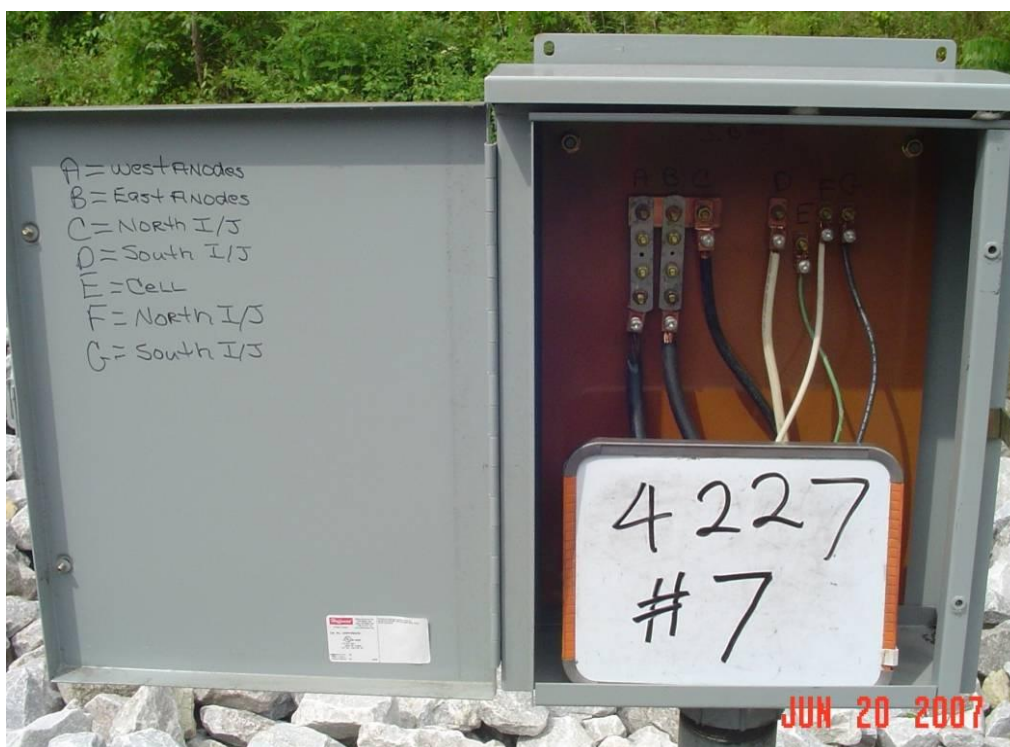
Figure 243 - Test Station 4227-7 close-up

Test Box: Above ground
 Terminal Board: 7 terminals in good condition
 Wires: Good
 Other: _____

Test Box: _____
 Terminal Board: _____
 Wires: Potentials indicate labeling on the test box door are in correct
 Other: _____
 Comments/Recommendations: IJ appears to be failing.
