HO- 1000
Daisy Schoolhouse
15910 Union Chapel Road
Private

Maryland Historical Trust Maryland Inventory of Historic Properties Form

Inventory No. HO- 1000

historic Daisy Schoolhouse

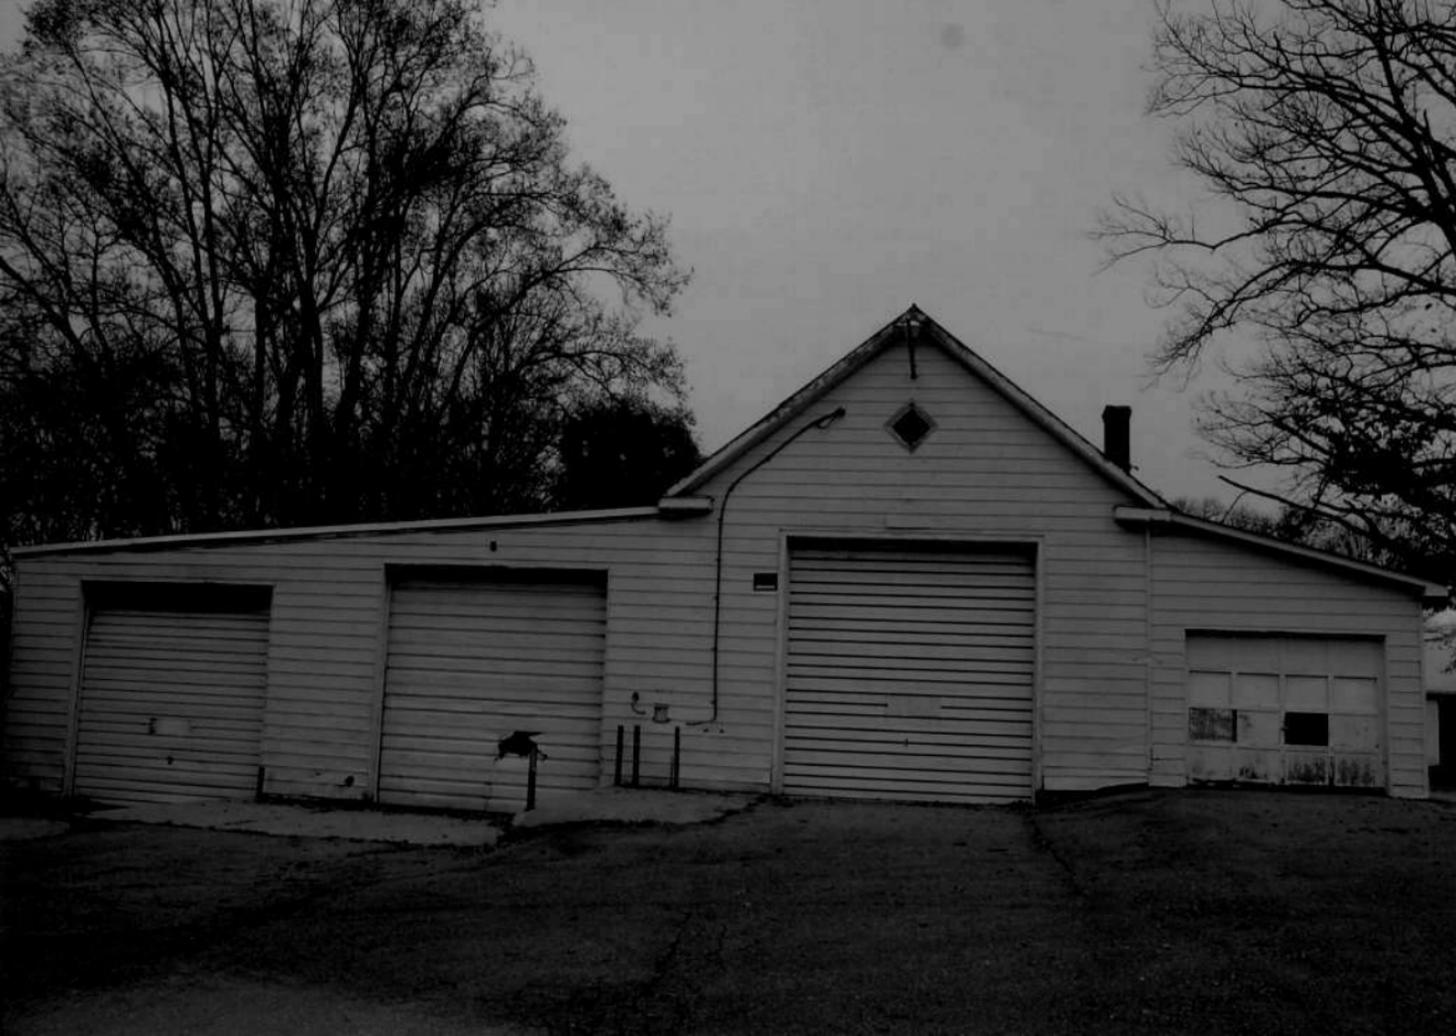
1/4

The south elevation of the main block has a large roll-up garage door in the center, and the gable end has a diamond window of one light. The building has a box cornice with returns. There is an exterior brick chimney set north of center on the east elevation, now covered by the east addition below the eave line. The north elevation has a long addition attached to it that covers everything below the eave line. The north gable end is identical to the south gable end.

South Elevation

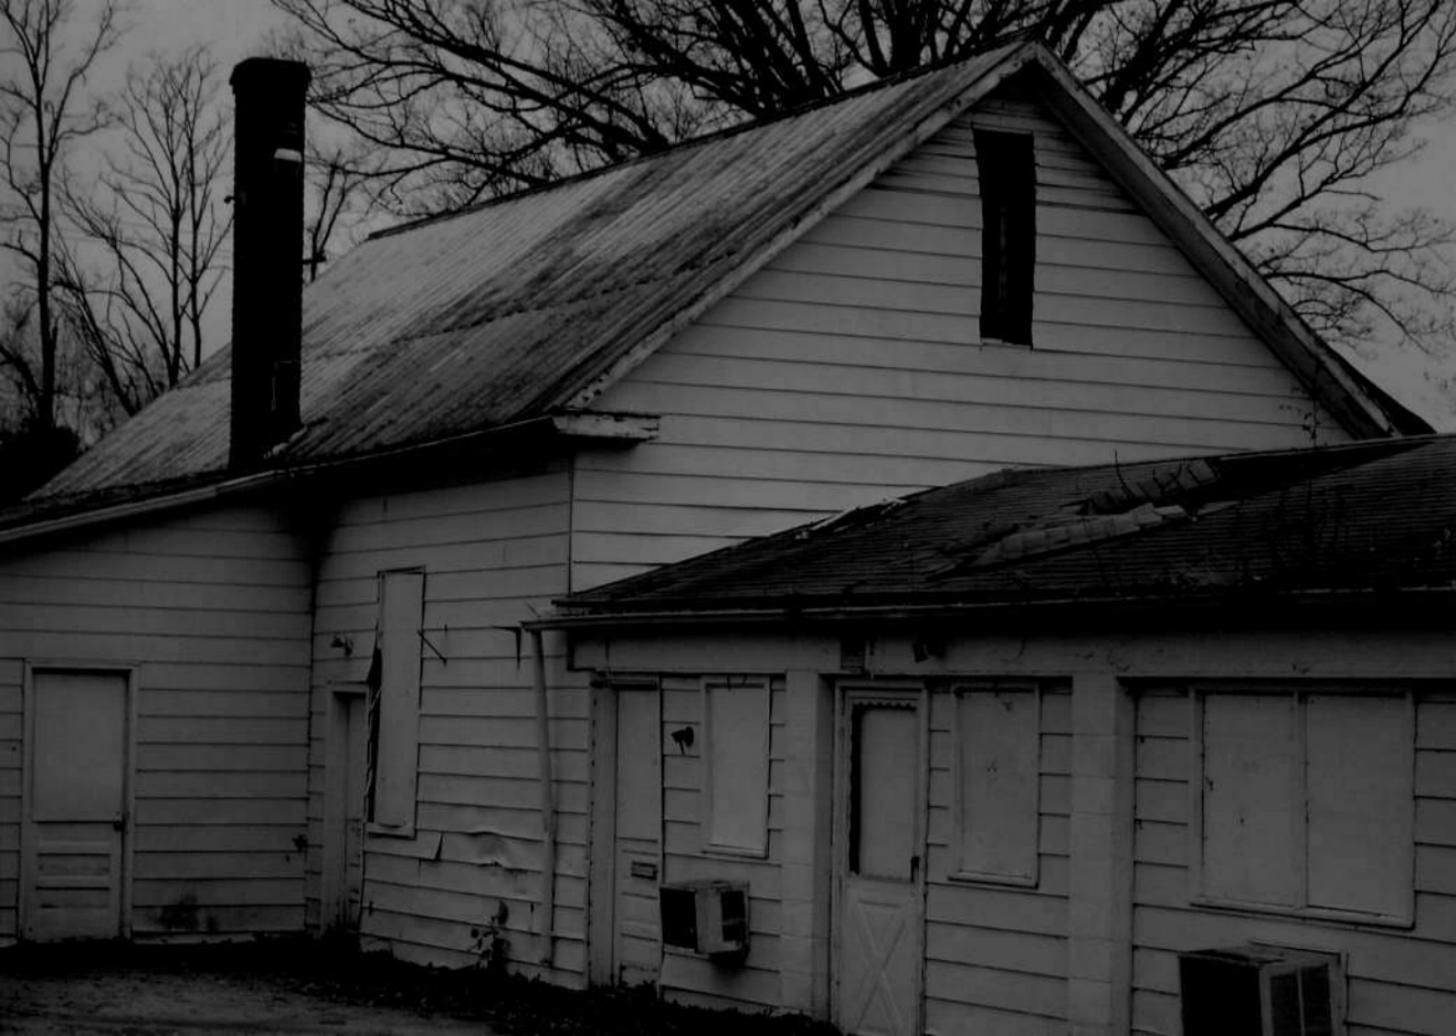
2/4

East & North Elevations

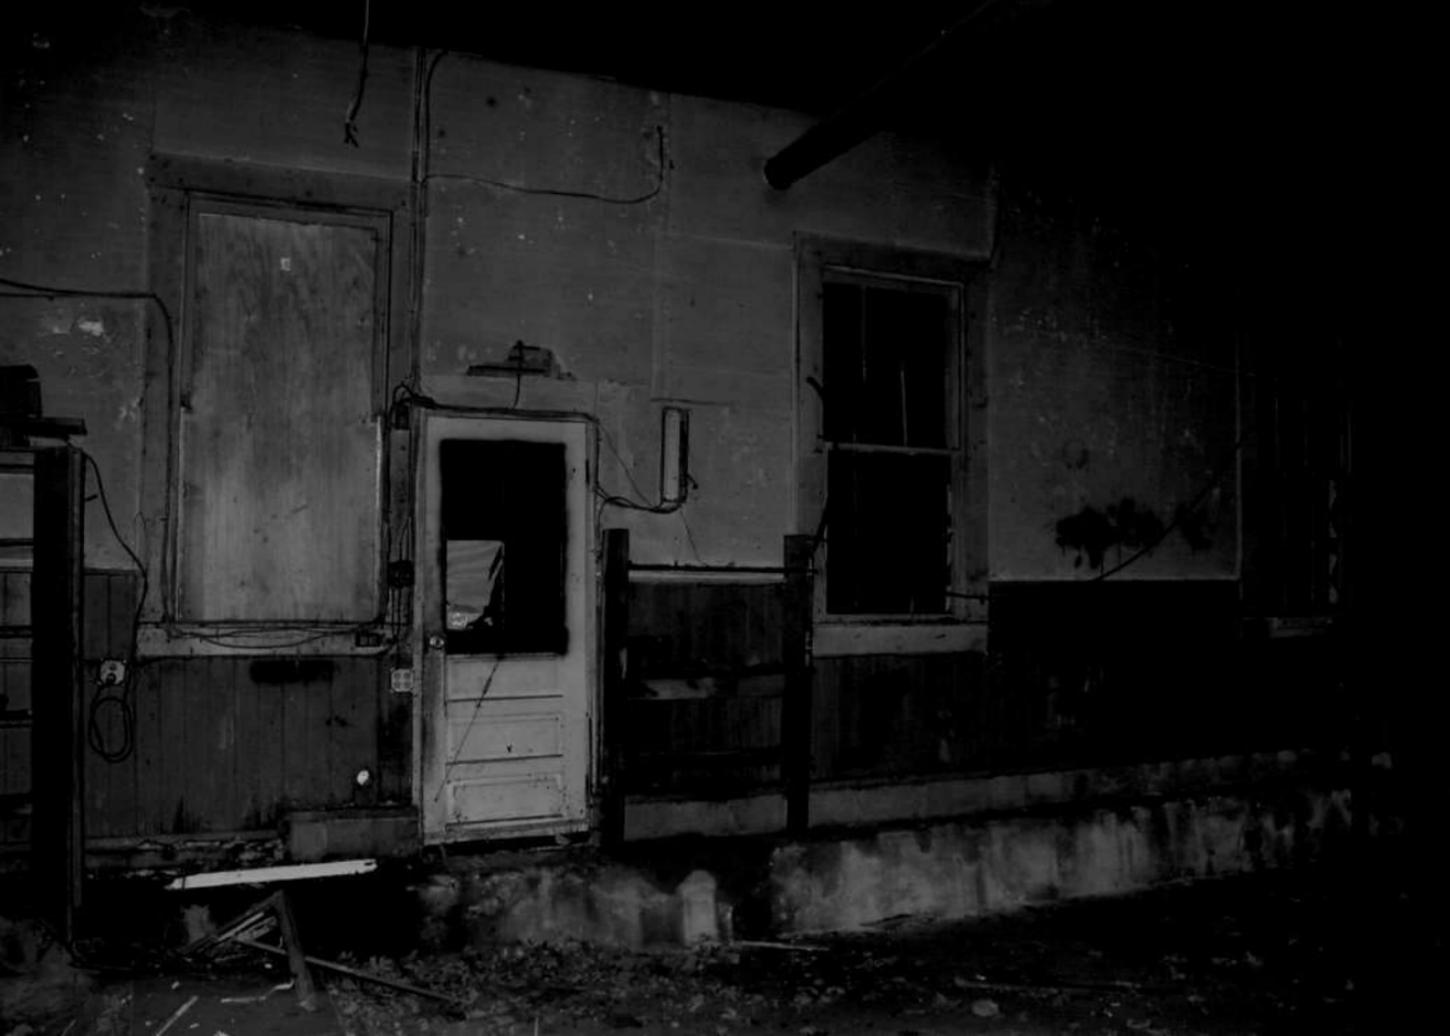
3/4

The east elevation has three six-over-six sash, with a doorway between the center and north bays that has four lights over three lying panels. This doorway appears to be cut through the wall at a later date. The north elevation has no openings, but has four horizontal boards set just above the wainscot, and the east, west, and top sides of this arrangement of boards all had a one-inch board of trim around it that has now been broken off. These boards are now painted white, but beneath it there is black paint indicating that this was a blackboard originally. The blackboard boards are machine-planed on the back side, and are tongue-and-grooved. The wainscot railing on the north end has been broken off, so it is not possible to tell how deep it was, but it projected from the wall much further than the wainscot rail on the east and west elevations. This railing probably served as a chalkboard ledge. The west elevation had three six-over-six sash, but the center one was converted to a doorway when the west addition was constructed, and the floor here slopes down to reach the floor level in the addition; the top of the sash has been closed off. The ceiling is masonite.

Interior, East Elevation

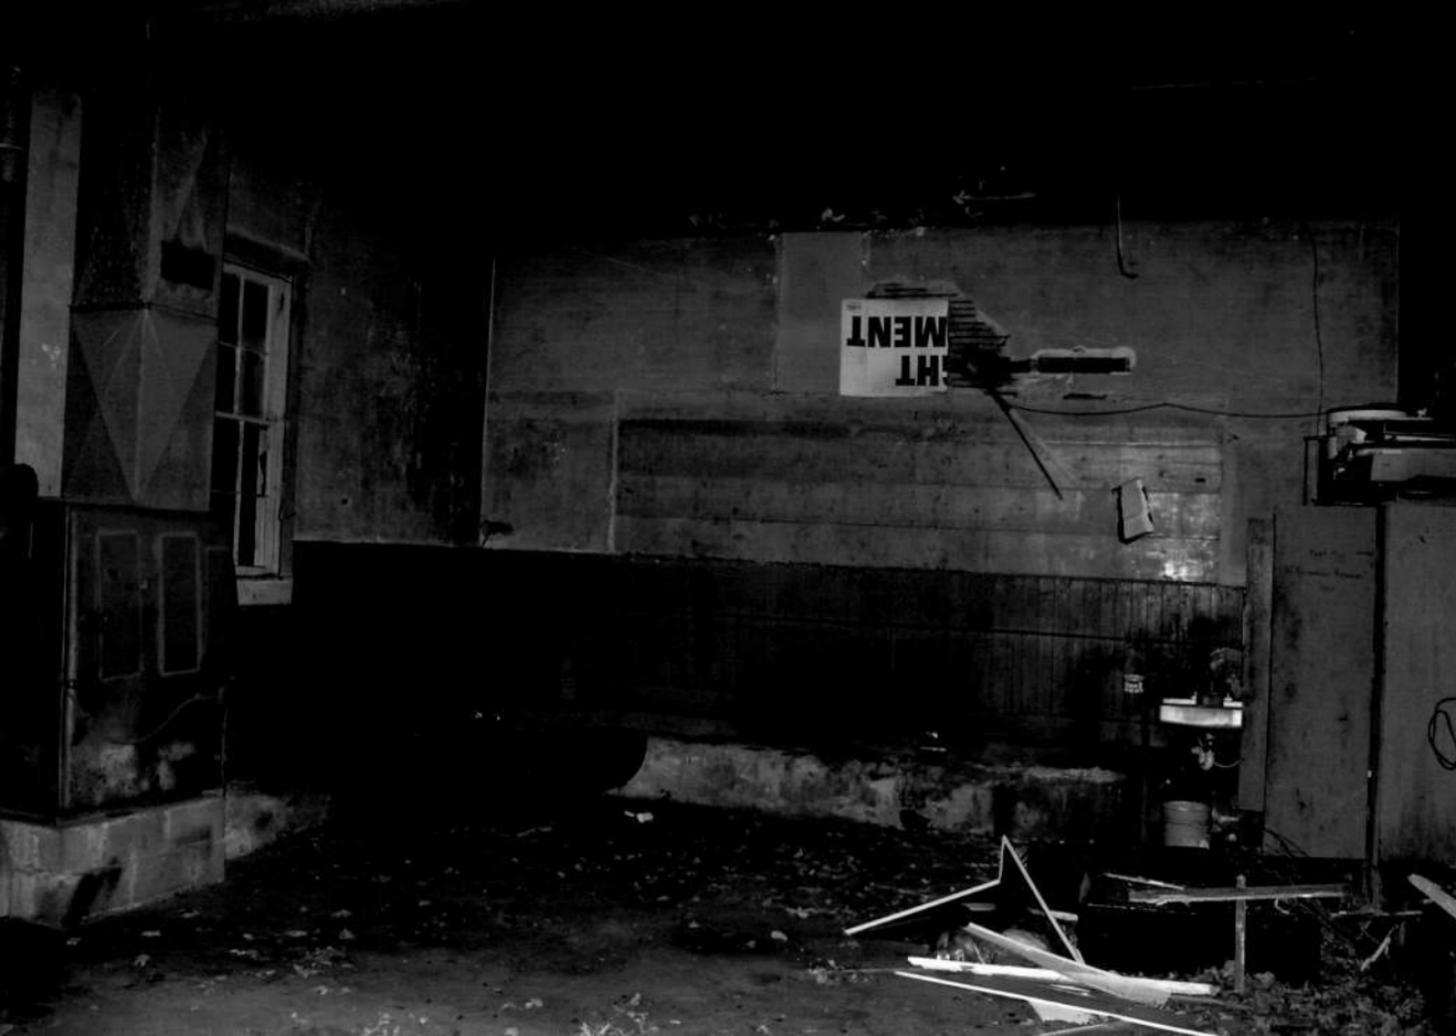
4/4

Interior, view northwest
