Maryland Inventory of Historic Properties number: ~~HO-35~~ HO-662

Name: Hopsley Mill Rd, over Cabin Rd.

Maryland Historic Highway Bridges
Bridge Type Metal Girder
Map D-10 Damascus #0-662
County Howard
Bridge # and name HO 35/Hipsley Mill
Rd. over Cabin Branch

MARYLAND INVENTORY OF HISTORIC BRIDGES
HISTORIC BRIDGE INVENTORY
MARYLAND STATE HIGHWAY ADMINISTRATION/
MARYLAND HISTORICAL TRUST

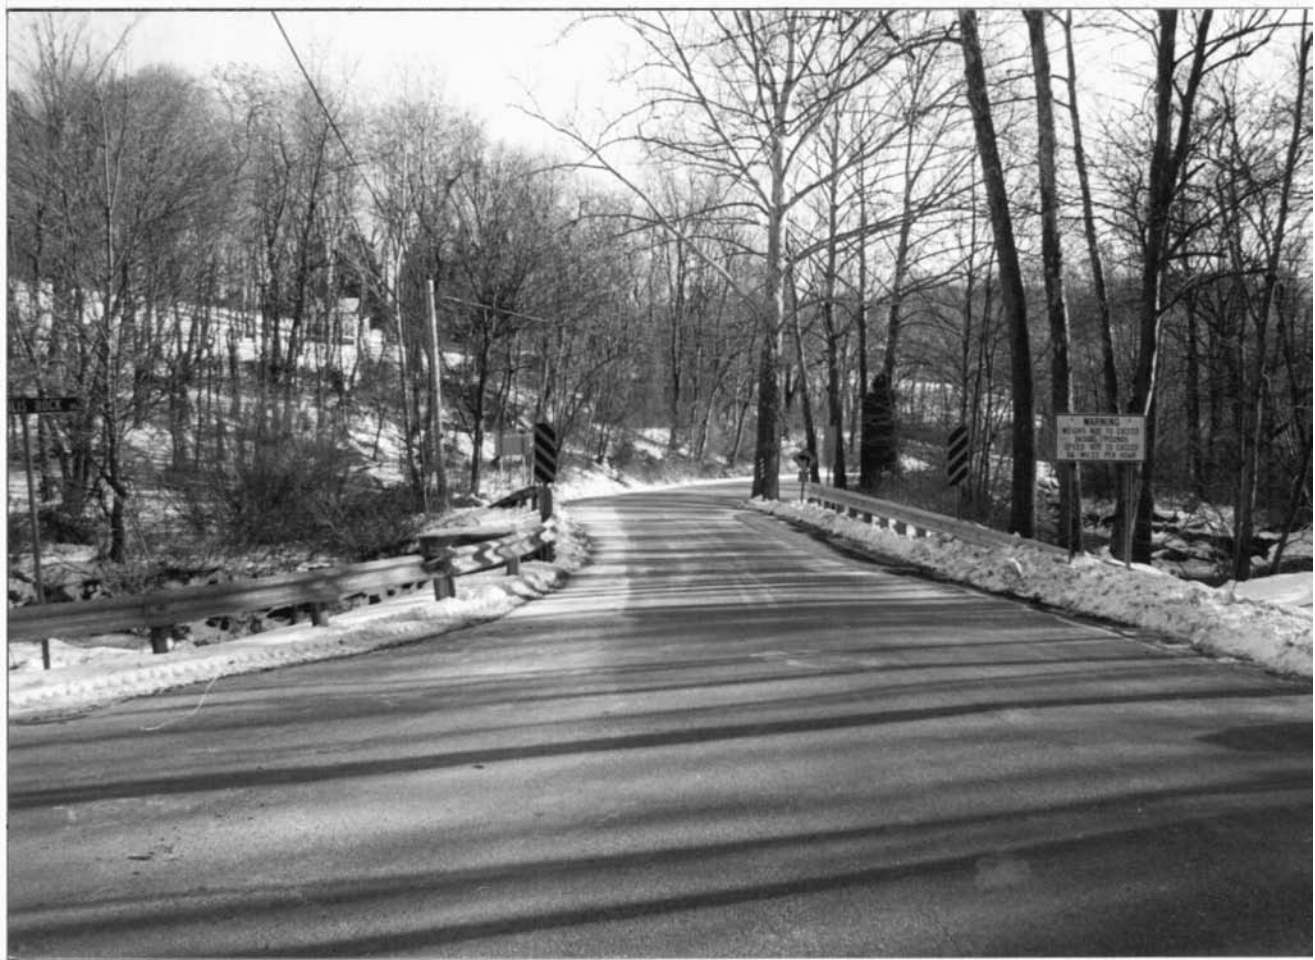
Number 1 4
13 of 31

Description SOUTH APPROACH LOOKING
NORTHEAST

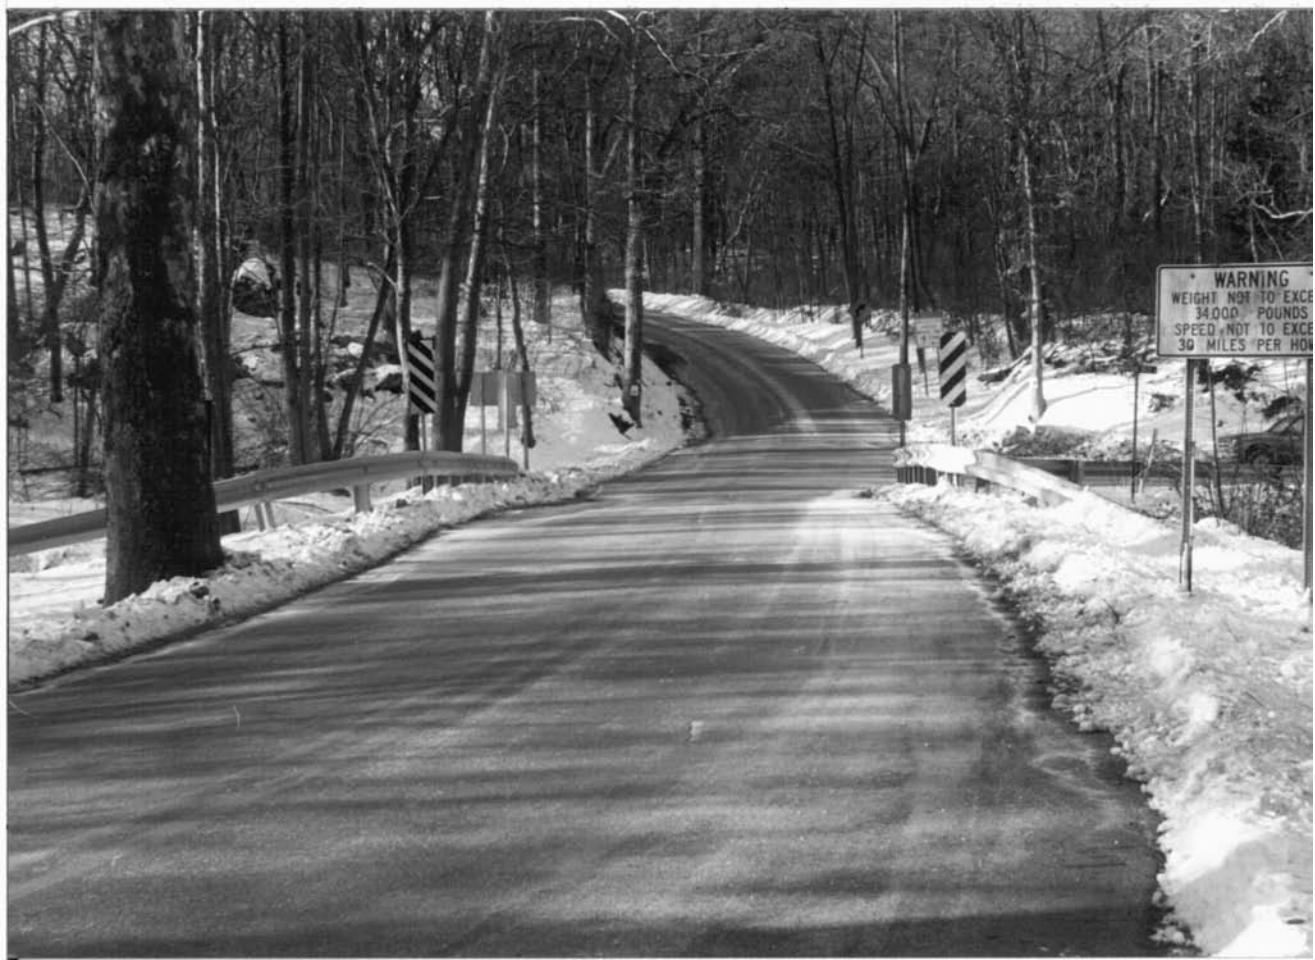
Number ²~~14~~ of ⁴~~31~~

WARNING
WEIGHT NOT TO EXCEED
34,000 POUNDS
SPEED NOT TO EXCEED
30 MILES PER HOUR

Description NORTH APPROACH LOOKING
SOUTH WEST

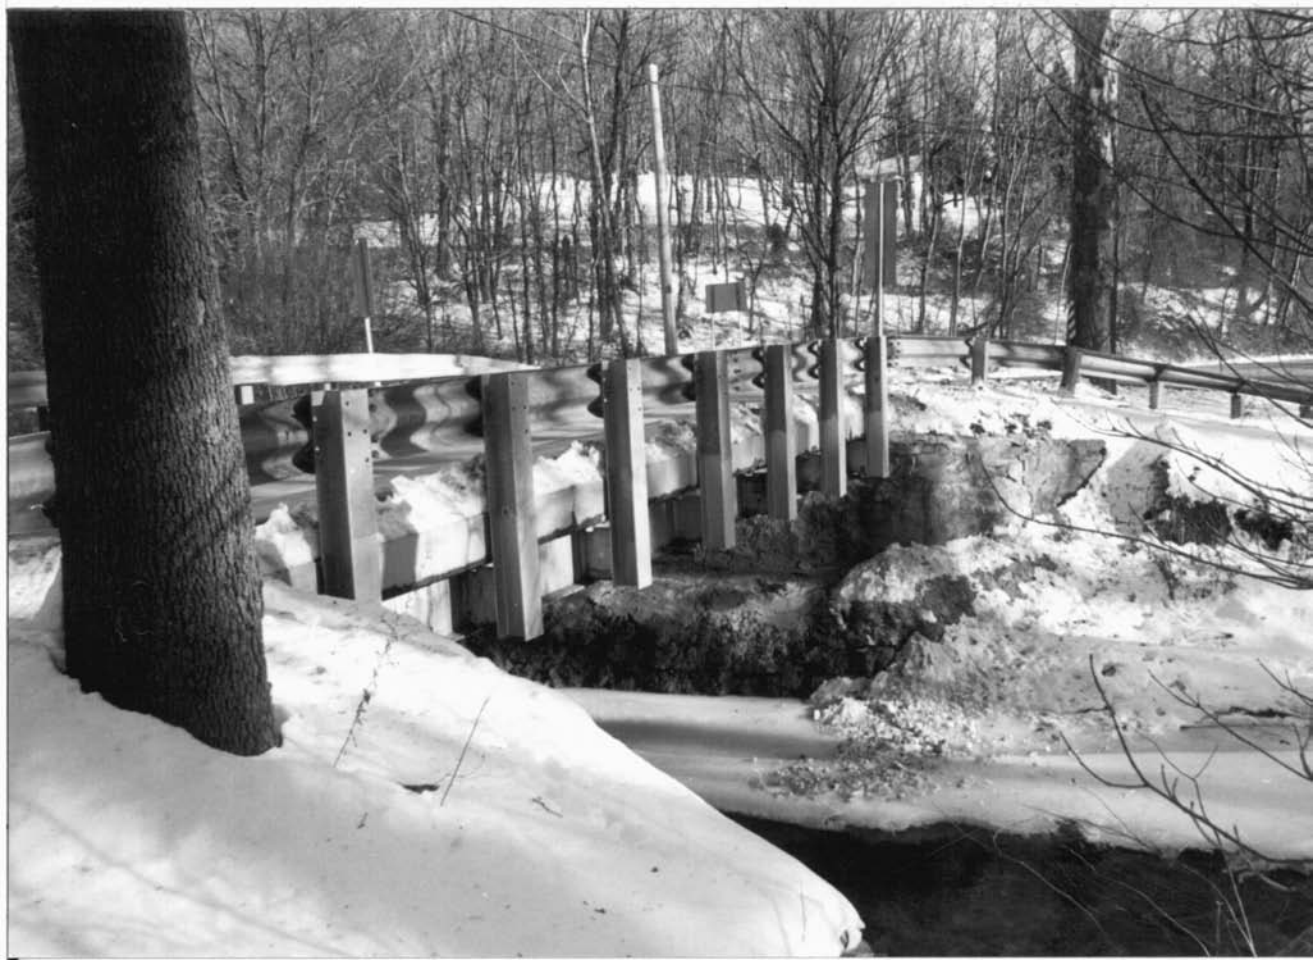
Number 15 of 21

Description EAST ELEVATION LOOKING

~~WEST~~ NORTH

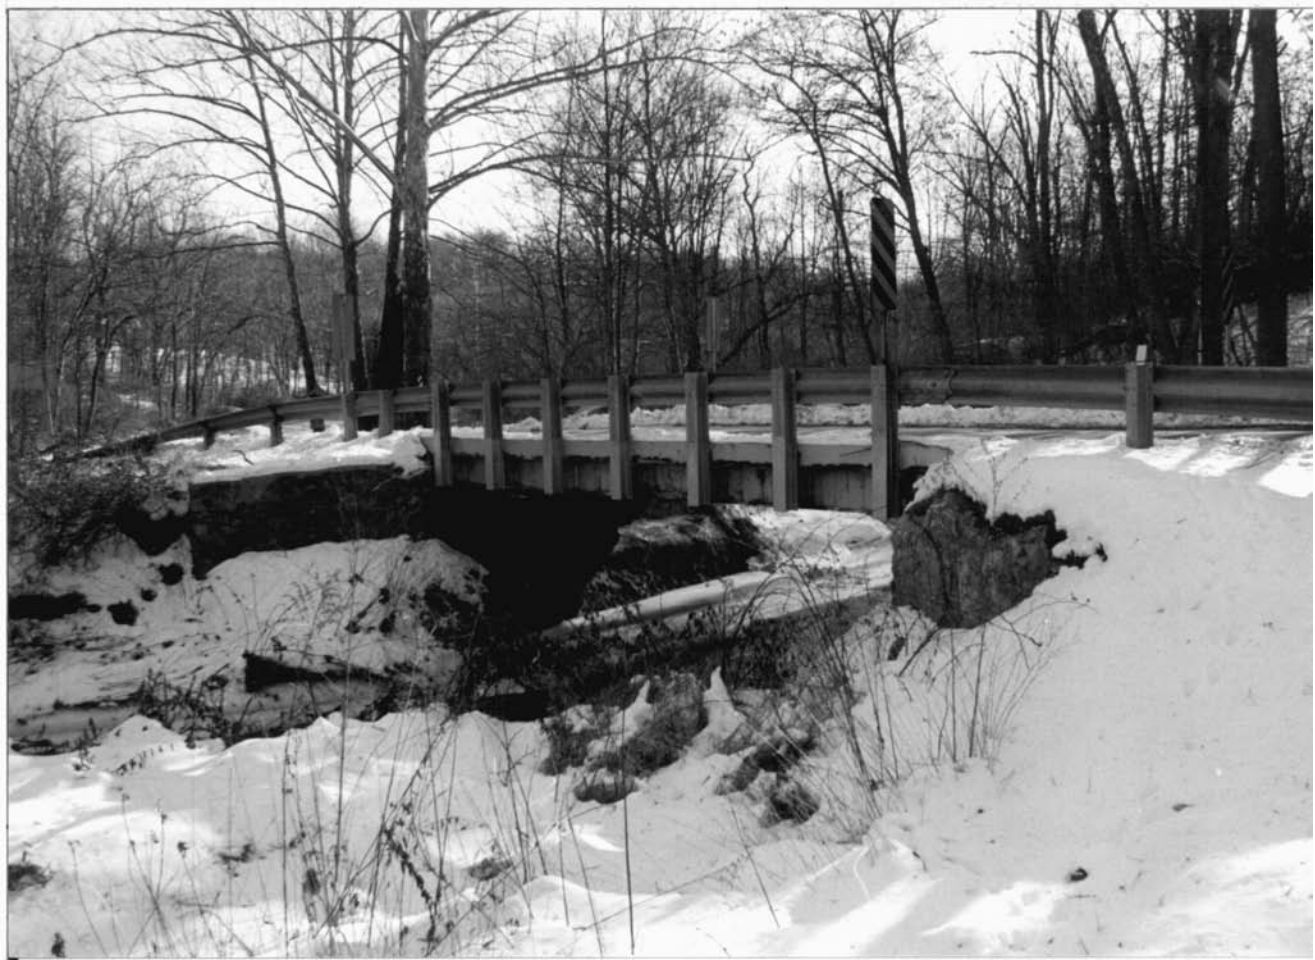
Number 4 of 4
~~X6~~ of 31

Description WEST ELEVATION LOOKING
EAST
