**MARYLAND HISTORICAL TRUST
NR-ELIGIBILITY REVIEW FORM**

Property Name: Small Structure No. 13166X0 Inventory Number: HO-753

Address: MD 983 over Tributary of Patuxent River City: Laurel, MD Zip Code: N/A

Project: MD 983 over Tributary of Patuxent River Agency: SHA

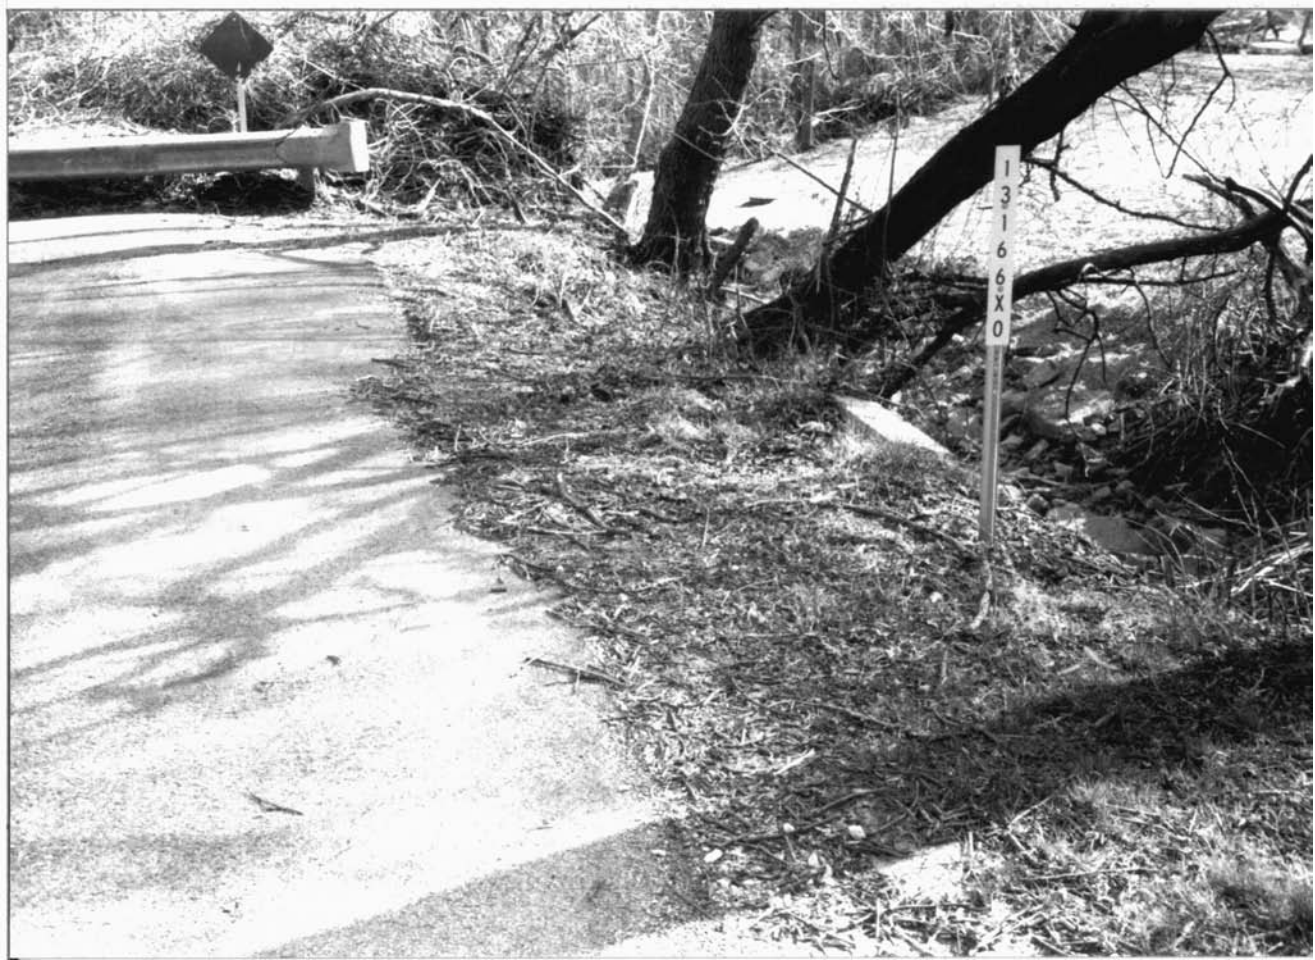
3/4

View of Inlet and (unclear) at
road [unclear]
