HO-948 Washington Boulevard near Oak Meade Way Waterloo vicinity

Maryland Historical Trust Maryland Inventory of Historic Properties Form

HO-948

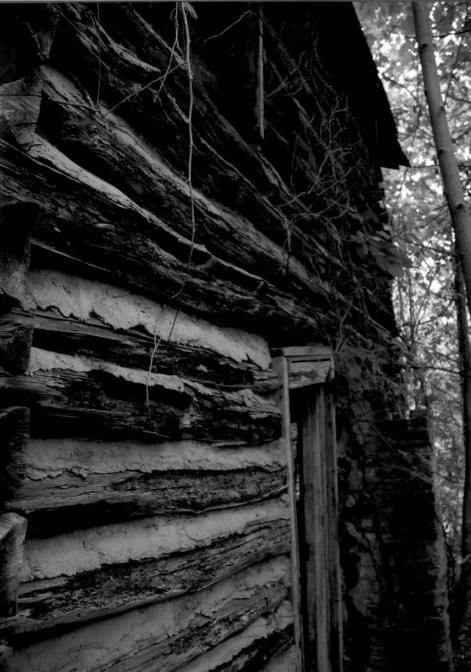
40-948 Washington Blod nr. Oak Meade Way Howard G. MD Ben Short, photographer 9-14-07 Southeast elevation

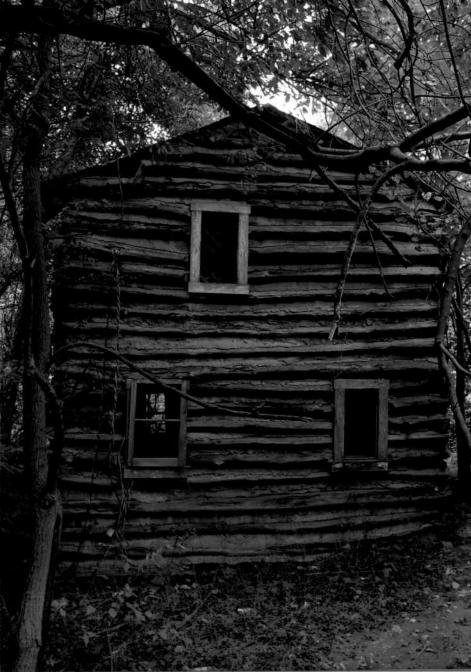
Ho-948 Washington Blod nr. Oak Meade Way 40-948 Howard Co MD Ben Short, photographer 9-14-07 Southwest elevation

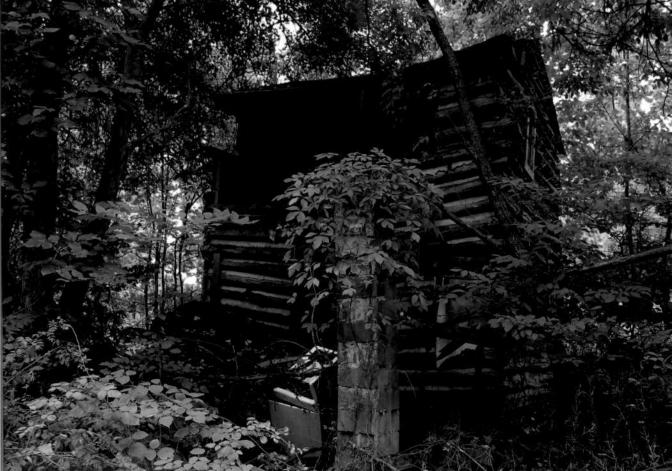
HO-948 Washington Blod na Ook Meade way Howard & MD Ken Shout, photographer 9-14-07 Morthwest elevation

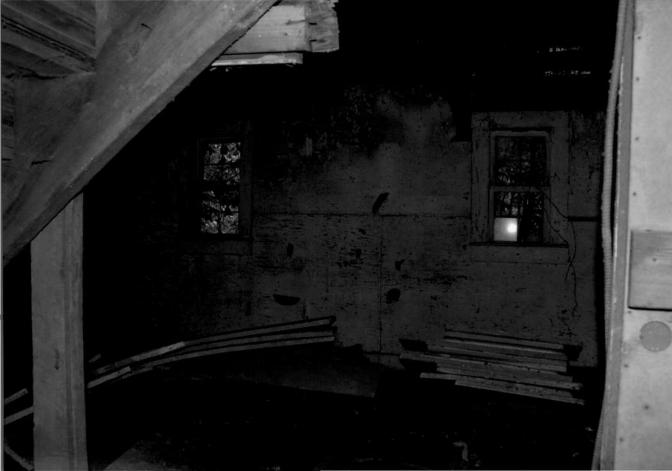
1111 Ho-948 Washington Blod no Oak Meade Howard COMD Way Ken Short, photographer 9-14-07 Interior, view northeast
