HO-989

Walter and Sadie Smith House  
14459 Frederick Road, Cooksville  
Private

# Maryland Historical Trust Maryland Inventory of Historic Properties Form

historic Walter and Sadie Smith House

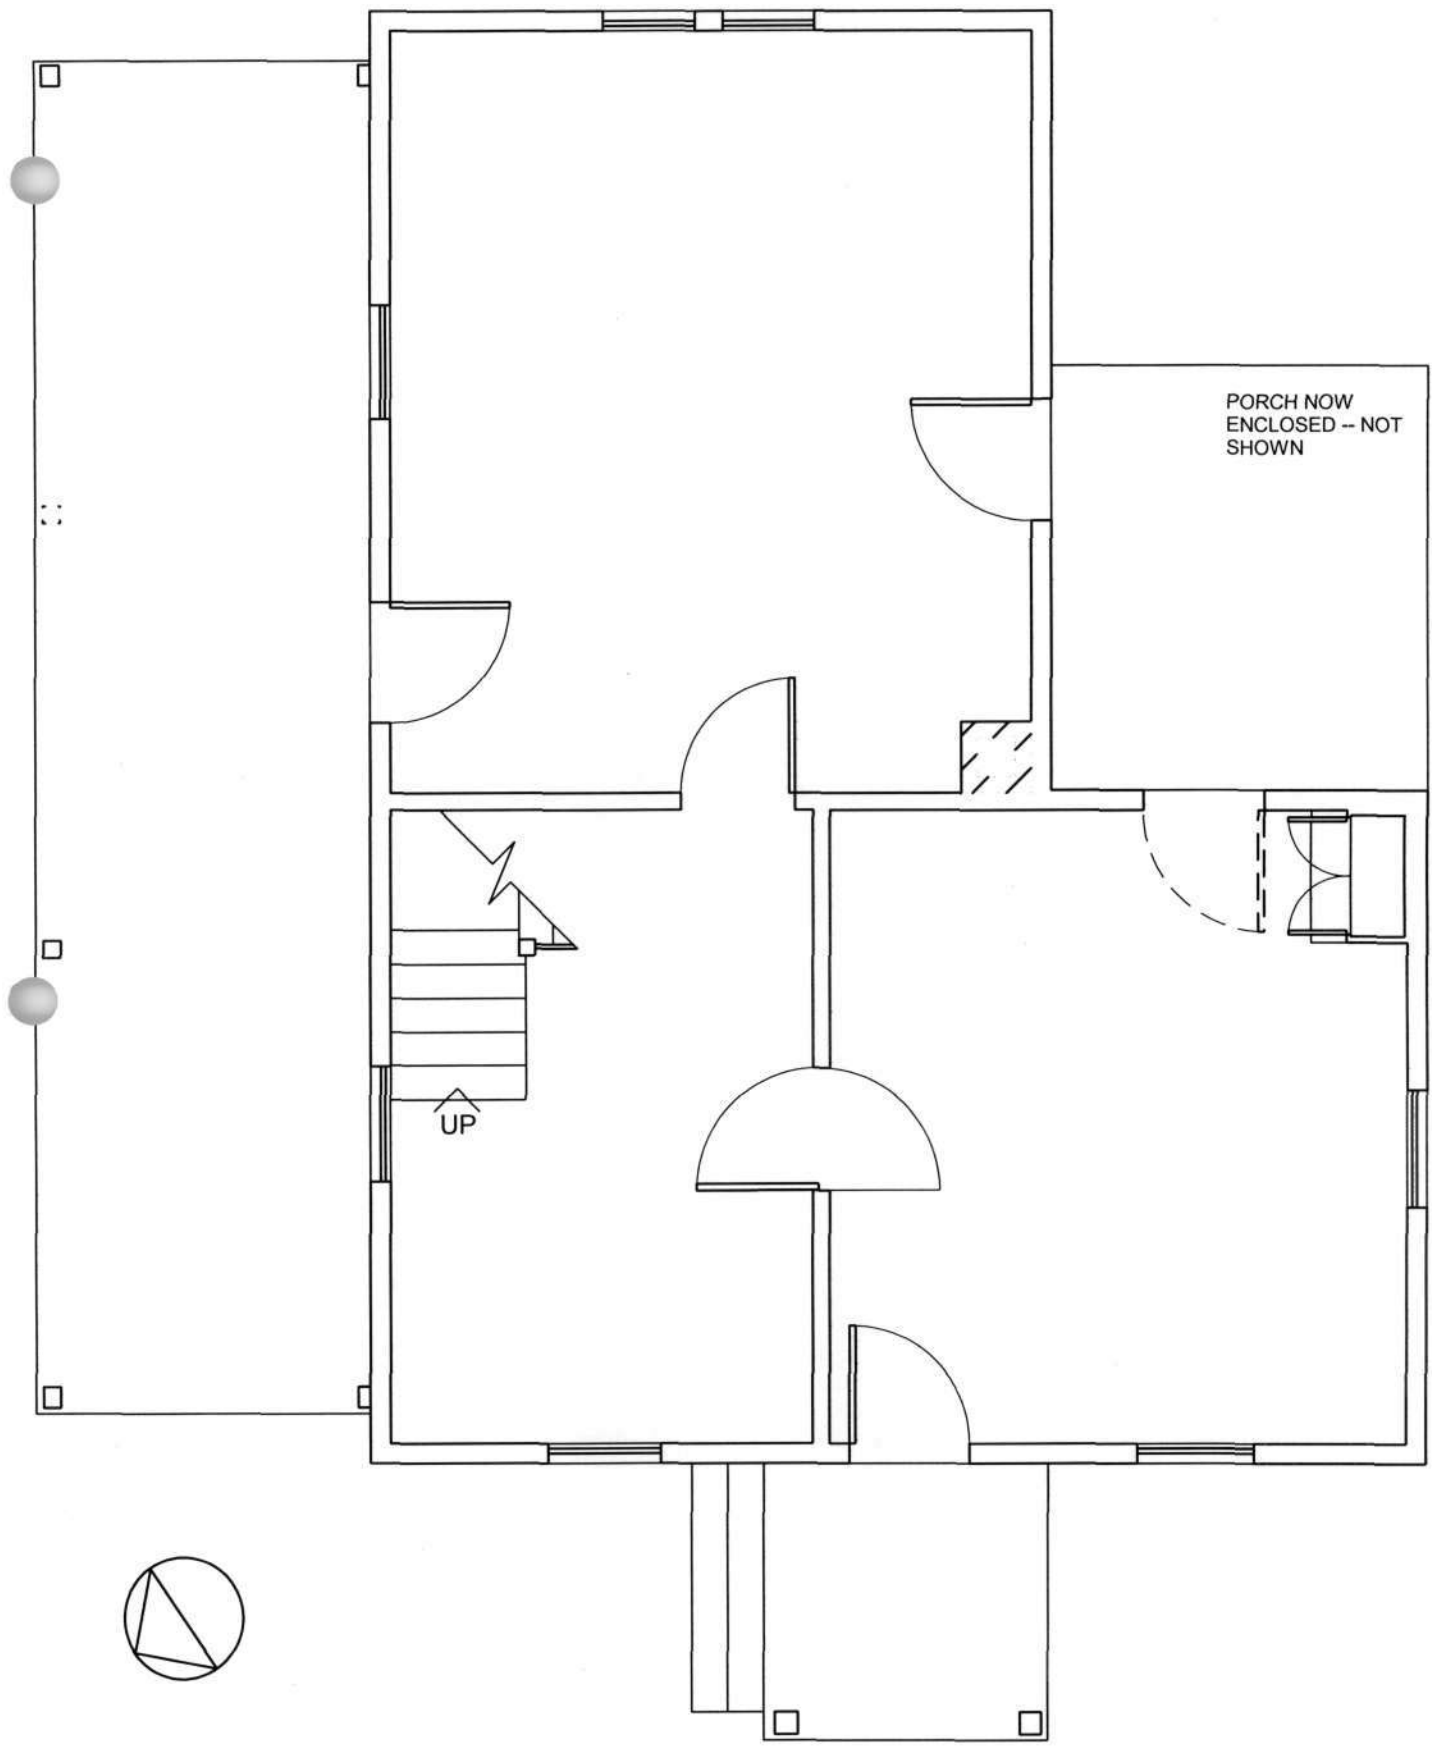
HO-989 WALTER & SADIE SMITH HOUSE 11459 FREDERICK ROAD  
FIRST FLOOR PLAN -- MEASURED AND DRAWN BY KEN SHORT -- APRIL 2009

PORCH NOW  
ENCLOSED -- NOT  
SHOWN

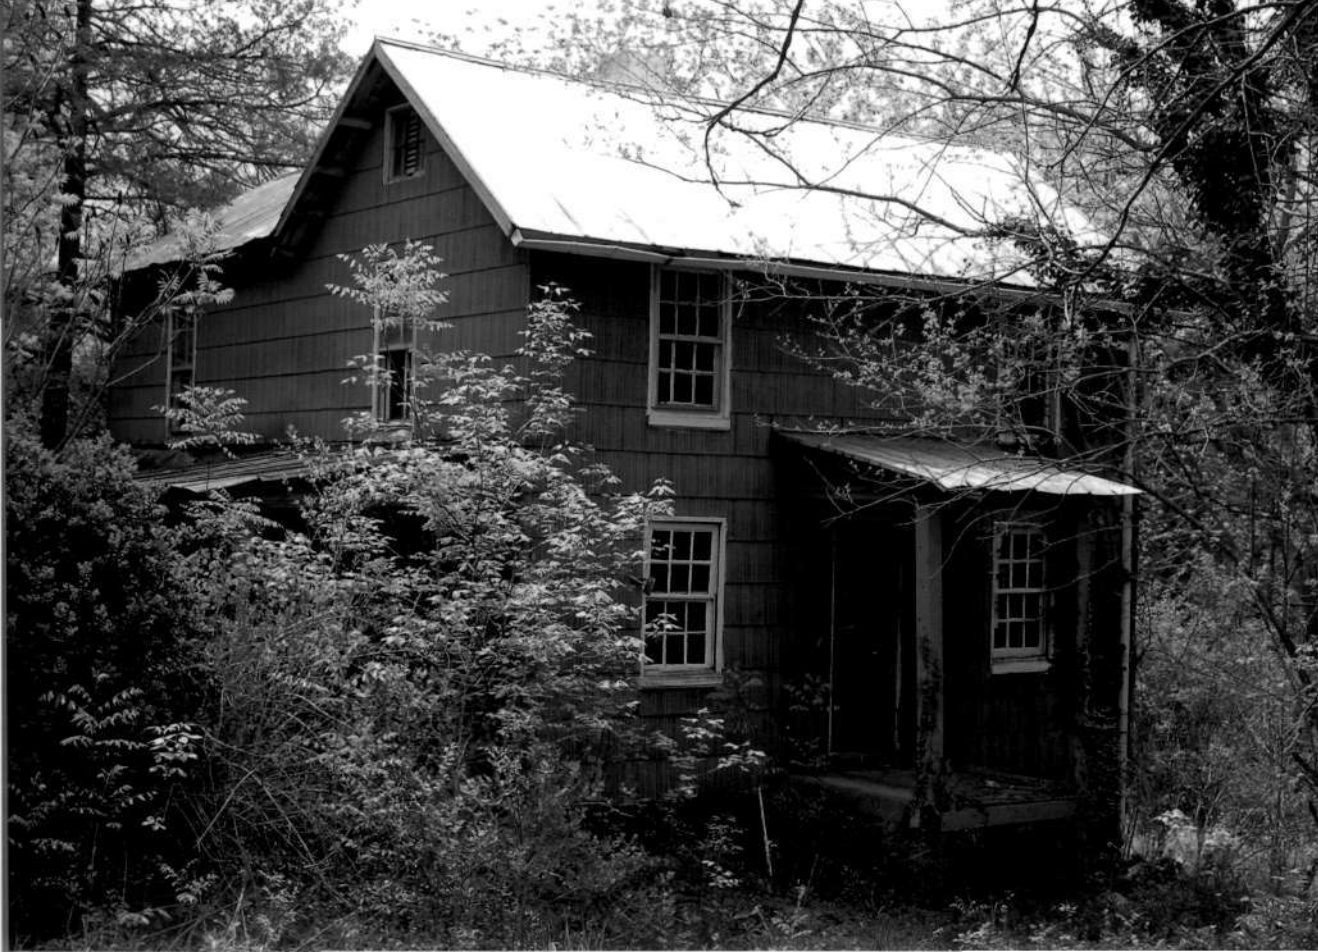
1/4

On the west elevation the basement has a window opening in each of the end bays, and these openings have been altered. The first story has a center door with five lying panels set in a beaded-interior-edge frame. There is a single six-over-six double-hung sash to each side of the door, and they have a wood sill, the same frame as the door, and a mortised and tenoned and pinned sash that has 8-inch by 10-inch lights. There is a one-story, one-bay porch with butted boards in the deck, square wood posts, and a bead-board soffit. It has a shed roof with inverted-V-seam metal roofing and ogee siding on the sides. The second story has a typical six-over-six sash in each end bay with no opening in the center.

The north elevation has a door in the center of the first story, which is the west bay of the ell, and it has six lights over two lying panels; the panels are sunken and flat, with no panel moulds. There is a two-over-two double-hung sash to each side with the same sills and frame as on the west elevation. There is

House, North & West Elevations

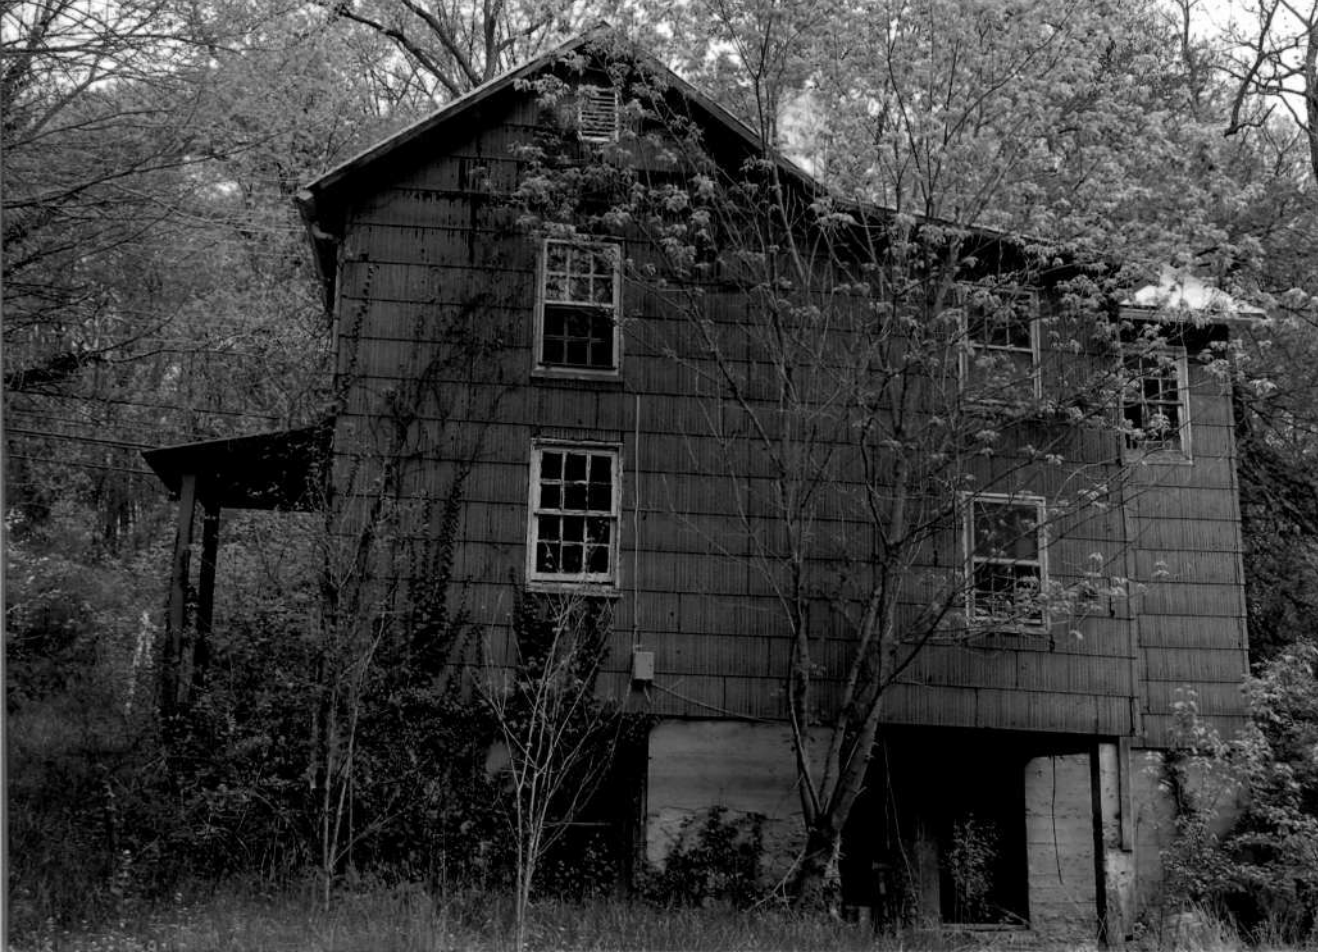
2/4

On the south elevation the basement is exposed, since the ground slopes down to the south toward a small stream. The main block has a door with beaded-edge vertical boards. The ell has a door under the open addition with six lights over two panels. It has sunken fields and ogee panel moulds, and is hung on cast iron foliate butt hinges with ball finials. The first and second stories each have a typical six-over-six sash on both the main block and the addition. The gable end has a vent. The first story of the ell has no opening in the east bay, and the second story has a typical six-over-six sash in the east bay.

House, South Elevation

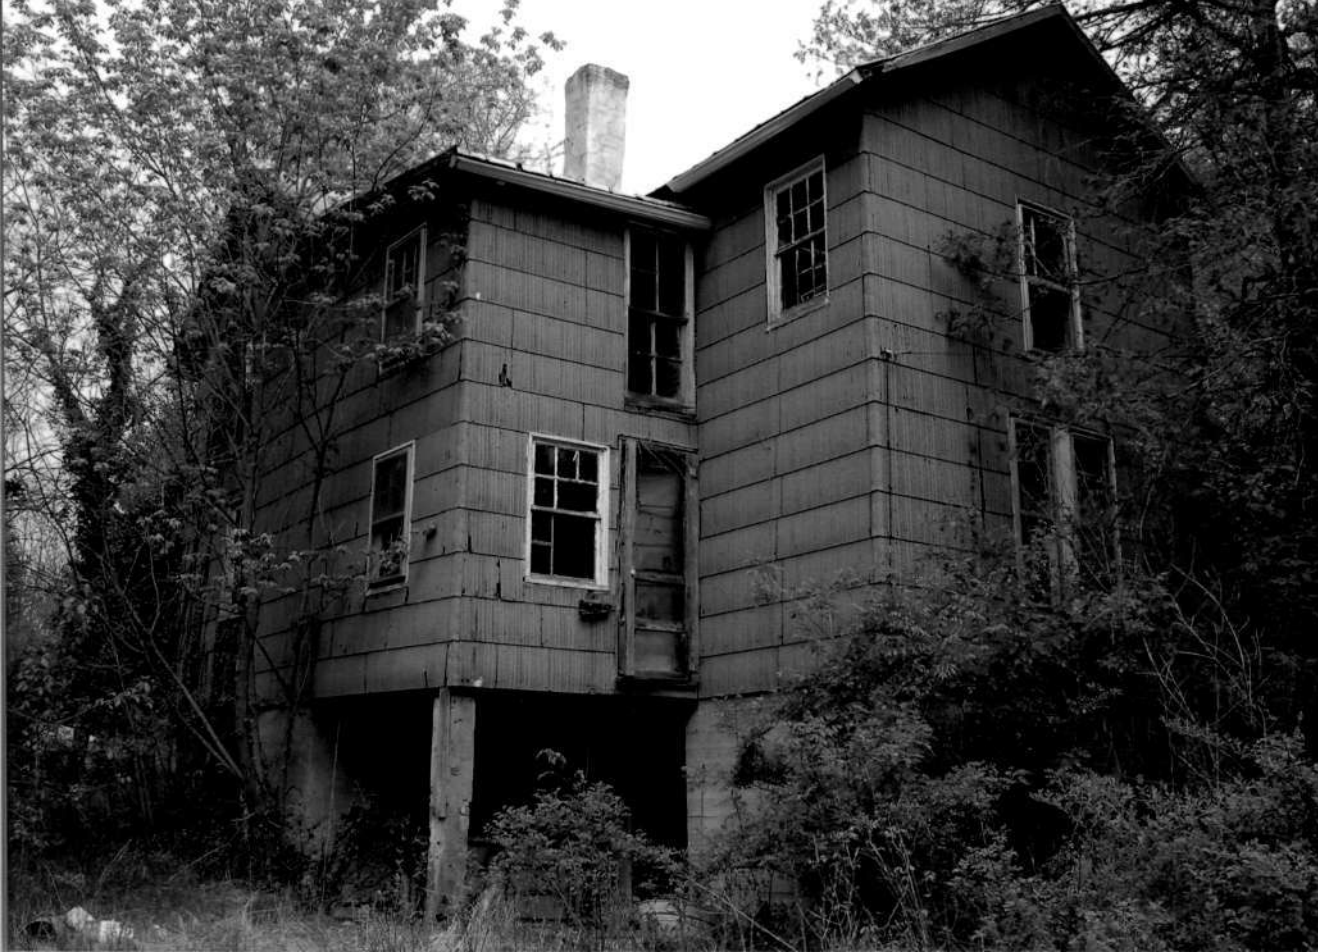
3/4

The east elevation of the addition, on the first story, has a six-over-six sash to the south and a door with five lying panels to the north. The second story has a large four-over-four double-hung sash that extends down to the floor. The basement of the ell has a large six-over-six sash that is full height, extending down to the ground level. The first story of the ell has paired one-over-one sash with a wide mullion between them, and the sash has a bullnose frame. The second story has a six-over-six sash, and there is no opening in the gable end.

South & East Elevations

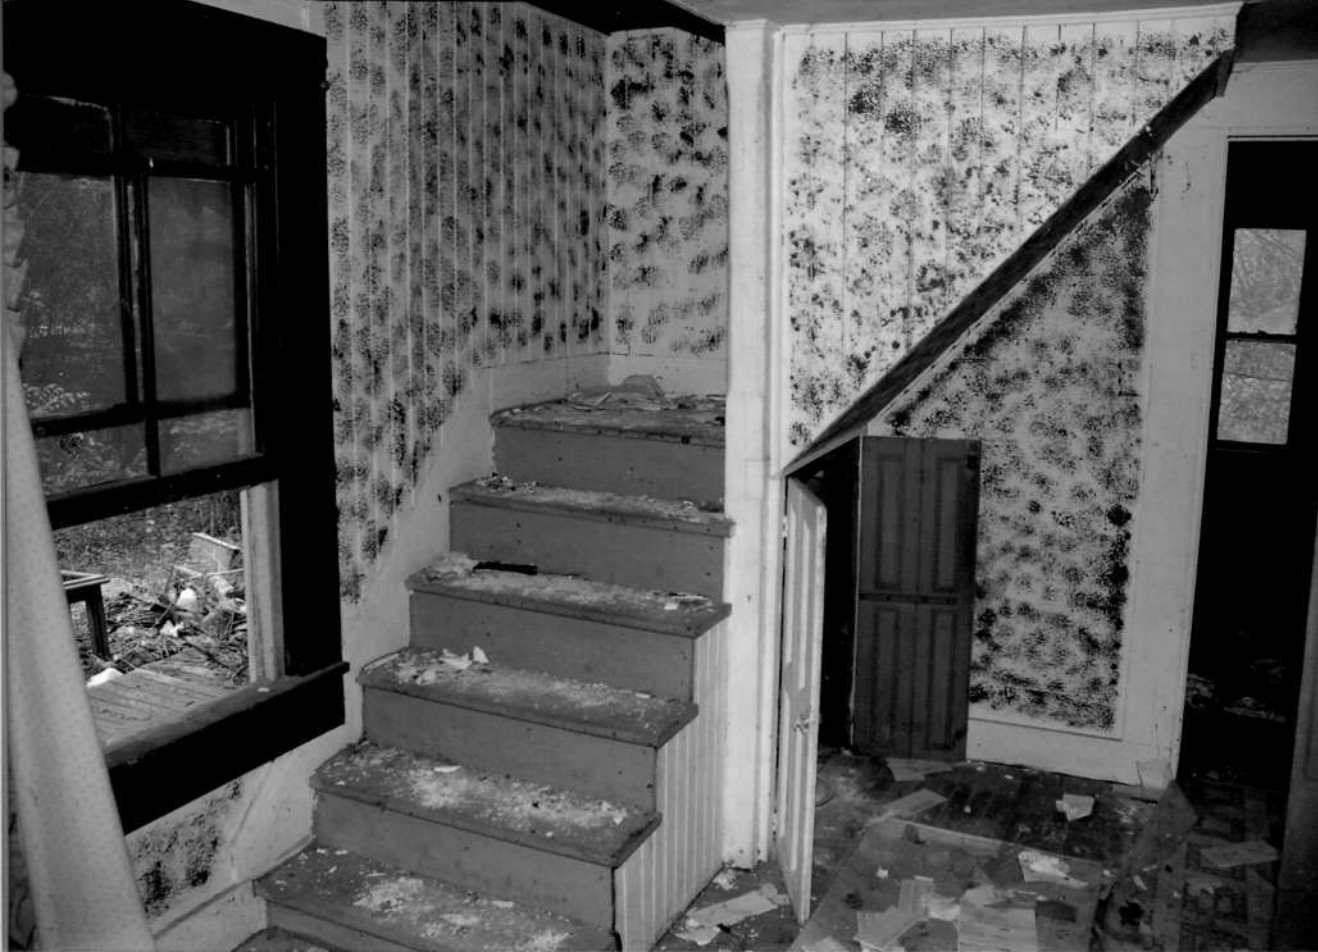
4/4

The main block has two rooms on the first story, and there is one room in the ell. The west door opens into the south room, and the north door opens into the ell. There is 2 ¼-inch tongue-and-groove flooring that runs east-west throughout the house, and this appears to be pine. There is plain baseboard and plain head cut trim, with plywood on the ceiling. The sash have no parting beads. The door between the north and south rooms has five lying panels and is a swinging door. In the north room the northeast corner has a two-run stair with beaded-edge vertical boards on the wall and the sides of the stair, while the stair is open on the bottom half. The landing newel is chamfered above the level of the landing. There is a closet beneath the stairway, and the doors here are reused shutters. The door to the ell has five panels, with one lying panel in the center, and they have sunken fields and quirked ogee moulds

Northwest room, view northeast
