# HOWARD COUNTY: PIPE BREAKS - FIELD DATA

DAY: July 14, 2010  
 TIME: 17:50  
 TIME OF BREAK: 14:30  
 ENGINEER: Tom Miller / Matt Teoder

LOCATION:  
 GPS LOCATION: 5458 Watercross Place  
contact 358 WAS

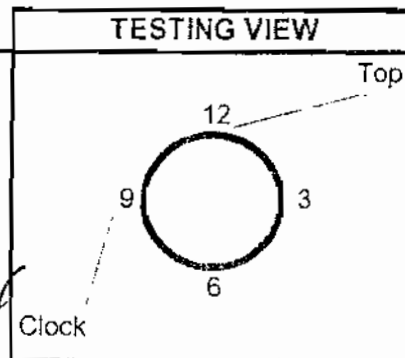
**SKETCH OF SITE**

two holes on bottom of pipe

second hole developed two feet from the first repair. excavation was filled with CRT and capped with cold patch when the water surfaced the second time

two three-inch full circle clamps
