# HOWARD COUNTY: PIPE BREAKS - FIELD DATA

**LOCATION:**  
 GPS LOCATION: 5785 Paradise Ave

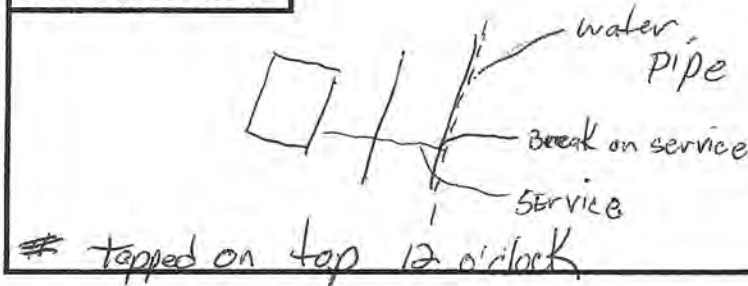
**SKETCH OF SITE**

*on service poly blue*
