# HOWARD COUNTY: PIPE BREAKS - FIELD DATA

DAY: 7-28-2009

GPS LOCATION: 6246 Sunny Spring

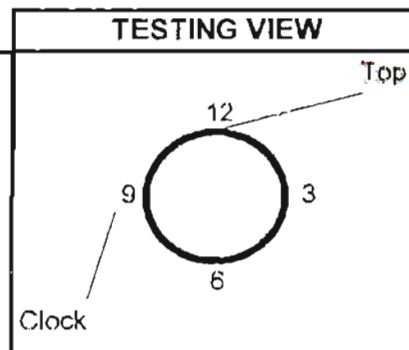
**SKETCH OF SITE**

**DETAILS:** 2 breaks within 4' 18" section blew out.

Form of Break: \_\_\_ Circular  Longitudinal \_\_\_ Other

Repaired with 2 Hymaxes and 5' off C900 PVC.
