# HOWARD COUNTY: PIPE BREAKS - FIELD DATA

DAY: 2-1-09  
 TIME: 6:00 Am  
 TIME OF BREAK: \_\_\_\_\_  
 ENGINEER: Lang

LOCATION: \_\_\_\_\_  
 GPS LOCATION: 6271 Dusty Glass CT.

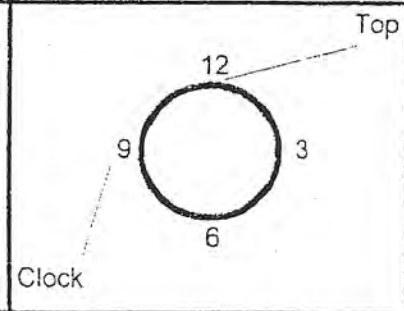
**TESTING VIEW**

Pipe Type:  Cast Iron  Ductile Iron  Steel  PCCP  Plastic ACP  
 Pipe Size: 6"  
 Repair Method:  Clamp  Weld  Cut  Other

6" x 1" Saddle
