# HOWARD COUNTY: PIPE BREAKS - FIELD DATA

DAY: 12-7-2009  
 TIME: \_\_\_\_\_  
 TIME OF BREAK: 2:00 Am  
 ENGINEER: Lang - Supervisor

LOCATION: \_\_\_\_\_  
 GPS LOCATION: 8340 Kings Heights Road

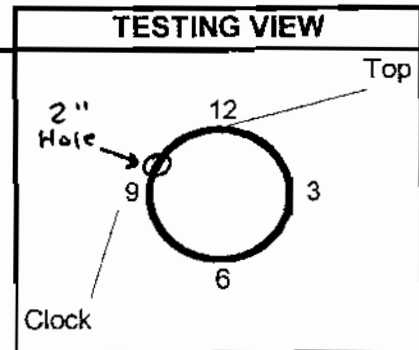
**SKETCH OF SITE**

2" Hole in pipe
