HOWARD COUNTY: PIPE BREAKS - FIELD DATA

DAY: 2-6-08
 TIME: 9:00 am
 TIME OF BREAK: 2-5-08 - 12:00 pm
 ENGINEER: G. Gibson

GPS LOCATION: 8826 WASHINGTON BLVD

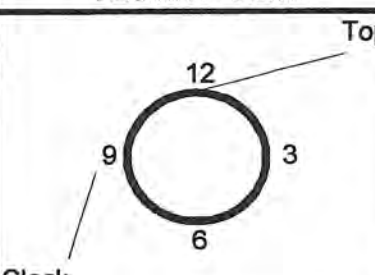
6" split - Drill holes at the end of split & used Repair Clamp

<p><u>6" split</u></p>	<p style="text-align: center;">TESTING VIEW</p>
