# HOWARD COUNTY: PIPE BREAKS - FIELD DATA

DAY: 8-29-2009  
 TIME: 9:00 AM  
 TIME OF BREAK: Approx. 7:00 AM  
 ENGINEER: Lang - Supervisor on site.

LOCATION:  
 GPS LOCATION: 9003 Sidelong Place

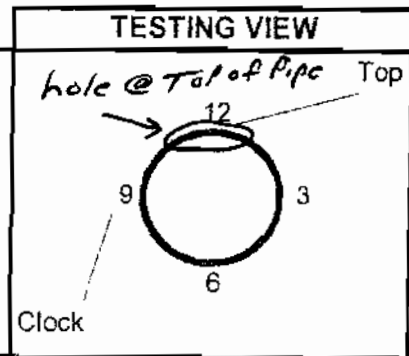
**SKETCH OF SITE**

4" lateral hole in Pipe @ Cap. Cut back, reinstalled cap & blocked.

**DETAILS:** hole
