HOWARD COUNTY: PIPE BREAKS - FIELD DATA

DAY: 8/2/09
 TIME: 2:30 PM
 TIME OF BREAK: Service Saddle
 ENGINEER: Bernie Sausbaugh

LOCATION:
 GPS LOCATION: 9059 LambSkin

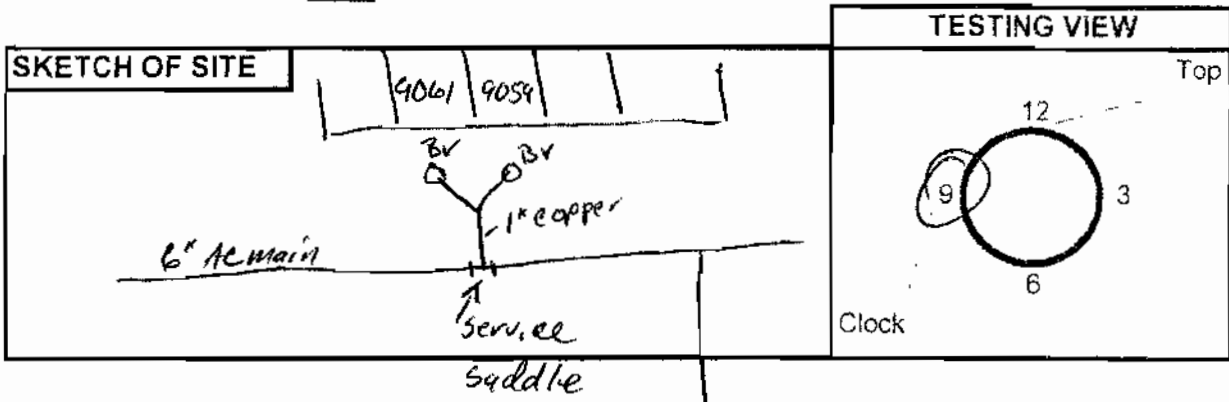
Service saddle rotted away
