HOWARD COUNTY: PIPE BREAKS - FIELD DATA

GPS LOCATION: 5051 Baiterway

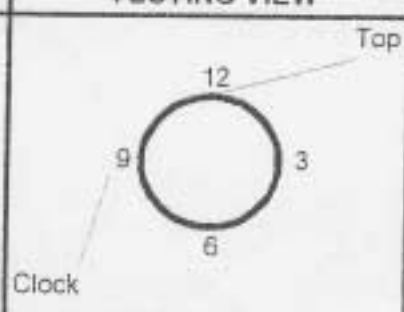
SKETCH OF SITE

Form of Break: Circular Longitudinal Other

8" from corp 3/4"
