HOWARD COUNTY: PIPE BREAKS - FIELD DATA

DAY: August 30, 2005
 TIME: 5:00 PM
 TIME OF BREAK: " "
 ENGINEER: _____

LOCATION: _____
 GPS LOCATION: 5705 Green Valley Place

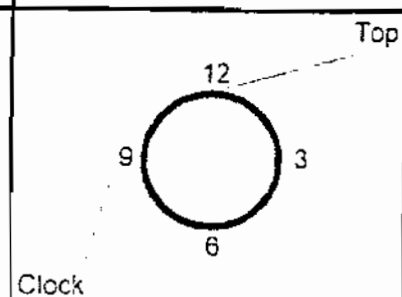
TESTING VIEW

4' Split, Replaced 5' of C.I.P. with D.I.P.

4' split
