# HOWARD COUNTY: PIPE BREAKS - FIELD DATA

LOCATION: 8032 Red Jacket Way  
 GPS LOCATION: \_\_\_\_\_

GPS: \_\_\_\_\_ Contract 870

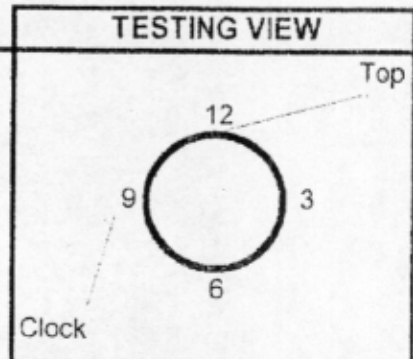
**SKETCH OF SITE**

**DETAILS:** hole blown out on bottom of pipe

Repair Method:  Clamp \_\_\_ Weld \_\_\_ Cut \_\_\_ Other

**DETAILS:** full circle extend range
