**HOWARD COUNTY DEPARTMENT OF PUBLIC WORKS  
CORROSION CONTROL TEST STATION  
FIELD DATA SURVEY FORM**

Location: (114+50) Date Surveyed: 05/31//2007  
 T/S #: 4 Surveyed by: AS/MJ  
 T/S Type: ST w/Anode Contract #: 44-3218  
 Was the T/S located? YES / NO YES Pipe Size: 16"

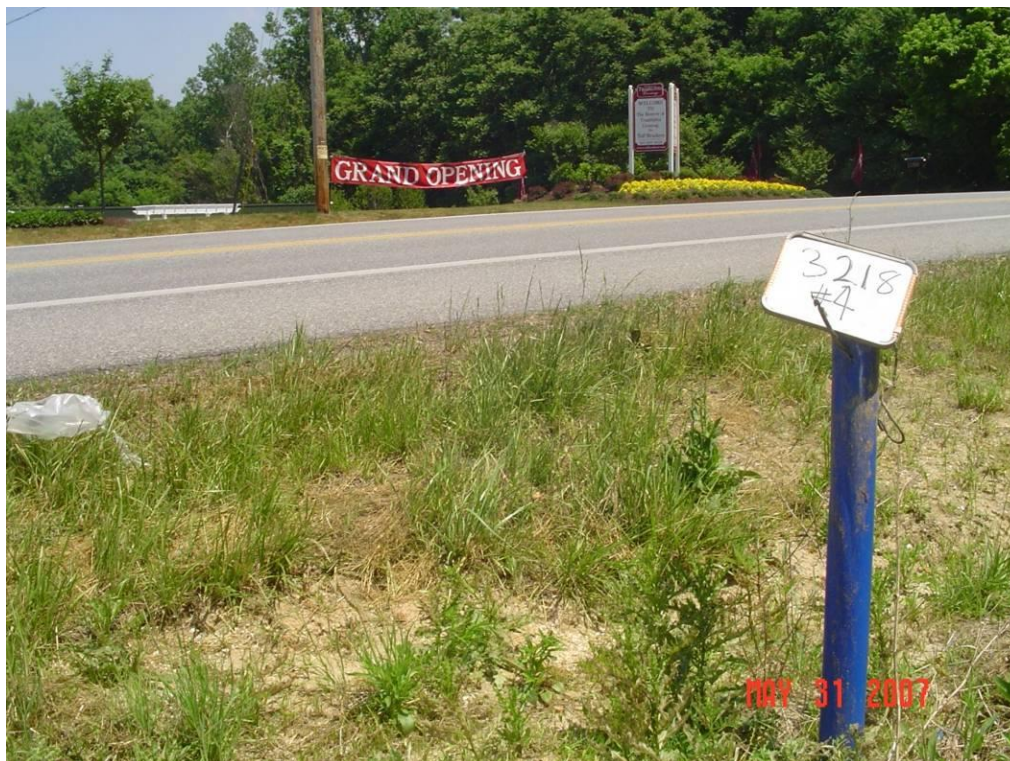
Figure 115 - Location of Test Station 3218-4 (before the repair)

Test Box: Damaged sue to vandalism.  
 Terminal Board: Missing  
 Wires: Good  
 Other: \_\_\_\_\_

Test Box: Repaired by sawing off the damaged (crushed) part.  
 Terminal Board: Replaced  
 Wires: New termination  
 Other: \_\_\_\_\_  
 Comments/Recommendations: A vehicle had run over the test station. Test Station was repaired.
