# HOWARD COUNTY: PIPE BREAKS - FIELD DATA

DAY: 7/29/05  
 TIME: \_\_\_\_\_  
 TIME OF BREAK: \_\_\_\_\_  
 ENGINEER: \_\_\_\_\_

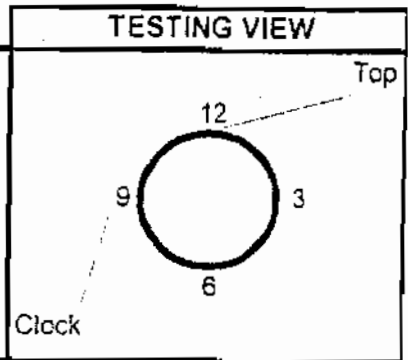
**SKETCH OF SITE**

Blow out Service

Repair Method:  Clamp \_\_\_ Weld \_\_\_ Cut \_\_\_ Other
