## Howard County Traffic Signal Inspection Summary Report:

**Signal Number:** 006  
**Location:** Harpers Farm Rd. at Cedar La.  
**Inspection Date:** 02/27/2018

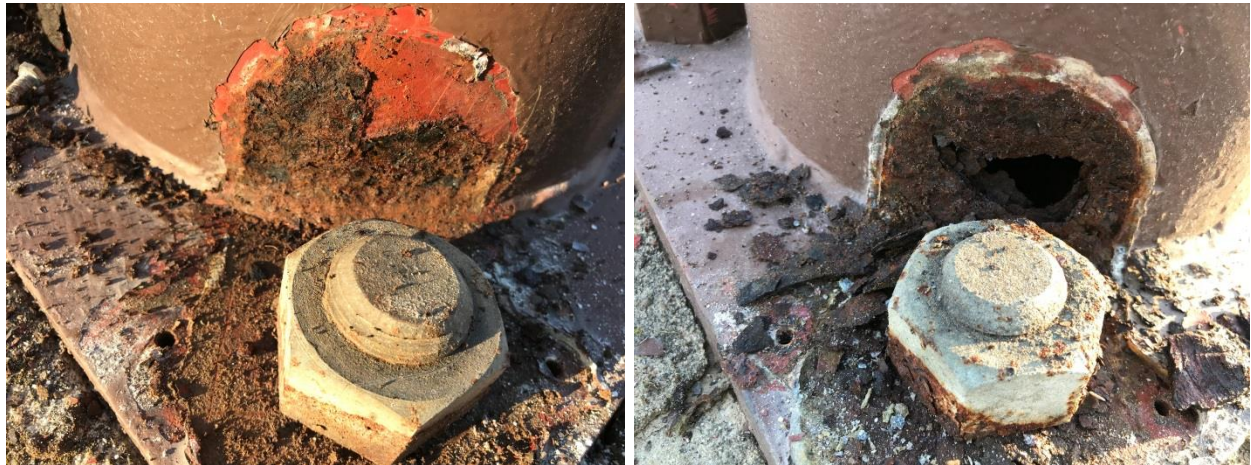
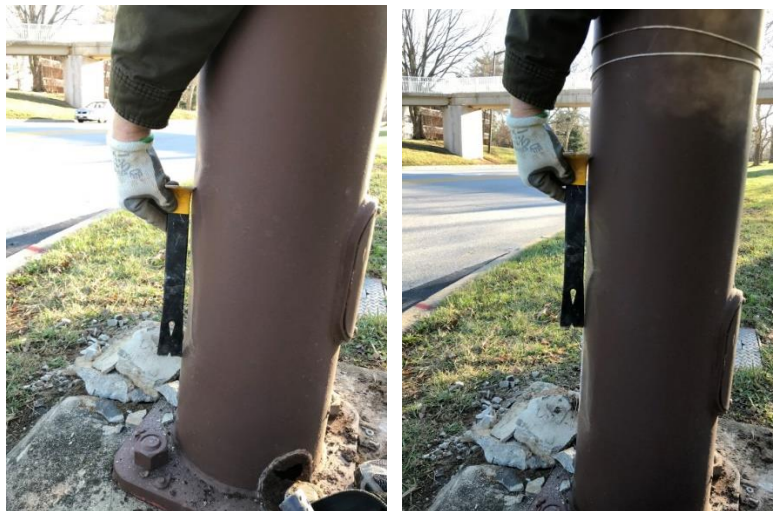
Single mast-arm structure located on the SE corner has severe rusting and deterioration around the base of the pole in the area behind the tightening nut caps. In one area there was an approximate two inch diameter hole in the base of the pole directly above the base plate weld. This pole also has signs of vehicle impact damage.
