HISTORIC PRESERVATION CERTIFICATION APPLICATION
REQUEST FOR CERTIFICATION OF COMPLETED WORK

1. **Name of property:** Burgess Tenant House (Burgess Estate Complex)(Sam Caplan House)
Address of property: Street 8454 Main Street
City Ellicott City County Howard State Md Zip 21043
Is property a certified historic structure? yes no If yes, date of certification by NPS: 4/29/88
or date of listing in the National Register: _____

Burgess Tenant House HO-338
8454 Main Street
Ellicott City, MD 21043
Part 3 Application

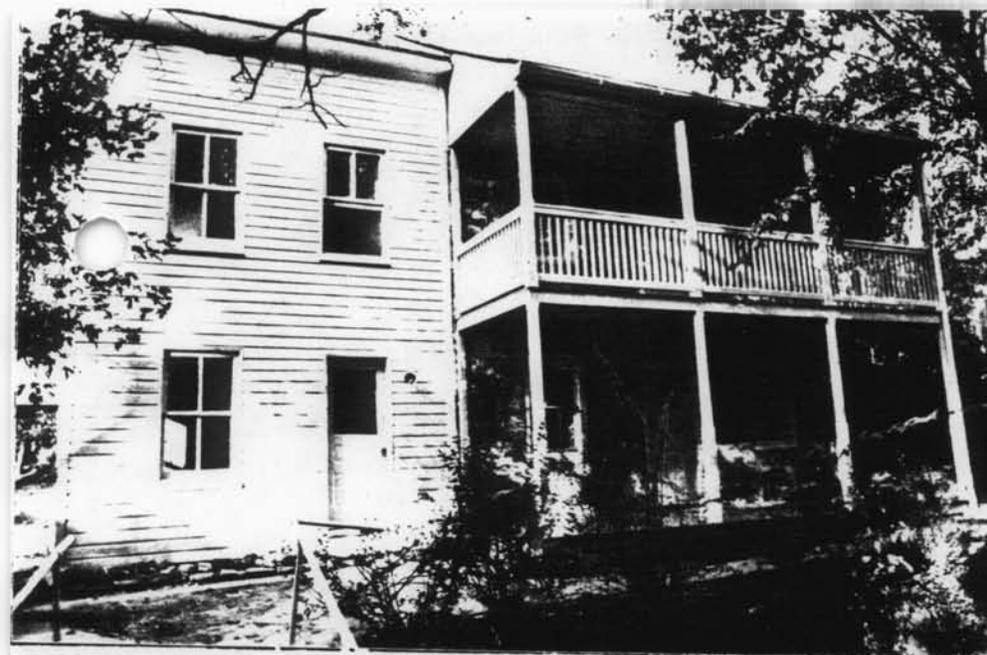
Fig. 1 Front Facade -- porch posts and railings rebuilt based on hist. photo. Doors and windows repaired and along with siding repainted. No site work around the tenant house was done.

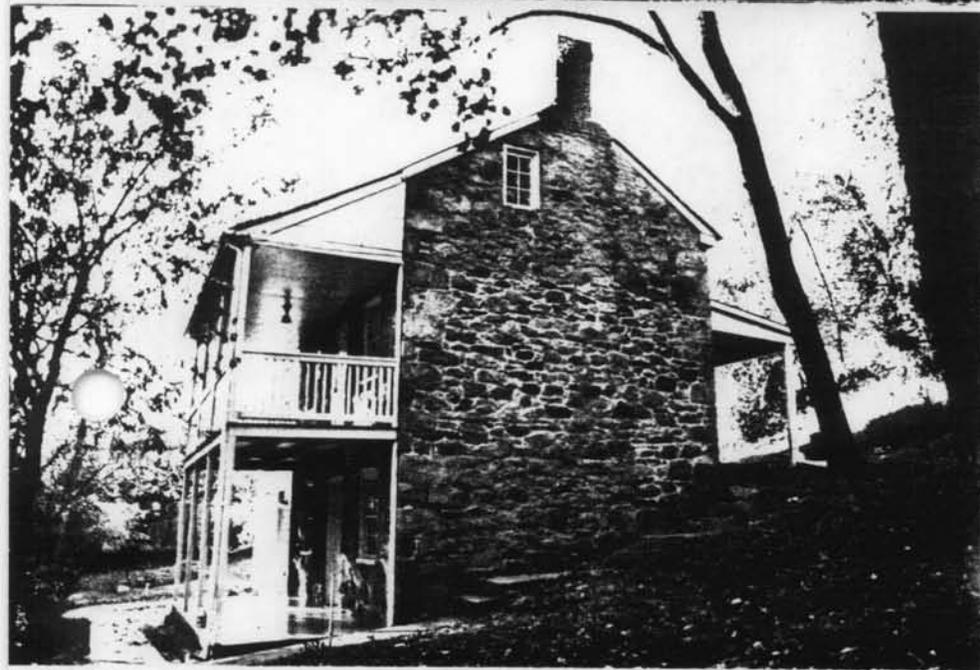
Fig. 2 Window screen and wood rail by side steps removed. Chimney work was not done -- chimney exists as pre-rehab. East side elevation.

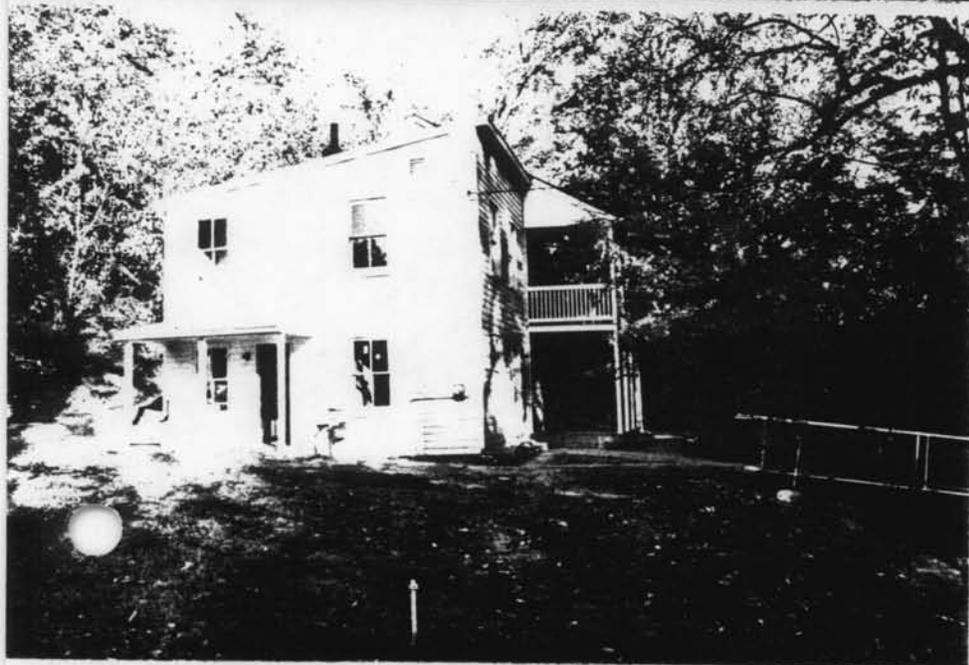
Fig. 3 Mud room porch enclosure of recent vintage was removed. Siding was repainted. West side elevation

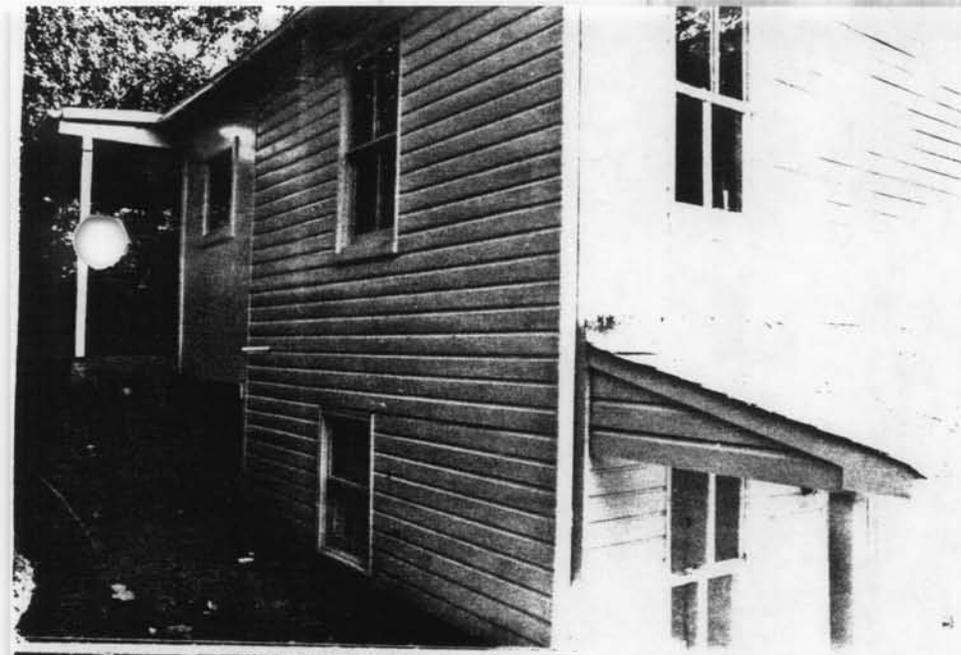
Fig. 5 Rear elevation. Partial 1970s porch enclosure was removed. Missing columns installed. Doors repainted.

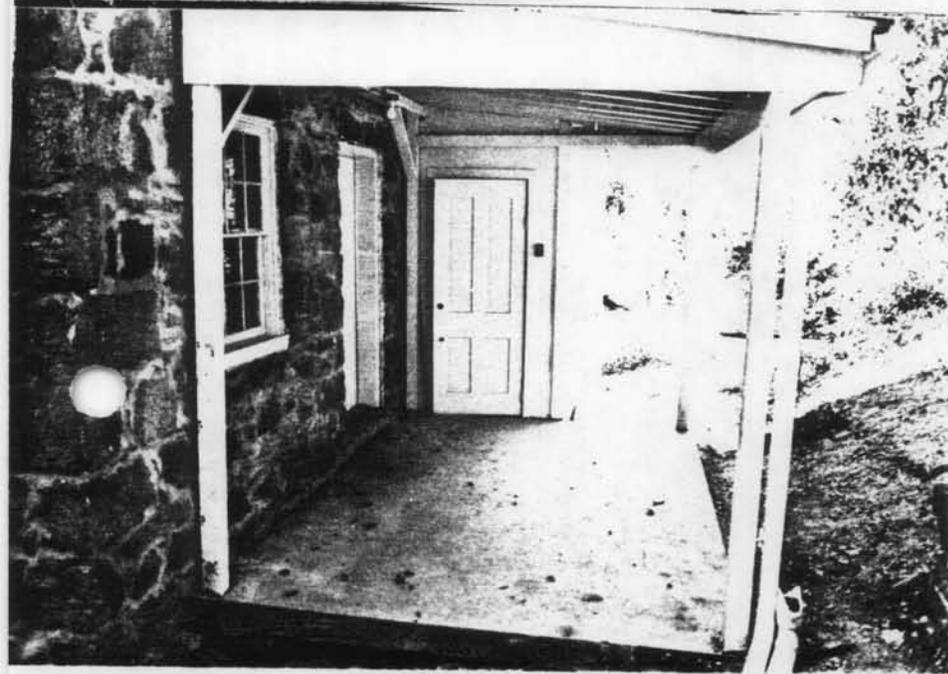
Fig. 6 Front elevation -- second floor. New flooring and wood ceiling to replace deteriorated one-- matches historic. Existing door retained.

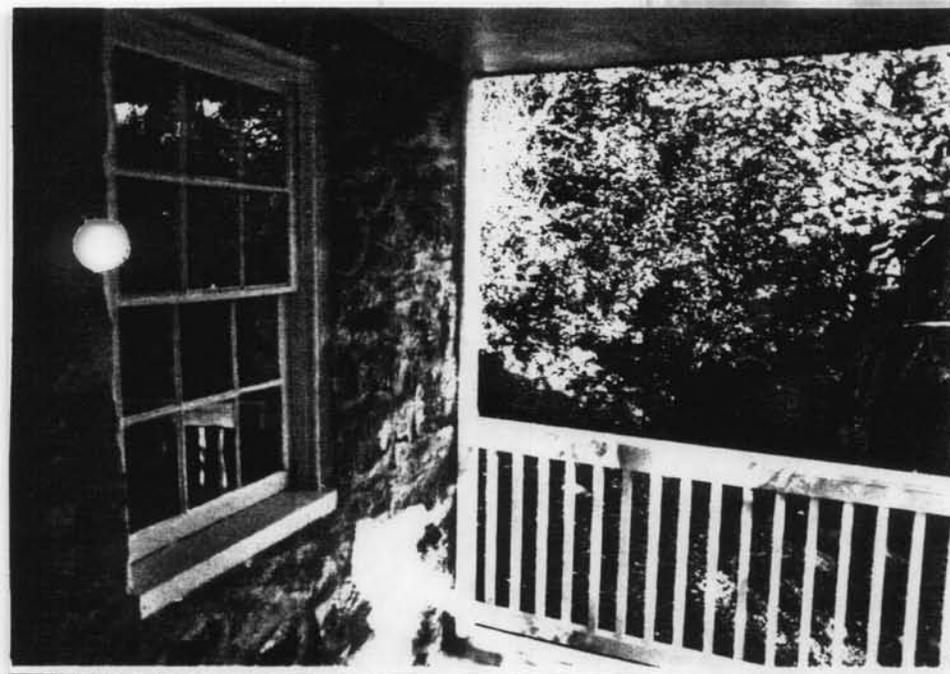
Fig. 7 Front elevation -- second floor. Original windows retained and repaired throughout the bldg.

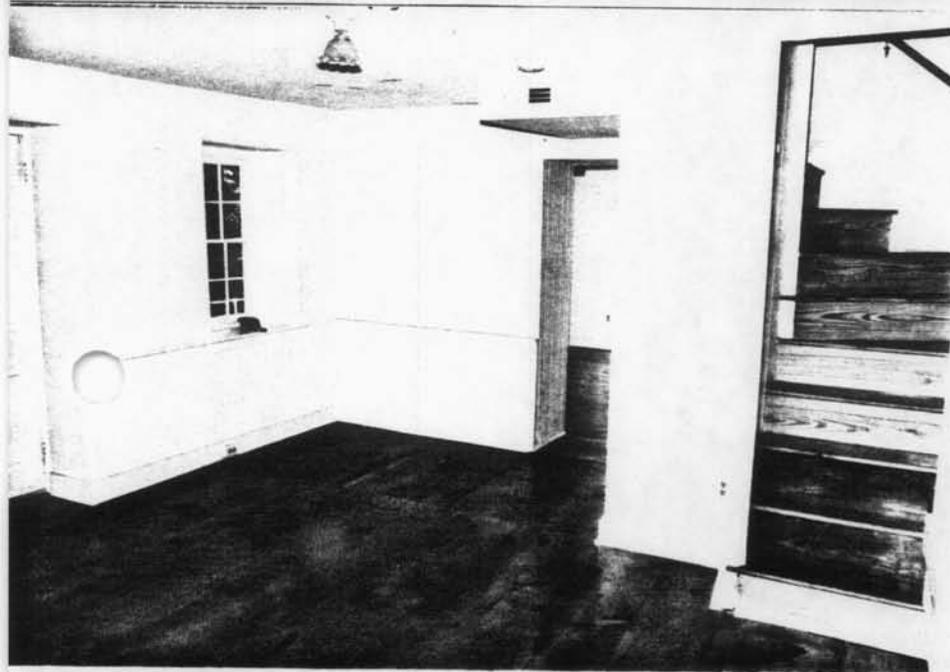
Fig. 8 Living room on first floor. 1950s partitions removed. Floors patched and refinished. Wainscoting retained. Walls are a mix of plaster sections and drywall depending upon pre-rehab condition and new work required. Stairs and doors retained and repainted.

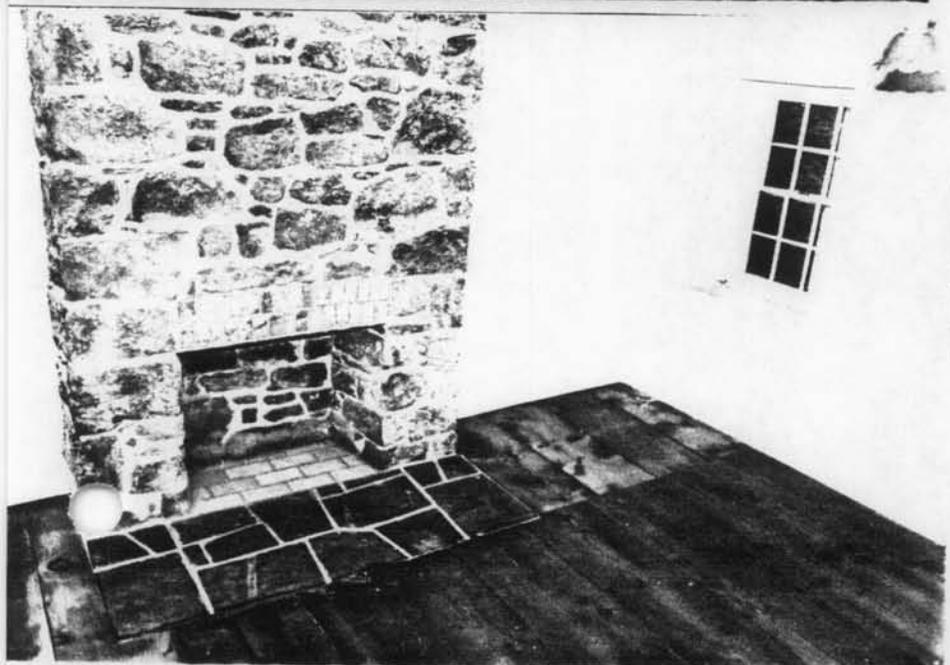
Fig. 9. Living room on first floor. 1950s partitions removed along with 1920s alterations. Existing fireplace was restored by removing 1920s enclosure. Stone was repointed using soft mortar as existed.

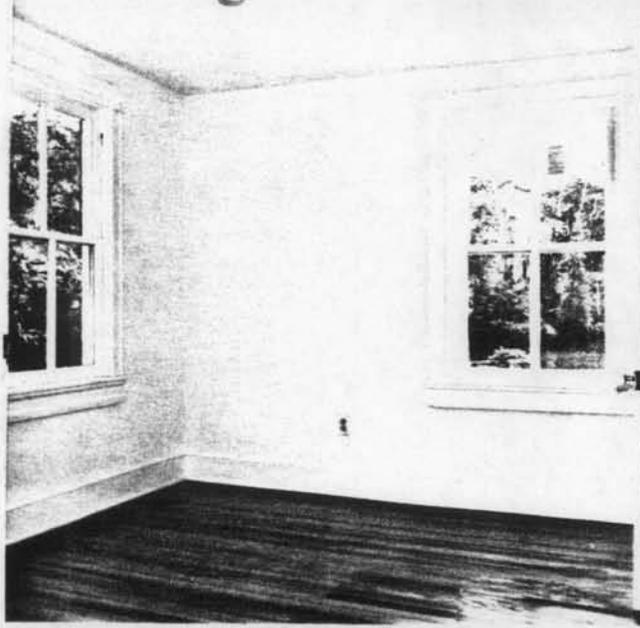
Fig. 10 Victorian wing--first floor:
Front door retained; new drywall
replaced patchwork of drywall and
plaster. Floors refinished; window
and door trim saved and repainted.

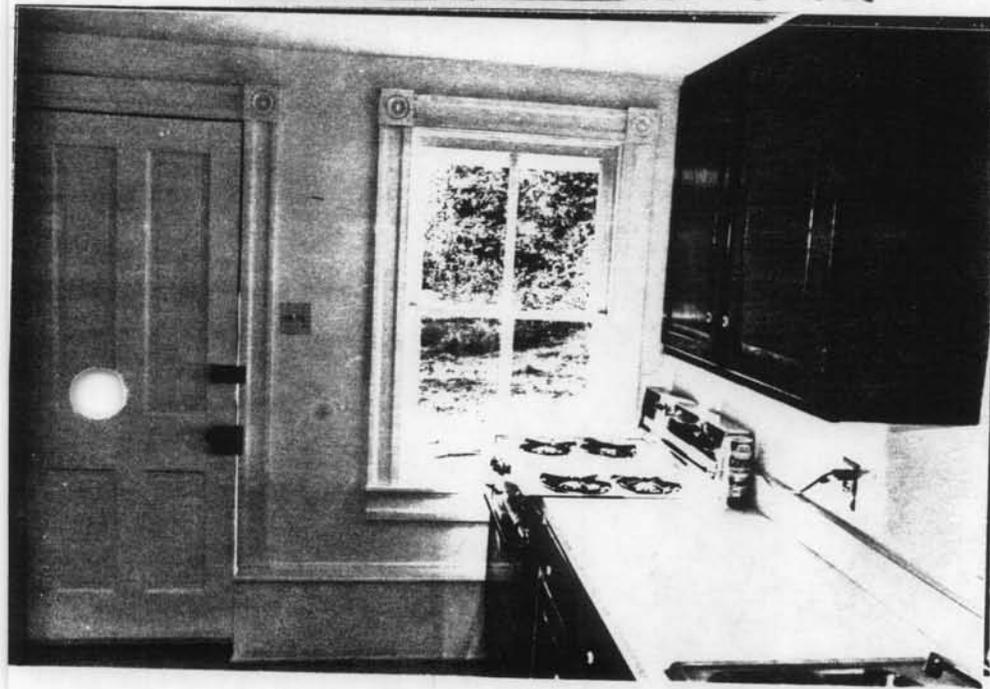
Fig. 11 Victorian wing--first floor
rear portion. New kitchen installed.
Existing door and window onto mudroom
retained and now visible from exterior.

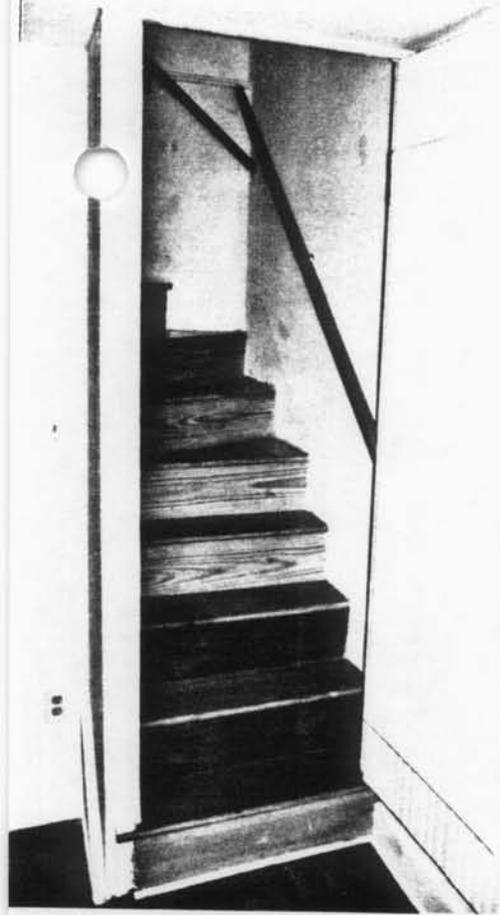
Fig. 12 Stairs from first floor of stone house to second floor retained. A number of the treads were replaced due to damage, wear and rot. Existing door retained.

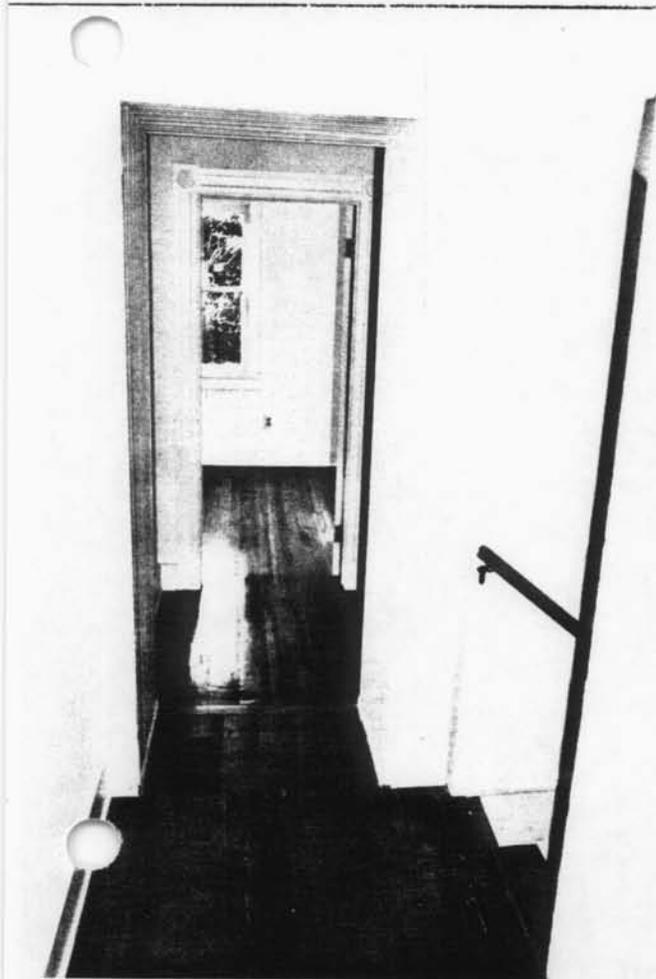
Fig. 13 Stairhall on second floor of stone house. Floor refinished and 1950s alterations removed; walls repaired and reconstructed. Looking from stairs to Victorian wing.

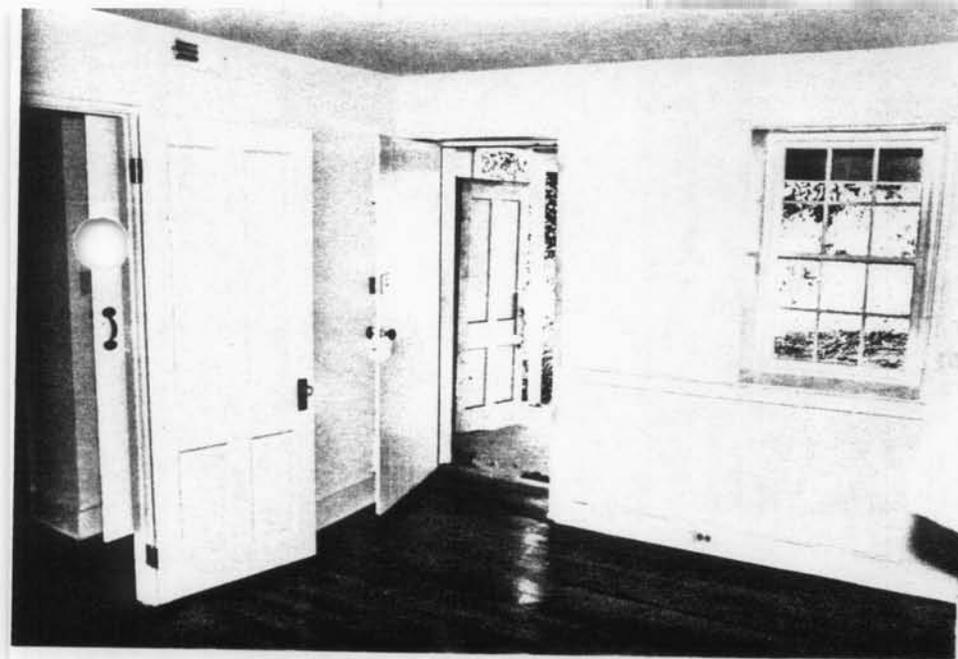
Fig. 14 Second floor of stone hse. Later partitions removed; fireplace, floors, trim and wainscoting repaired and restored. Door onto back is original and was retained along with all historic interior doors. Stairs to attic reoriented to stair hall by turning bottom several steps 90 degrees.

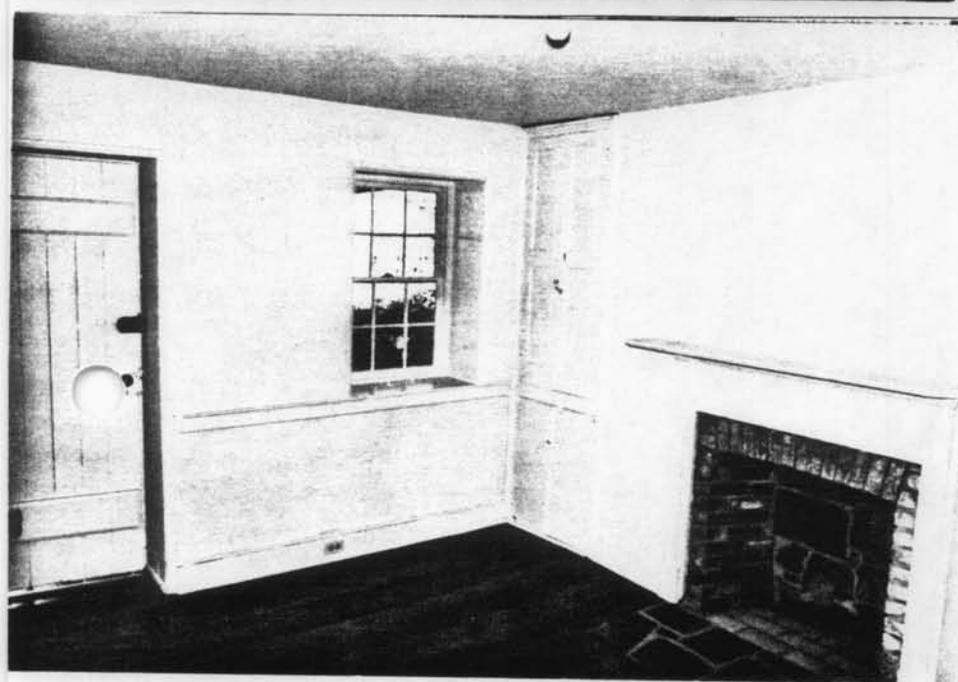
Fig. 15 Second floor of stone hse. Existing fireplace restored.

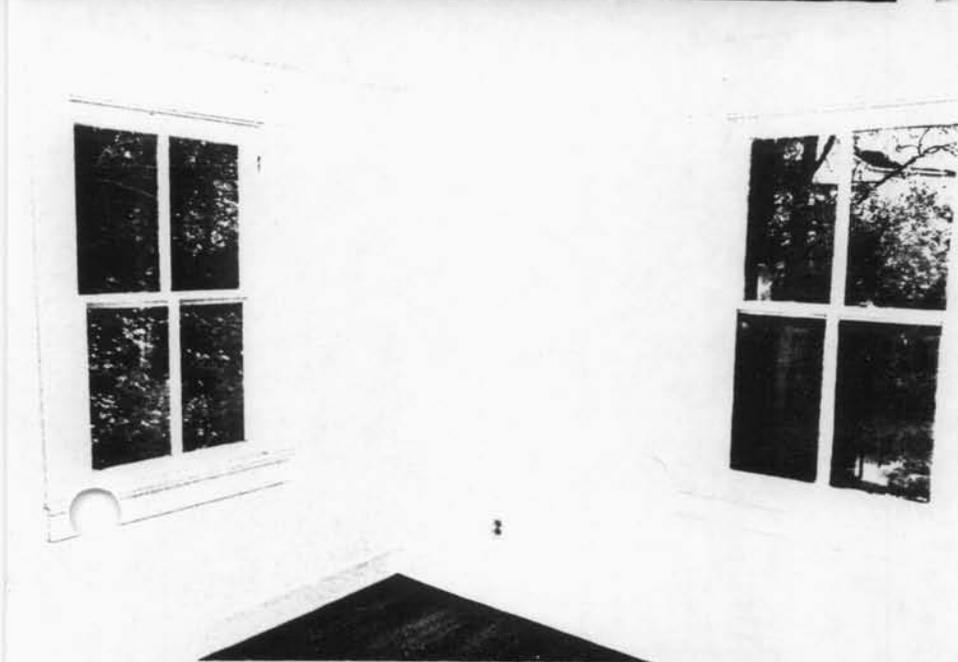
Fig. 16 Second floor of Victorian wing--front room. Existing windows and trim restored; room restored to full size.

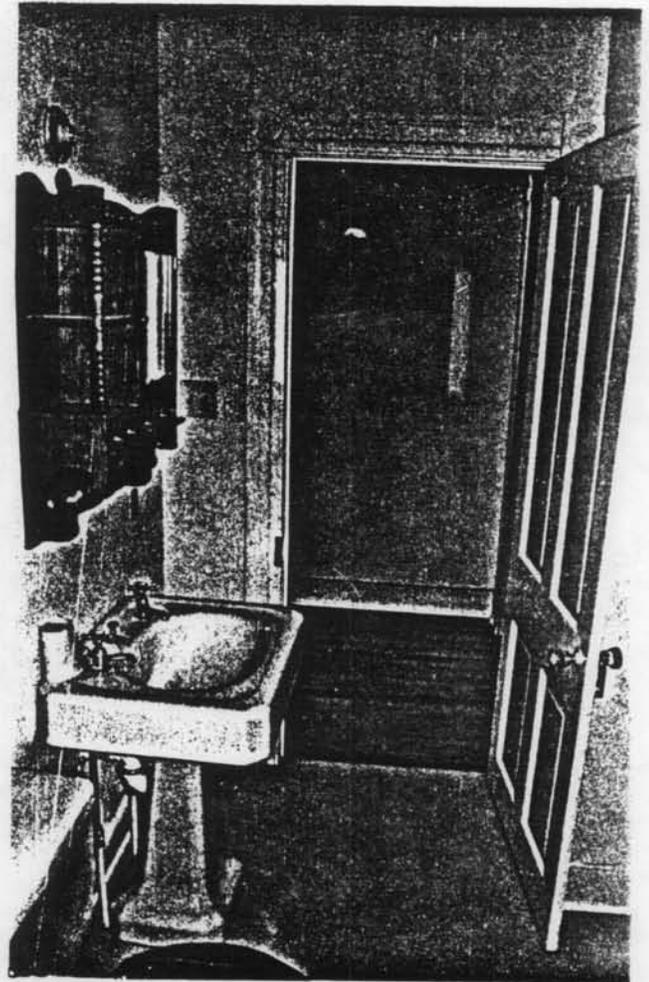
Fig. 18 Victorian wing on second floor showing new bath.

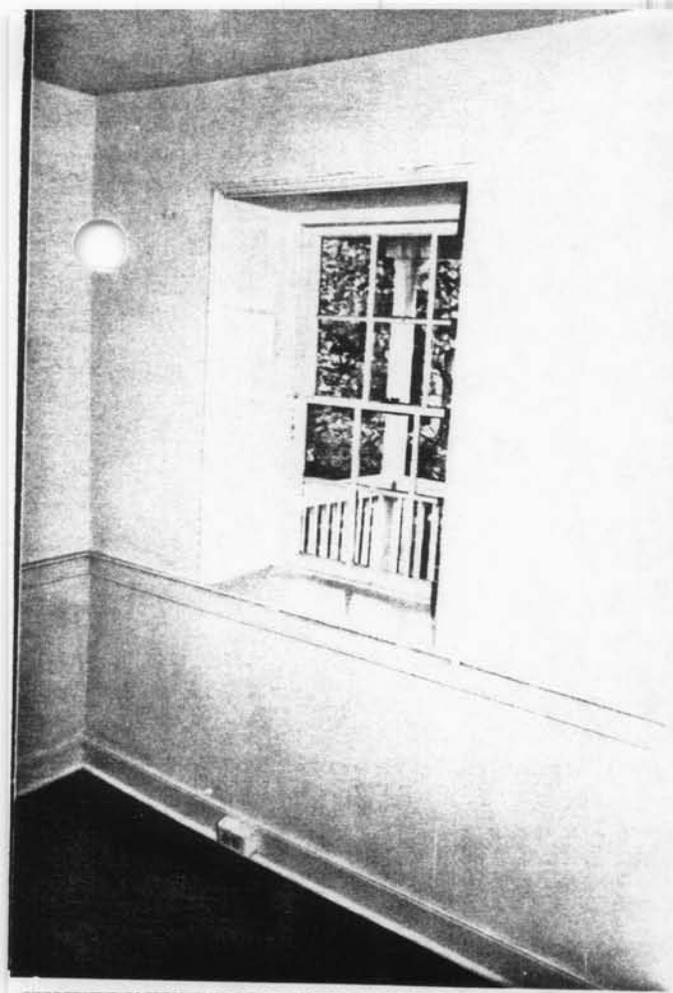
Fig. 19 Stairs from attic to the second floor. All steps shown in view are original and were restored in existing location. Only bottom several steps not shown in this view were turned 90 degrees.

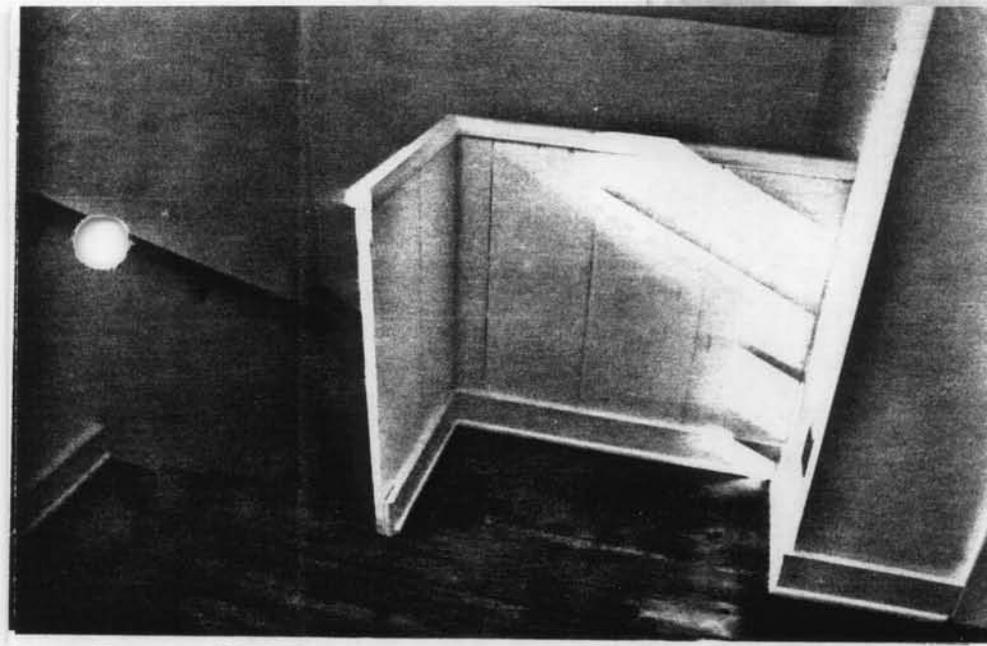
Fig. 20 Top of stairs in attic of stone house showing historic detailing which was retained. Floors were refinished.

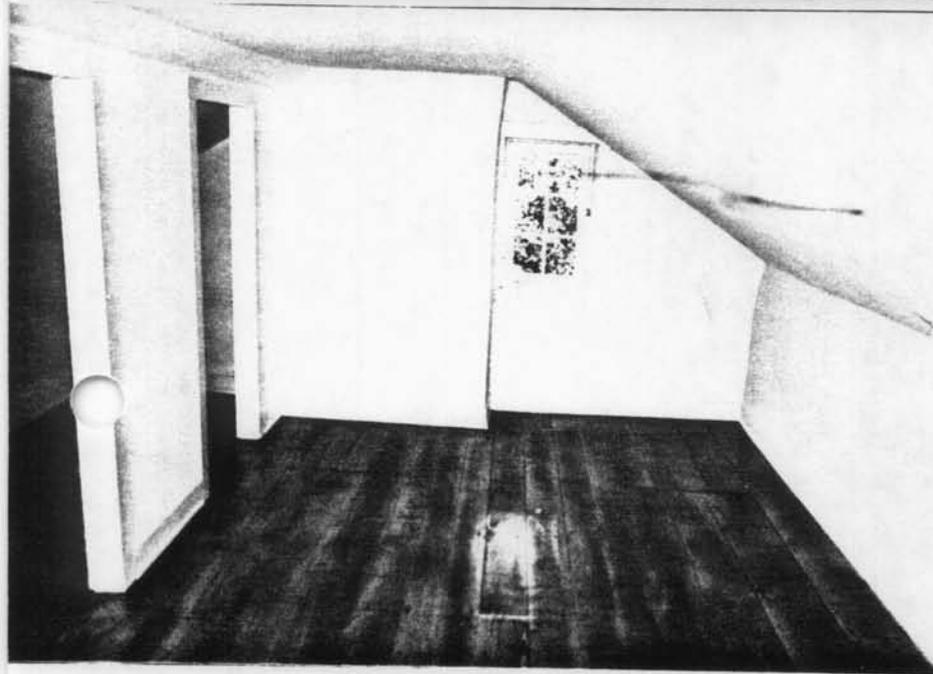
Fig. 21 Attic of stone house
Later center partition was removed
New left side wall was installed for
contemporary closet space. Fire-
place stack shown to left of restored
window. Floors were refinished.
