HO-109

Ann B. Dunn's Log House

Woodbine

INVENTORY FORM FOR STATE HISTORIC SITES SURVEY

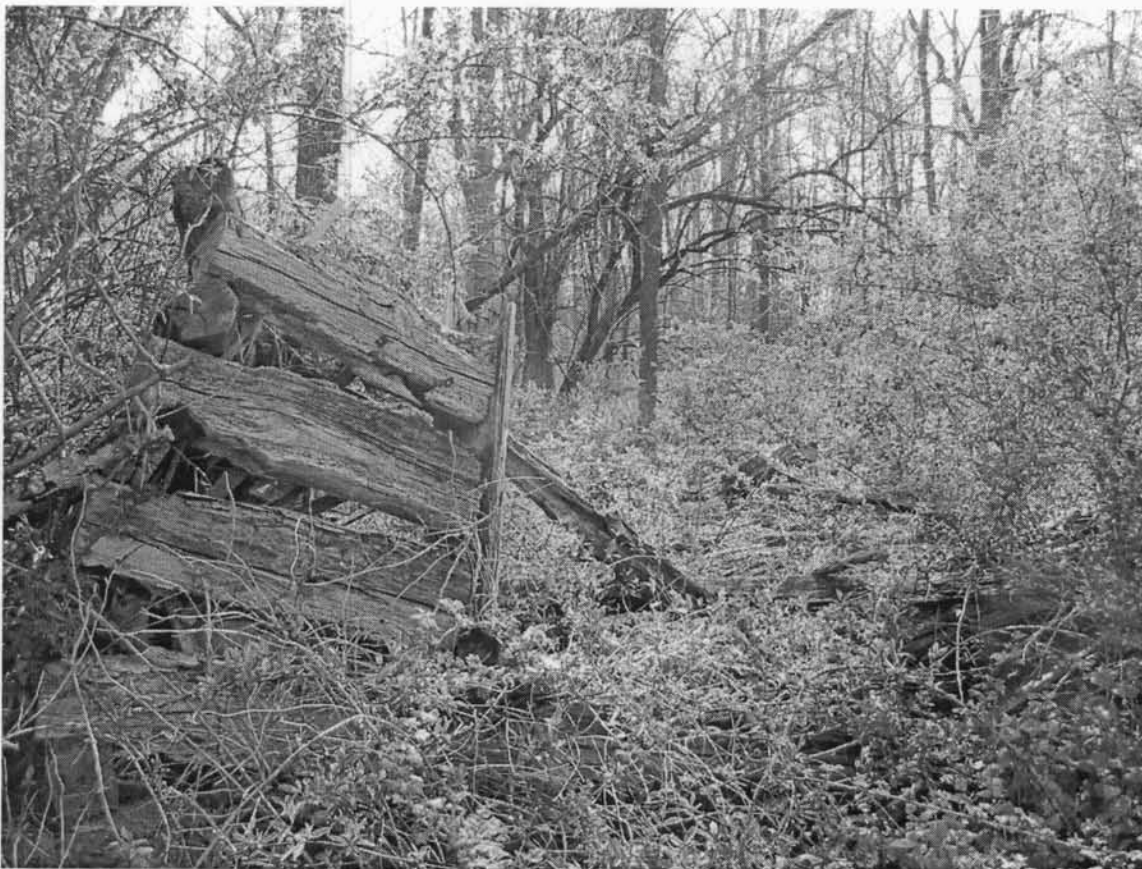
HO-109
Ann B. Dunn's Log House, ruin
Daisy Road north of Jennings Chapel Road, east side
Woodbine
Jennifer K. Cosham
April 21, 2004
Digital color photo on file at MHT

This small log house is now in ruins. The roof is gone, and only two of the walls are standing (west and north). The west elevation (towards Daisy Road) had a central door flanked by two window openings, and smaller square windows above that, just below the eave line.

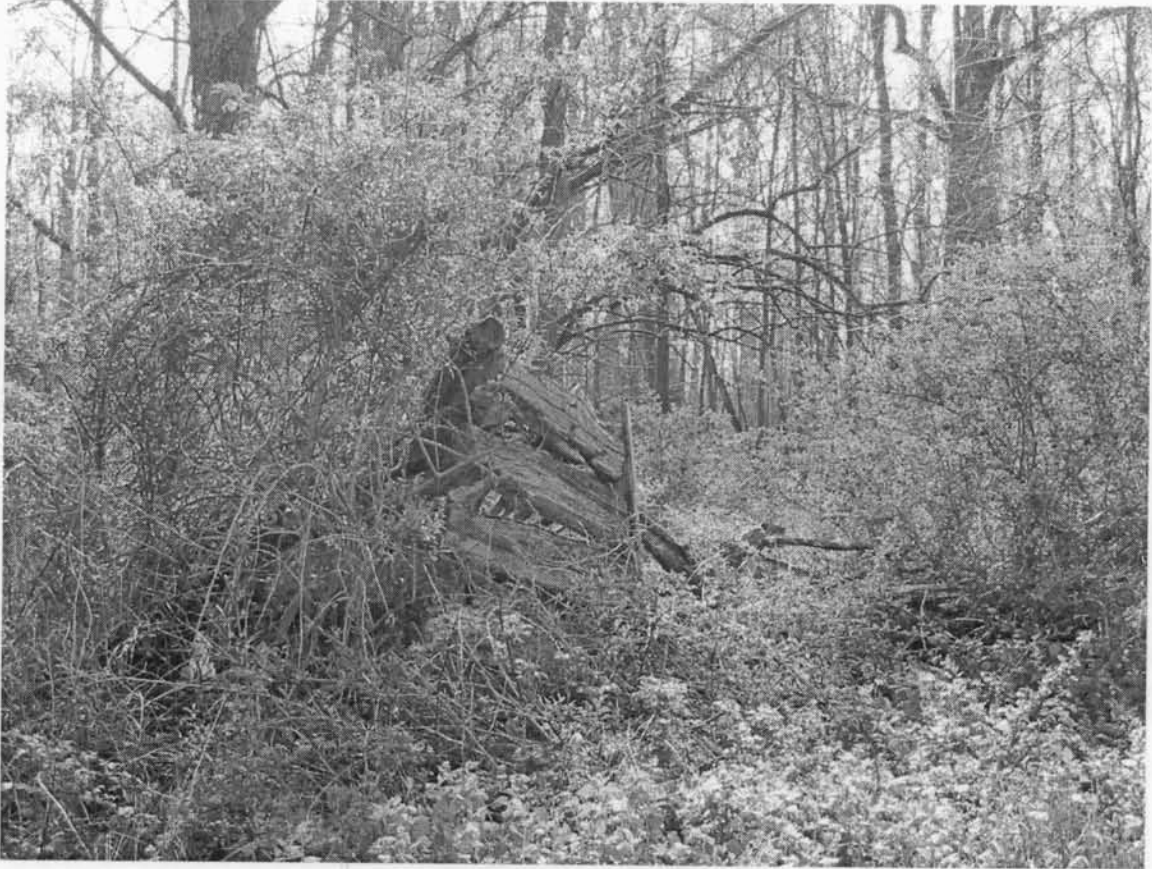
HO-109

Ann B. Dunn's Log House, ruin

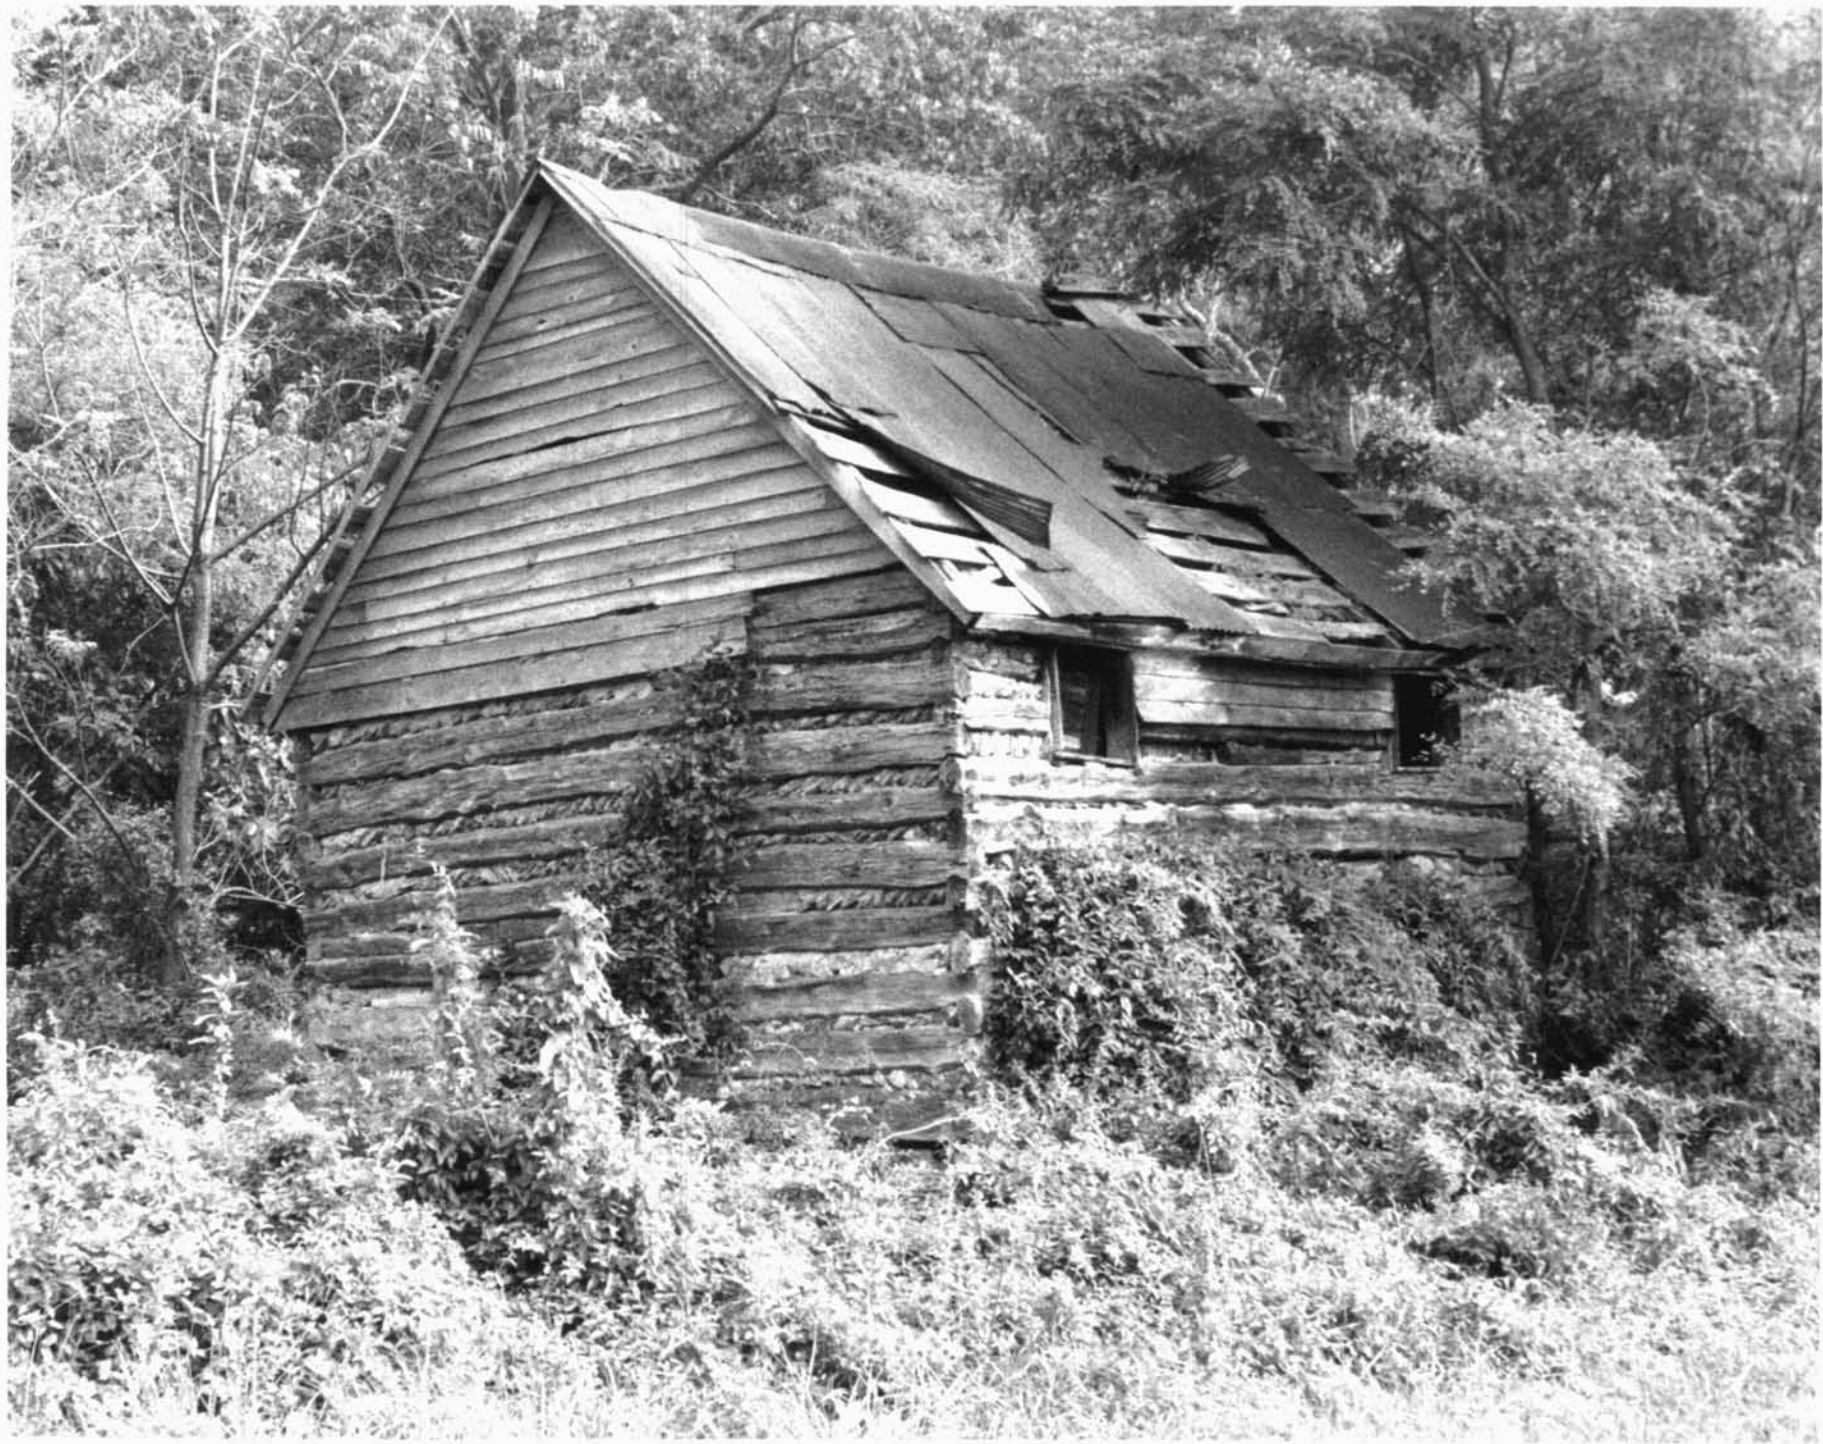
HO-109
ANN B. DUNN'S LOG HOUSE
SOUTH WEST

The south elevation holds two rectangular apertures with two square second floor windows above, all of which have no sashes. A central door is located on its north wall with a window to its west, and two square second floor windows above. An additional entrance is located on its east wall with a square second floor window centered above. The west wall holds no apertures. The building is composed of hand hewn logs, separated and filled with thin stone slabs and mortar chinking. The roof appears to be of a later period than the log house with six inch boards (running east-west) covered with tin sheets of varying sizes.

The log house was at one time covered with clapboards which have been removed except in the A's formed by the gables. The house has settled considerably on its north elevation and is in a state of disrepair with no window sashes. It appears, however, quite intact and sound otherwise and should be considered for rehabilitation and future reuse with required modernization.

The Ann B. Dunn Log House is significant architecturally to Howard County and the State of Maryland as a representative log house of the nineteenth century of a comfortable scale. Though settling on its north elevation and presently abandoned and in a deteriorating state, it is not beyond repair and renovation.
