HO-1157
Engle-Hartsock-Knill Farm
1181 Morgan Station Road
Private

Maryland Historical Trust Maryland Inventory of Historic Properties Form

Inventory No. HO-1157

historic Engle-Hartsock-Knill Farm

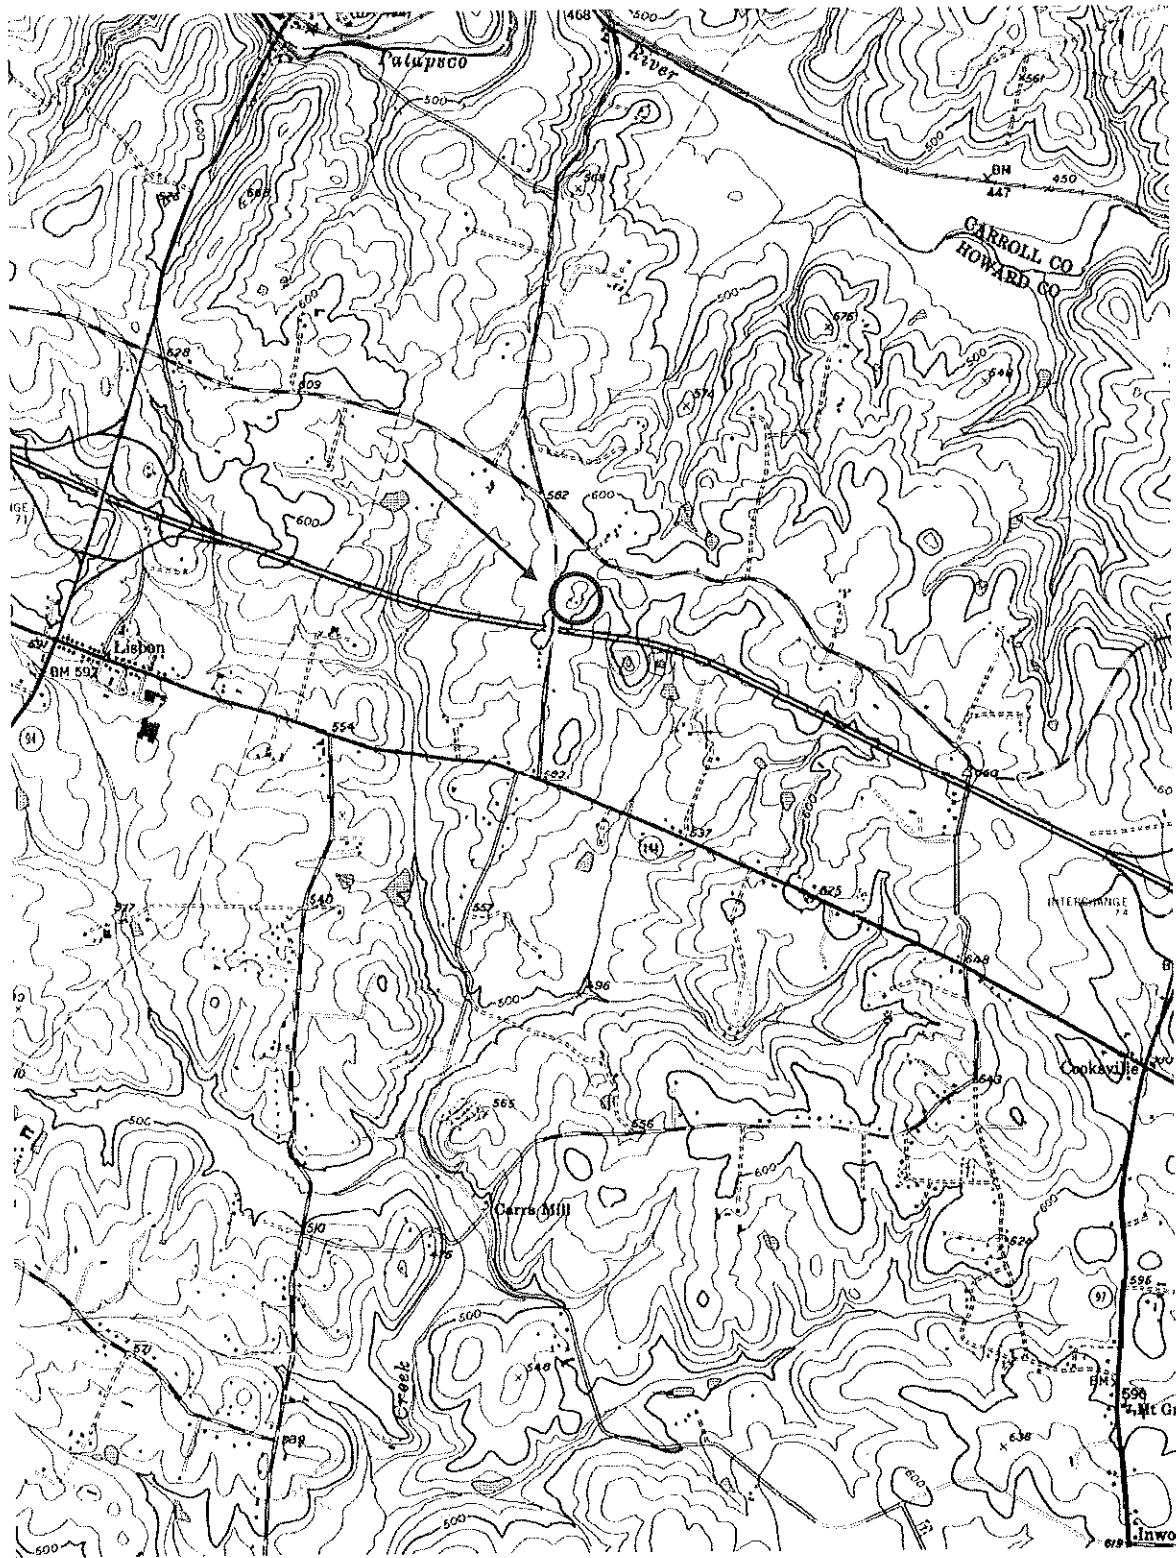
HO-1157 Engle-Hartsock-Knill Farm 1181 Morgan Station Road Site Plan

The Engle-Hartsock-Knill Farm is located at 1181 Morgan Station Road, on a fairly level lot on the east side of Morgan Station Road and just north of Interstate 70. There is a drive that runs east from the road to the center of the parcel, where it widens to create a courtyard, with most of the buildings arranged approximately in a circle around this courtyard.

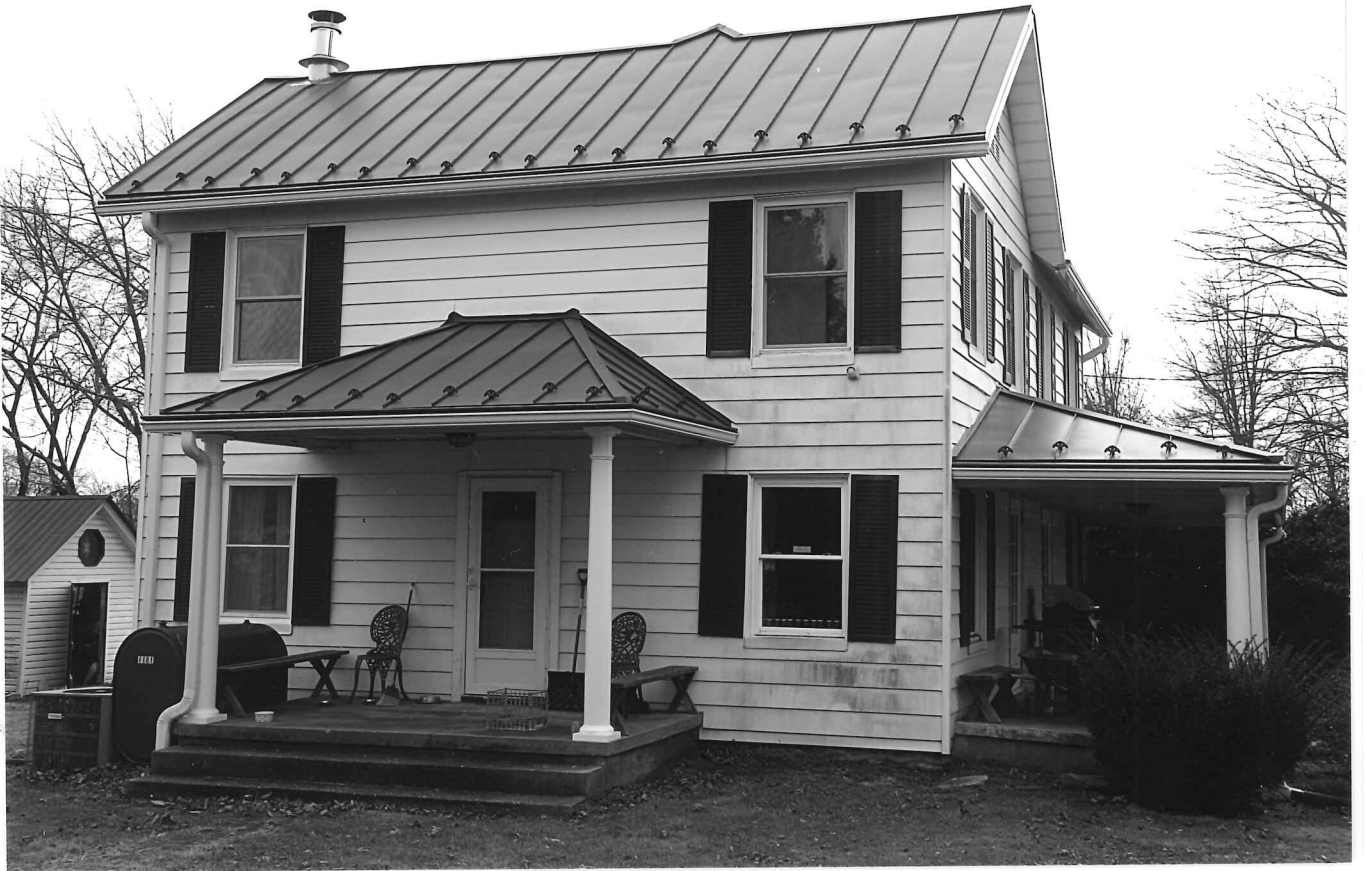
1 of 8

The north elevation of the main block has a center entrance on the first story that contains a new door. There is a one-bay porch with a concrete deck, new columns, and a hip roof. On either side of the doorway is a new one-over-one sash with fake blinds, which is typical for the house. The second story has a typical one-over-one sash in the end bays and no opening in the center. There is a new metal

House, north Elevation

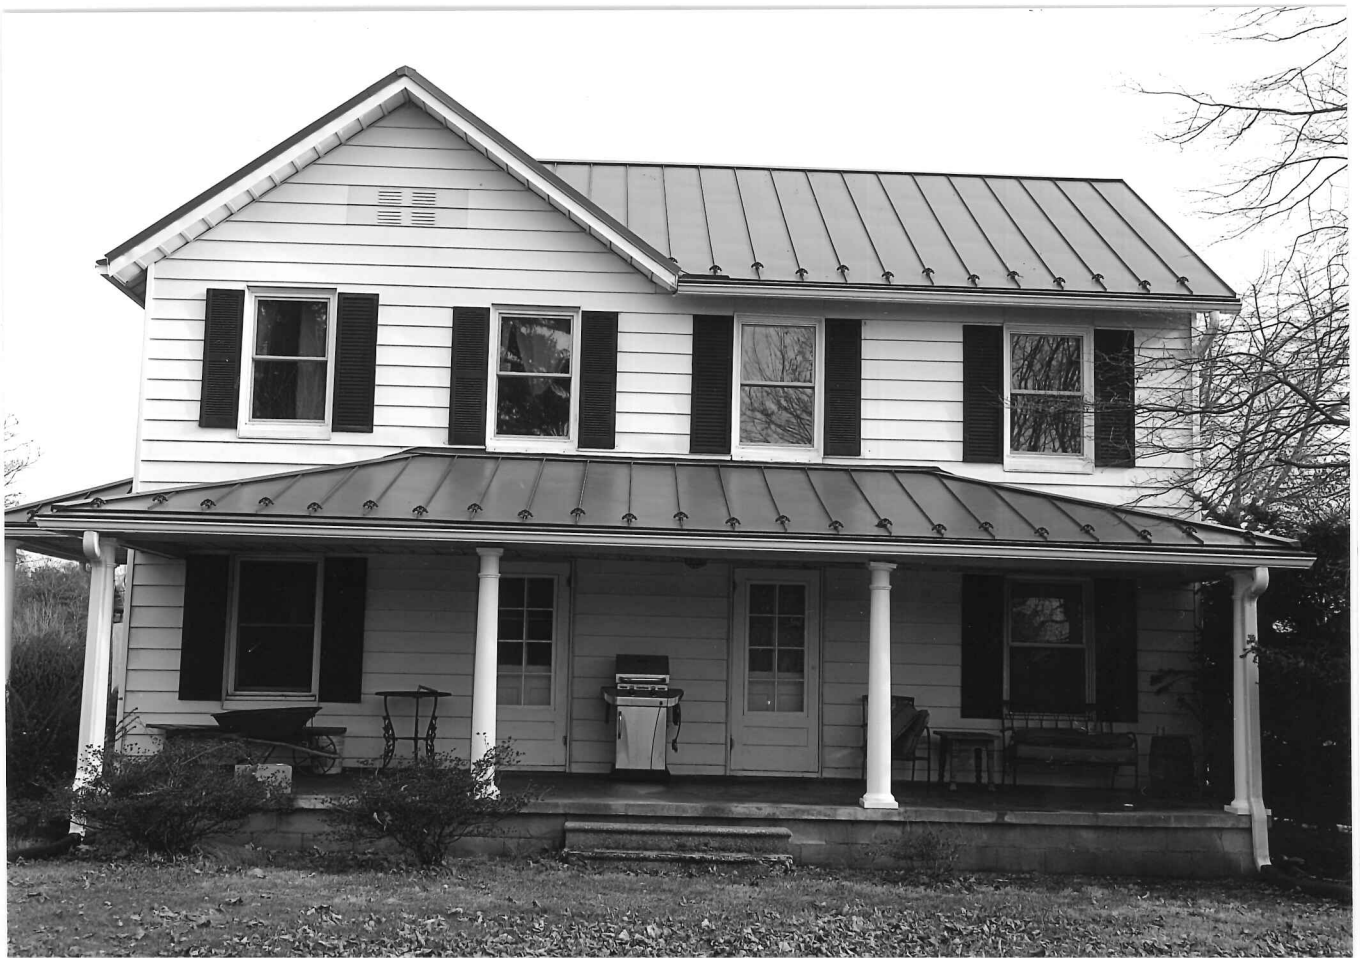
2 of 8

The west elevation of the main block, on the first story, has a typical one-over-one sash to the north and a door with four lights over two panels to the south. The second story has two typical one-over-one sash, and there is a vent cut into the siding in the gable end. The west elevation of the ell has a door with four lights over two panels to the north and a typical one-over-one sash to the south. There is a one-story porch across all four bays, with a CMU foundation, a concrete deck, new columns, and a hip roof with standing-seam metal.

House, west elevation

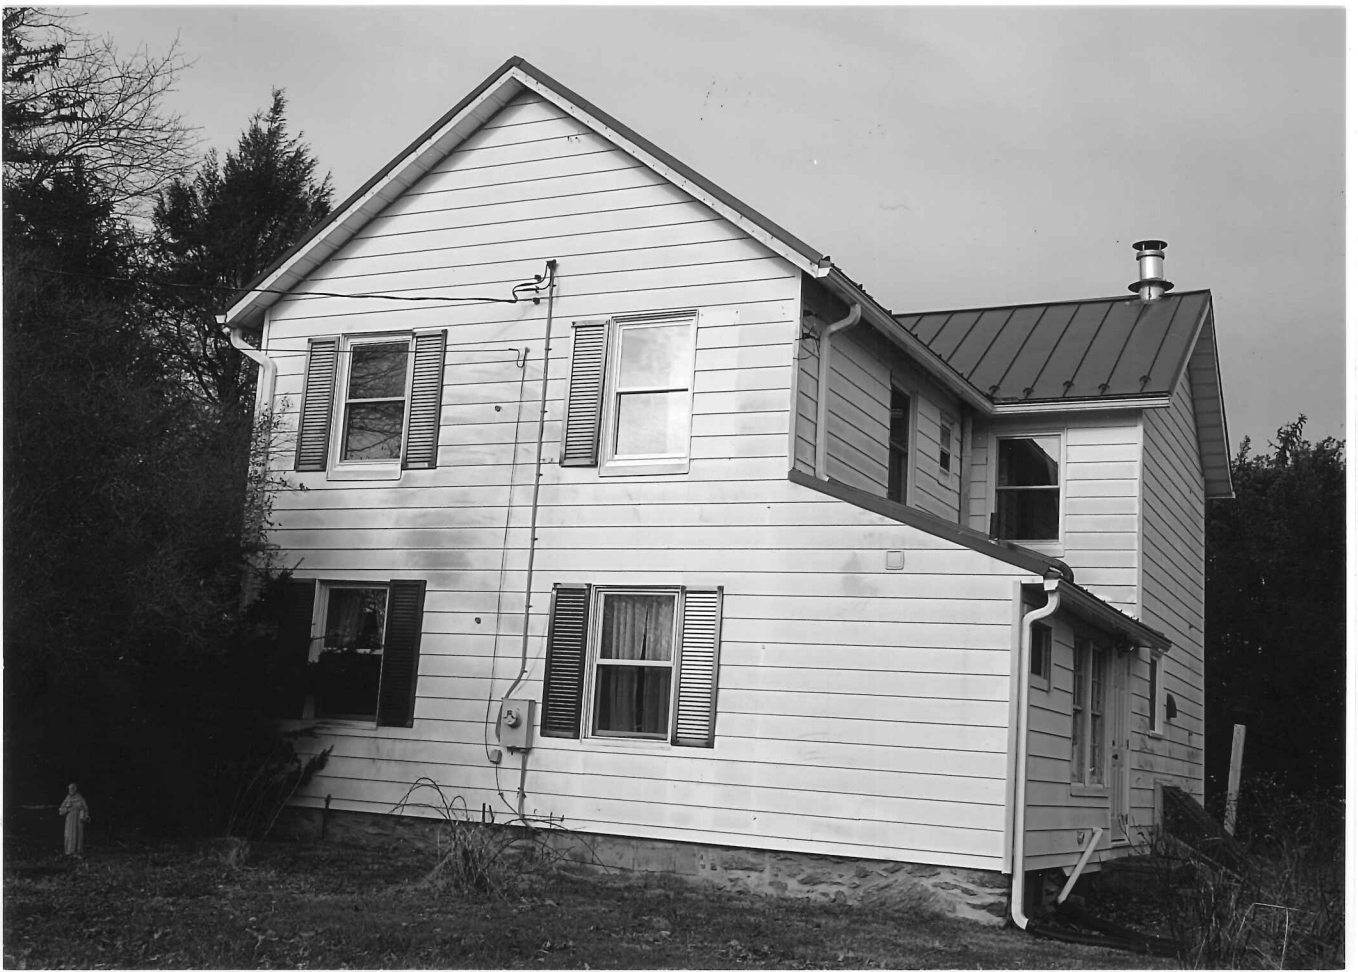
3 of 8

The south elevation of the ell has two typical one-over-one sash on both the first and second stories, and no opening in the gable end. The south elevation of the main block is covered by the enclosed porch on the first story and has a typical one-over-one sash on the second.

The east elevation of the ell has an enclosed porch that is not historic on the first story. The second story has a typical one-over-one sash in the center, with a new, small one-over-one sash to the north. The main block, on the first story, has a typical one-over-one sash in the south bay. The second story and gable end have no openings.

House, Southeast elevations

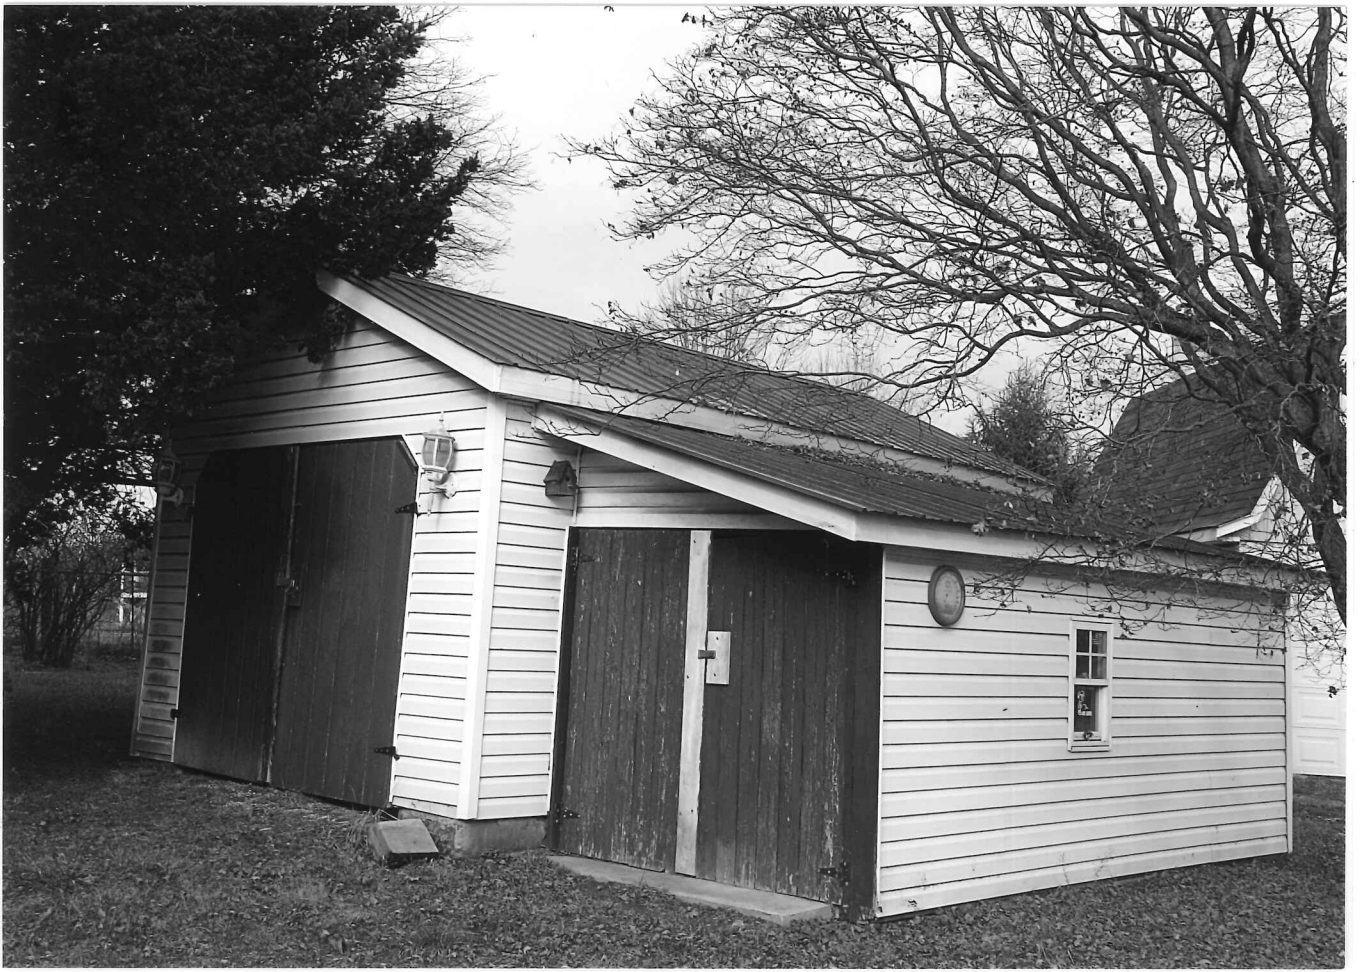
5 of 8

About 40 feet northeast of the house, at the northwestern edge of the courtyard, is an old garage. It is aligned to face the house to the southwest, not the other buildings around the courtyard. It is a one-story, one-bay by one-bay structure with a concrete foundation, vinyl German siding, and a gable roof with inverted-v-seam metal and a ridge that runs northeast-southwest. There is a one-bay, shed-roofed addition on the southeast. The southwest elevation has a pair of T1-11 doors hung on new strap hinges. The northwest elevation has a new one-over-one sash and the northeast elevation has no opening. It has a dirt floor and 2 by 4 construction in the walls and roof.

Garage, southwest & southeast elevations.

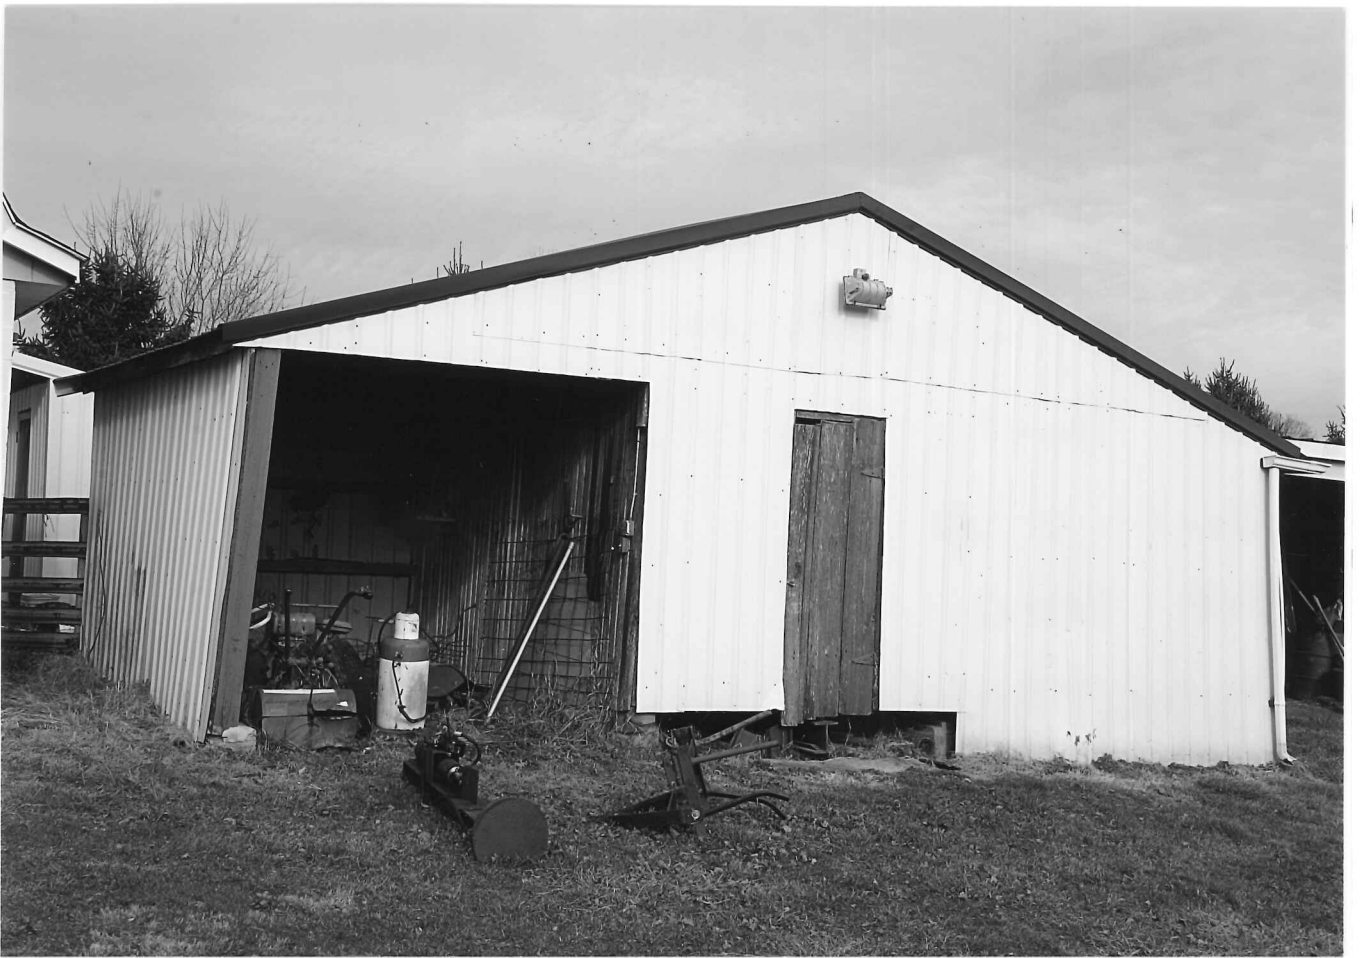
6 of 8

The wagon shed is located at the northern side of the courtyard, about 100 feet northeast of the house and between the new garage and the tractor shed. It is a one-story, three-bay by one-bay frame structure set on concrete piers that run north-south under all four of the north-south walls. There is inverted-v-seam metal over top of vertical-board siding, and the gable roof has inverted-v-seam metal with a north-south ridge. The south elevation has a vertical-board door in the center, hung on butterfly hinges. To the west is a wide opening and to the east is siding with no opening. There are no openings on the west and north elevations, and the east elevation is completely open, with no siding.

Wagon shed / Corn Crib, south elevation

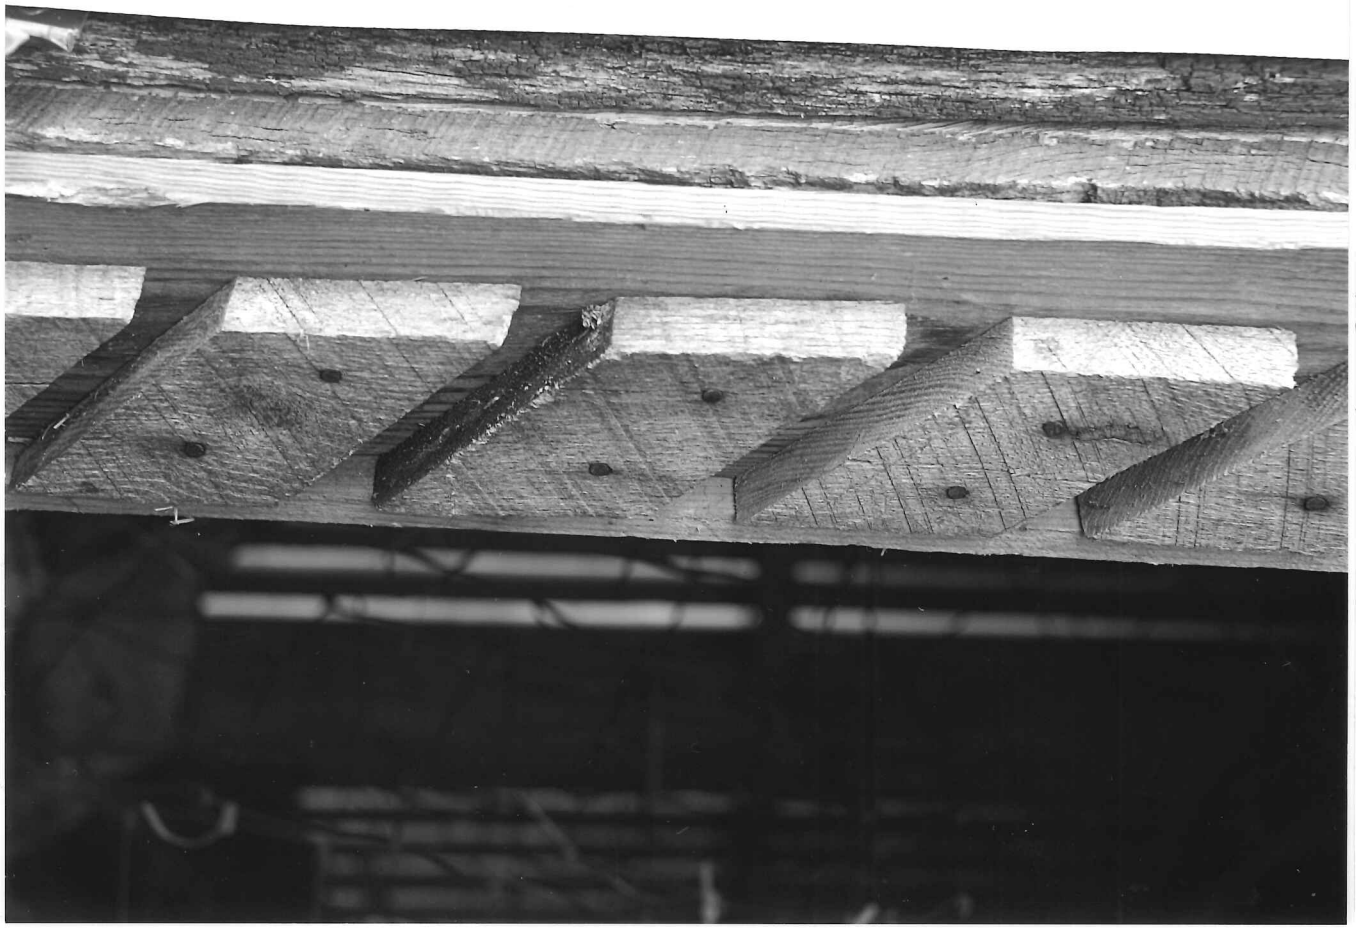
7 of 8

There is a crib in the center with sheds to each side. The crib has vertical slats that are wire-nailed. The west shed is constructed mostly of 2 by 4s, with a hewn sill and 2 by 4 rafters that are mitered and butted at the ridge. The crib has a heavy-timber square-rule frame that is mortised and tenoned and pinned. It has some hewn posts, many partly in the round, and has a dropped girt as well as a lower girt. The horizontal nailers that stiffen the slats are circular-sawn and wire-nailed. The north wall has been rebuilt on the interior. The doorway has angled pieces nailed to each jamb with wire nails, apparently to take wood louver slats. They are circular-sawn and not painted, and the slats appear to have been loose so that they could be removed. The east shed has circular-sawn rafters and the walls are mostly rebuilt. It appears that the sheds were added to a free-standing corn crib.

Wagon Shed/Corn Crib, doorway jamb

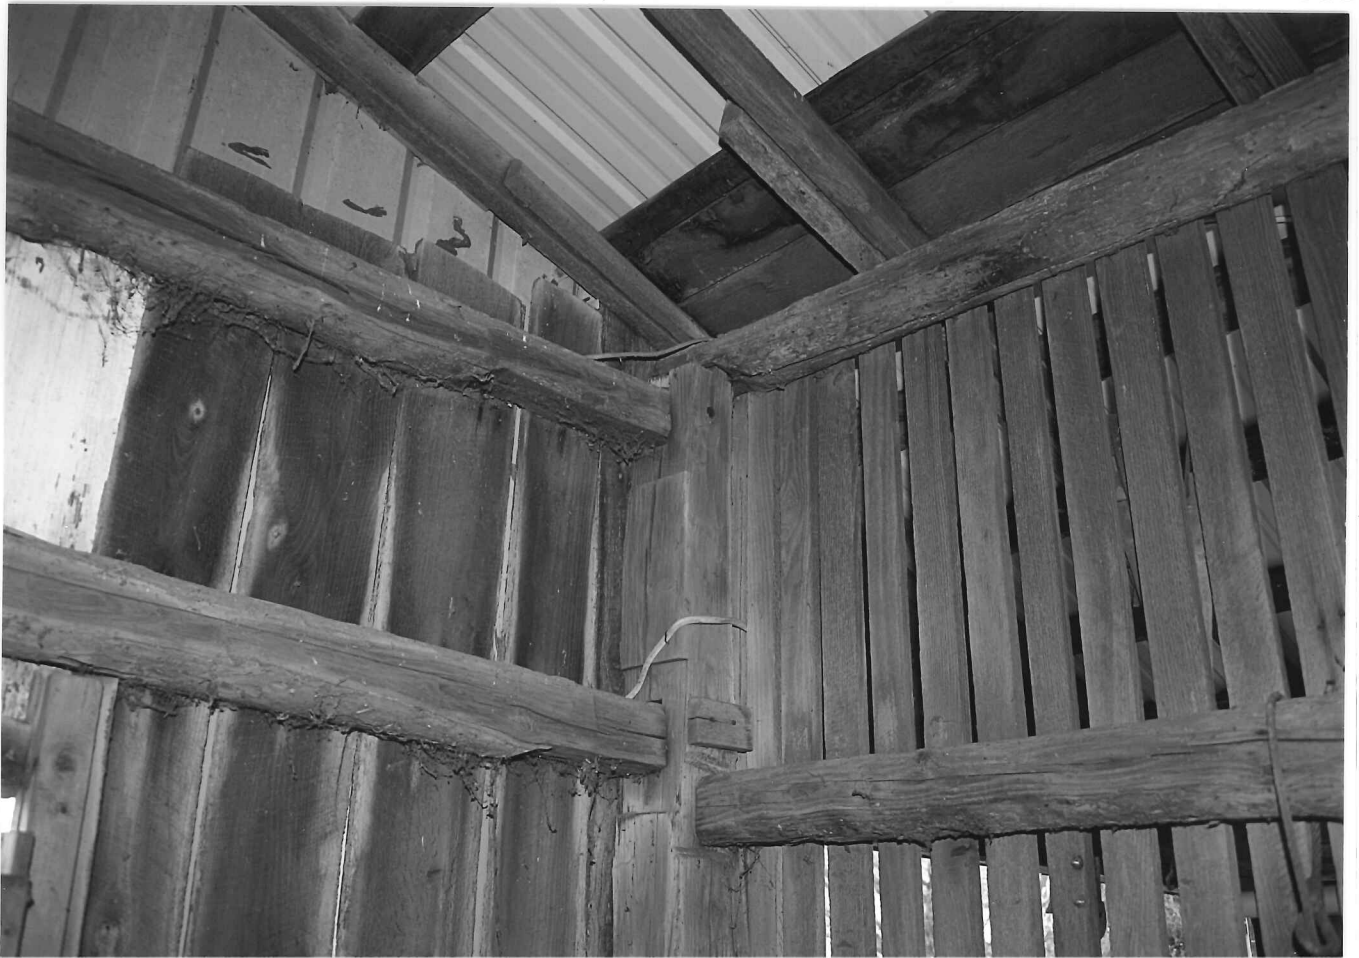
8 of 8

Wagon Shed/Corn Crib, northeast corner
framing
