HO-557  
Mount Misery  
Ellicott City  
Private

INVENTORY FORM FOR STATE HISTORIC SITES SURVEY

HISTORIC Mount Misery

STREET & NUMBER 8469 Hill Street

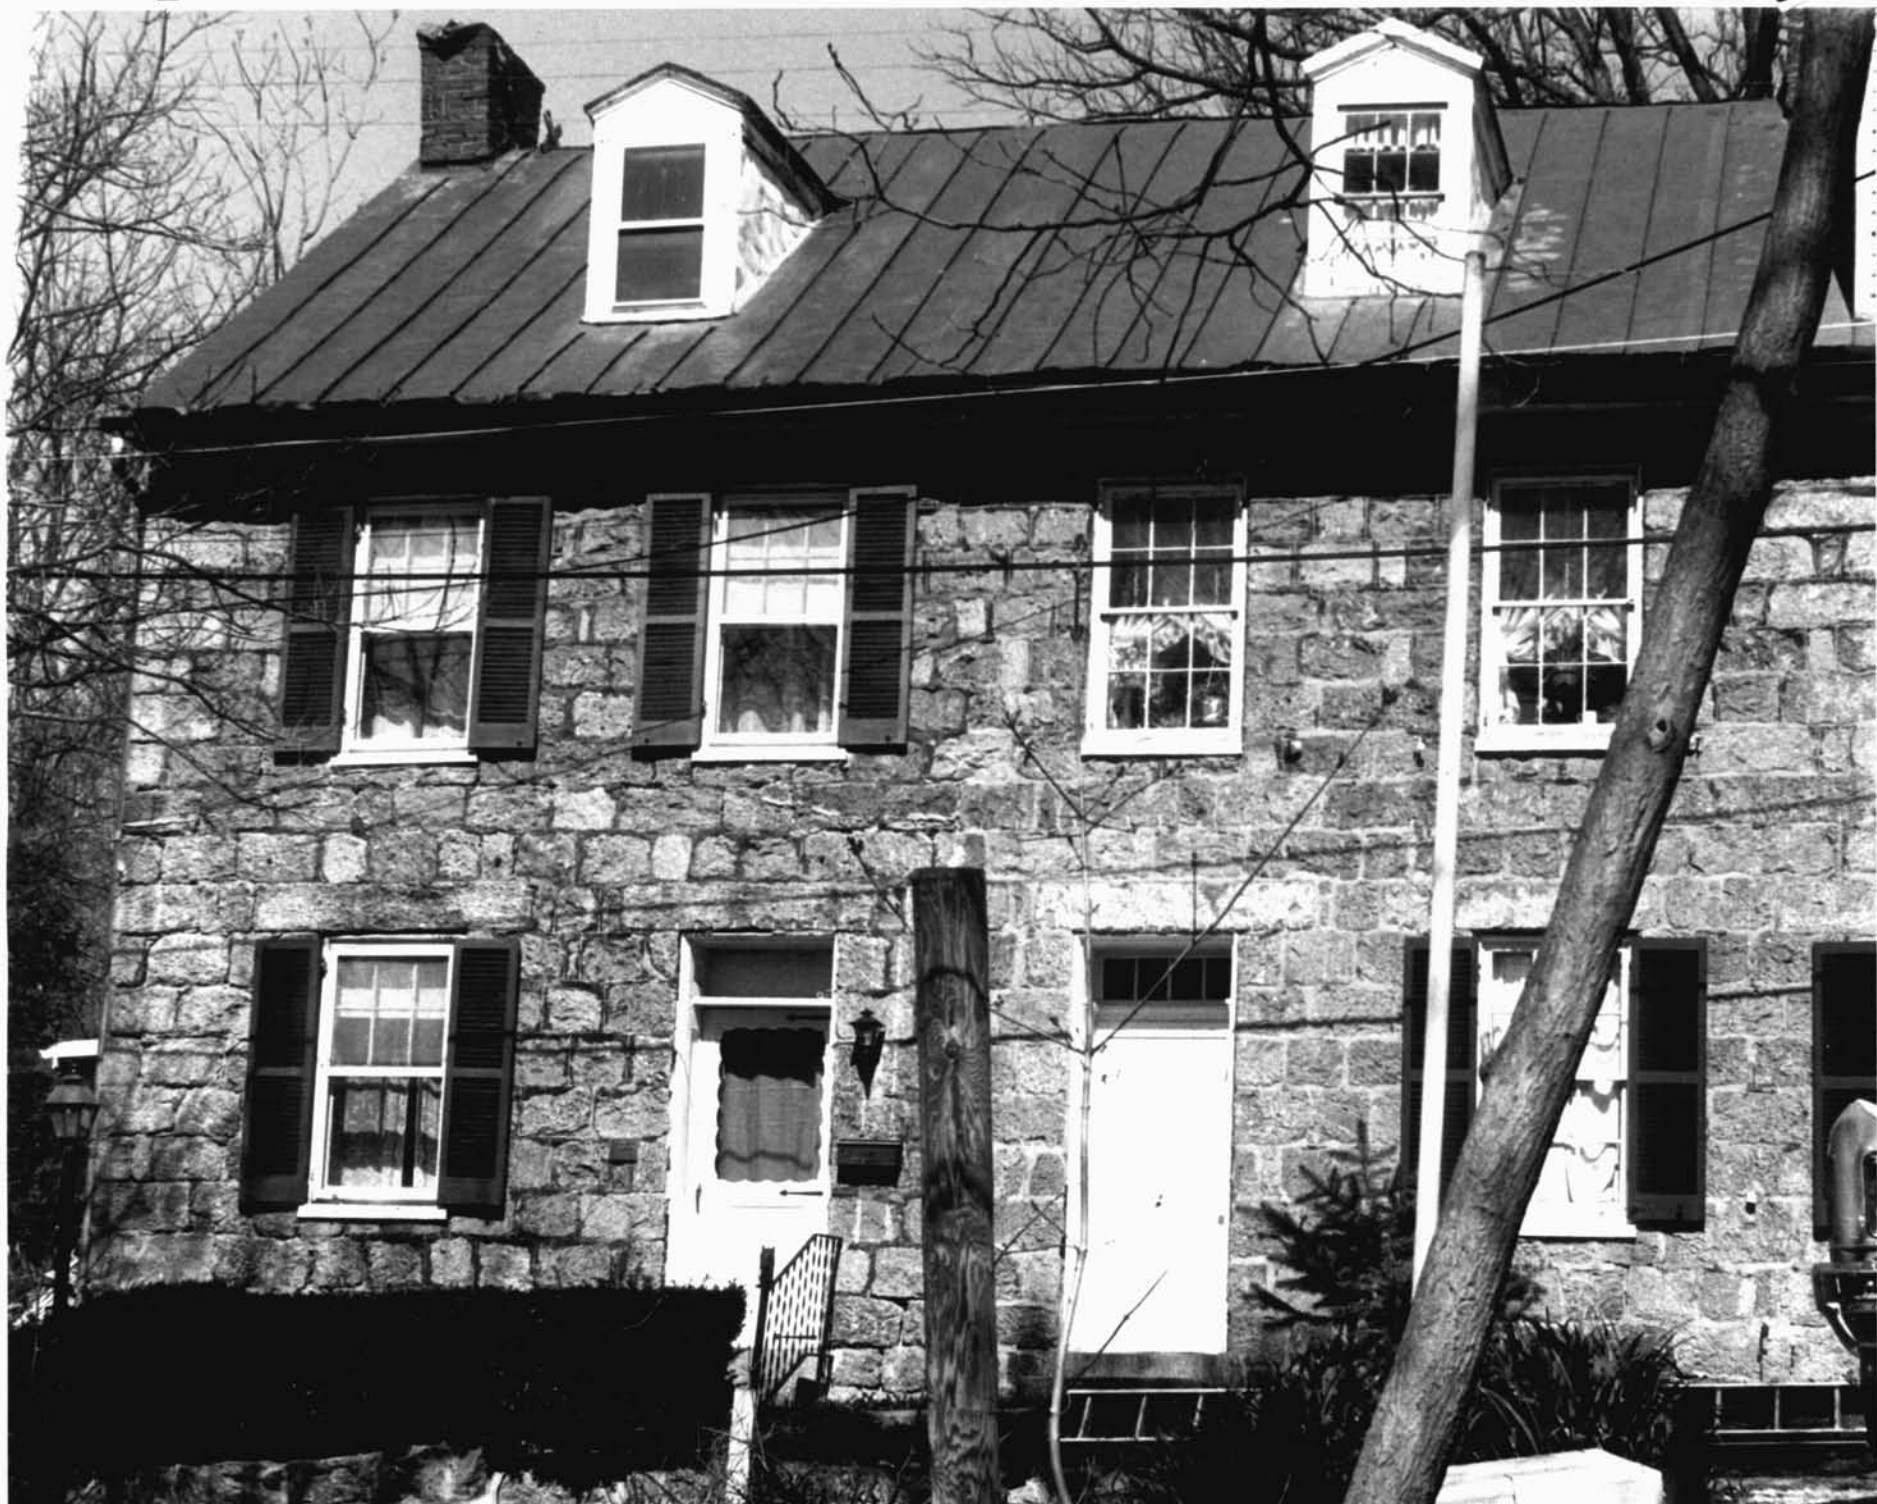
Name: HO-557  
Mount Misery  
Location: 8469 Hill Street  
Ellicott City, Maryland 21043  
Photographer: Cleora B. Thompson, A.I.C.P.  
Date of photograph: April, 1980  
Negatives in possession of the Maryland Historical Trust  
View: East  
Photographer looking: West  
Photograph number: 1 of 1

The east facade of the building features vertically aligned and proportionally scaled fenestration, with two central bay, rectangular entrance doors, surmounted by four light transoms (that in the south central bay now holds only one light, but features the original pegged window frames), and flat stone lintels. These windows are double-hung, retaining their original, pegged mortise and tenon sashes, but holding six-over-one lights on the south half of the house and six-over-six lights on the north half. Windows are underlined by flat wooden lintels, and decorated with shutters.

Two gabled roof, dormer windows are placed in the roofline at this elevation. They hold rectangular windows, flanked by fluted pilasters. The window on the south side holds one-over-one lights and that on the north side six-over-six lights. Excellent stone work is exemplified by the fine stone quoining and flat stone lintels, surmounting the doors and windows, as well as the choice of squarely cut stones for the east facade.

Two stone retaining walls have been constructed along the east elevation, one around the southeast corner of the building, and the other constructed along the west side of Hill Street as it slopes northward up the hill. Still another stone retaining wall runs along the west elevation of the building, creating a patio area west of the house.
