HISTORIC PRESERVATION CERTIFICATION APPLICATION
REQUEST FOR CERTIFICATION OF COMPLETED WORK

1. Name of property: Burgess Carriage House (Burgess Estate Complex)

HISTORIC PRESERVATION CERTIFICATION APPLICATION
PART 1 — EVALUATION OF SIGNIFICANCE

Historic Pres. Certification Applic.
8450 Main Street, Ellicott City, MD
North and East Elevations--
Before/After

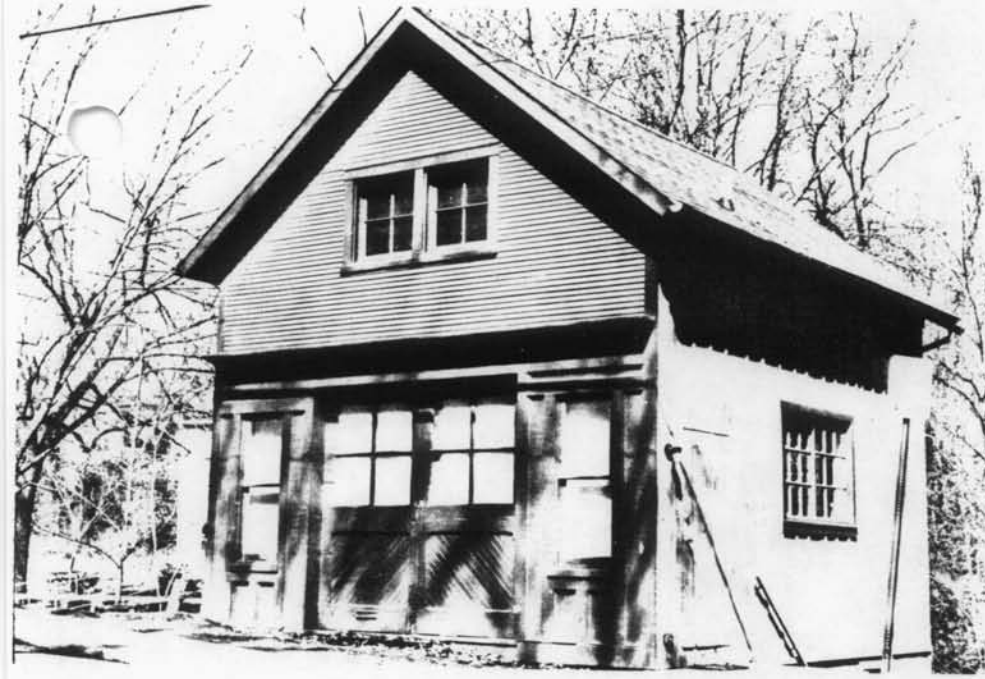
Fig. C-1 Front facade restored using all existing material. Windows and carriage doors repaired. Right side elevation shows new sliding wooden sash with true divided lights to match original plus new "concealed" door used as main entrance. All siding existed pre-rehab.

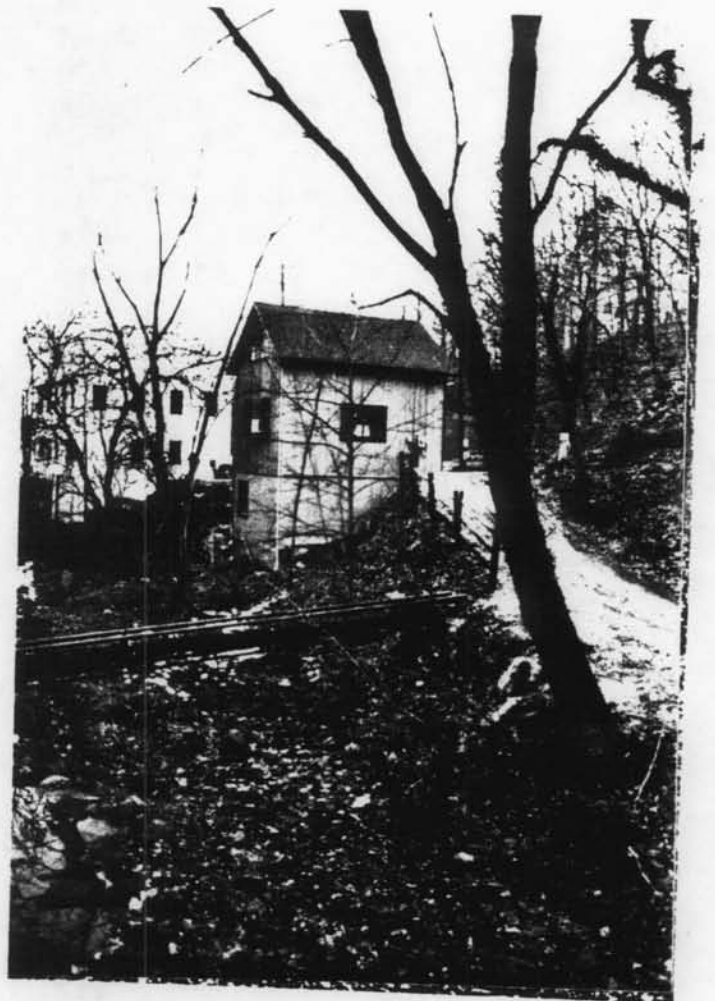
Fig. C-2 Left and rear side elevations after rehabilitation. Left elevation has replicated sliding wooden sash to match what existed originally. On rear, new window installed at basement level; heat pump shown in first floor window; and single window in attic converted to pair unit

All siding existed pre-rehab. No other changes to rear or left side elevation. Driveway upgraded slightly; otherwise no site change (new gravel at entrance and a little widening).

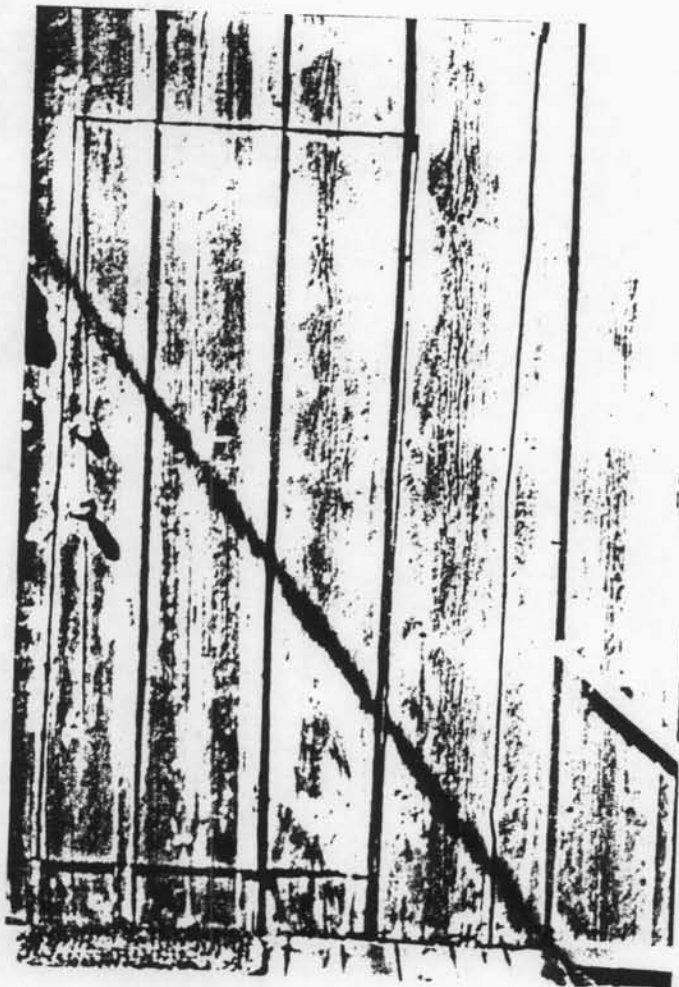
Fig. C-4 "New "concealed" door installed on right side elevation. Existed board and batten used as outside covering.

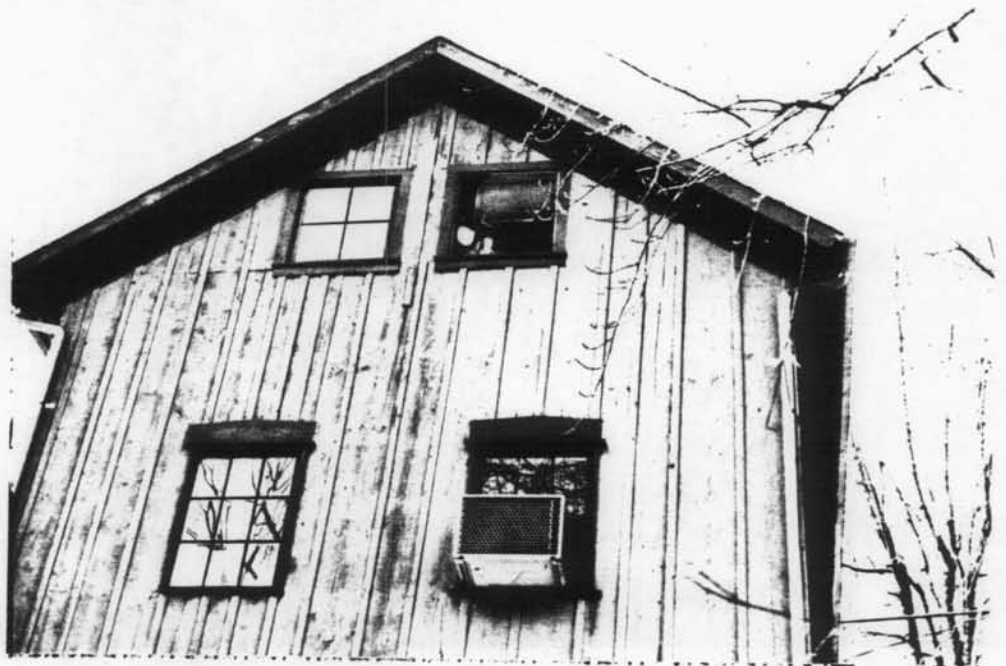
Fig. C-6 Rear elevation after rehab. Windows on first floor retained; board and batten retained. Window in attic converted from single 4-light opening to a split paired unit. Heat pump window units placed in 2 right windows to avoid cuts thru wall.

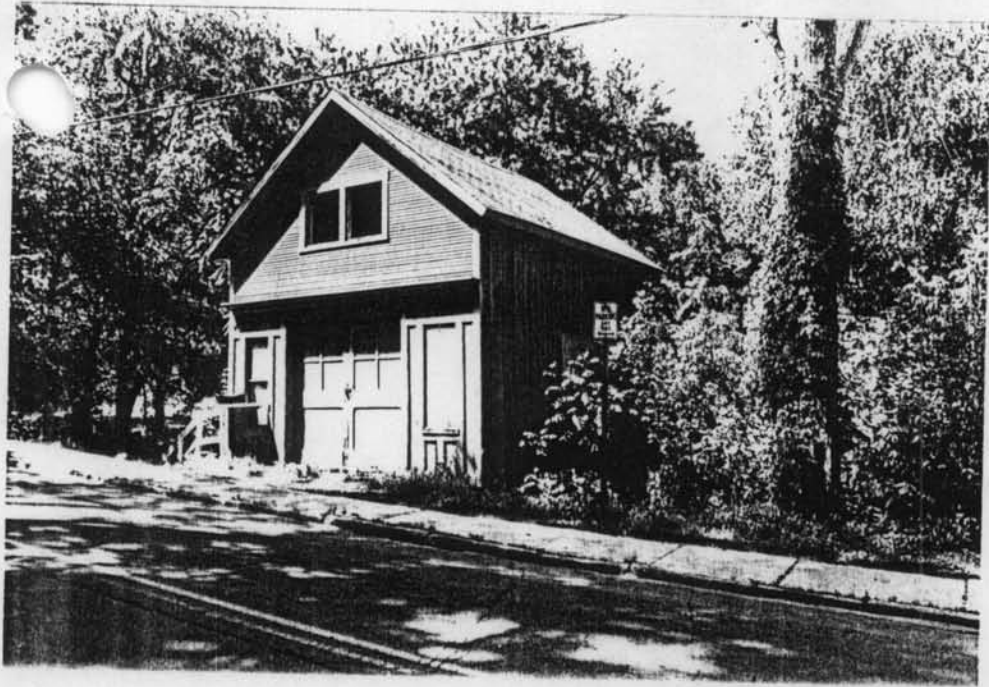
Fig 1.
Main Street facade of
Burgess Carriage House
