HO – 824 The (Joseph and Irene) Buncke Property 8402 Washington Boulevard Laurel, vicinity

Maryland Historical Trust Maryland Inventory of Historic Properties Form

HO-824 The (Joseph and Irene) Buncke Property 8402 Washington Boulevard, Laurel Savage quadrangle

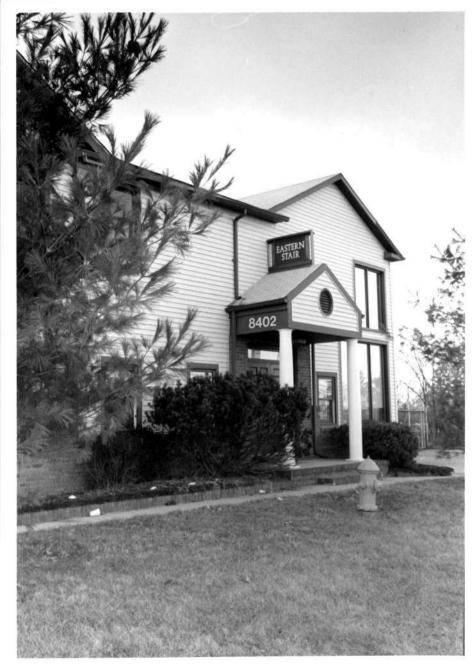
1054

The **front (east) elevation** is composed of a large, frame wall in five (5) parts and is two (2) stories in height. Overall, the façade is symmetrically arranged, although the fenestration pattern and entrances are not. Three gables, appearing at the attic level, define the façade. Between each of these gable roof forms is a section of what appears to be a sloping roof that corresponds to the wall plane below. The wall foundations have a non-historic brick veneer surface, extending approximately 2-3 feet above grade. The brick is a yellow brown shade and there is a header course creating a sill along the length of the façade. Above this sill level the wall is covered with a yellow shaded aluminum siding. All exterior wood trim is painted a dark brown color. Soffit trim, gutters and downspouts have a dark brown extruded aluminum material finish.

HO-824
BUNCKE PROPERTY
HOWHRD COUNTRY
WEW LOOKING MORTHWISET
FRONT FRADE

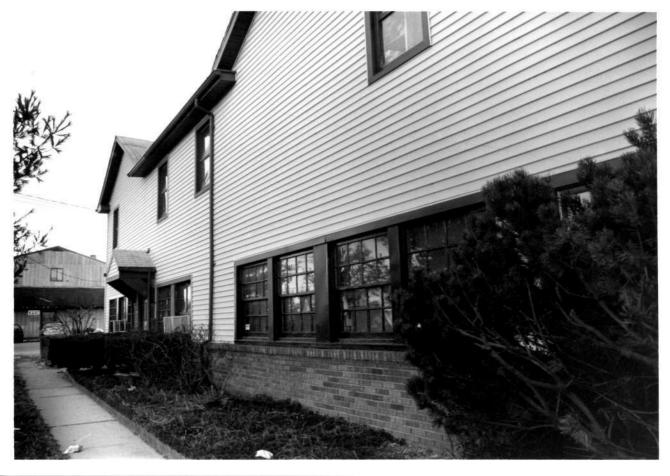
OX4

10-824 BUNCKE PROPERTY HOWARD COUNTY VIEW LOOKING SOUTHWEST FRONT FRADE

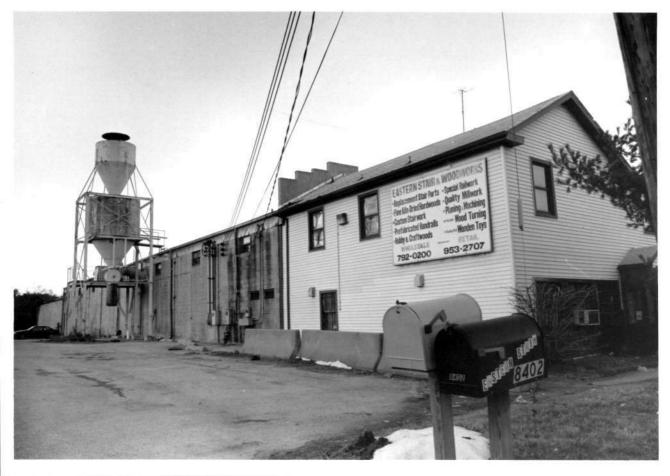
4044

The east end of the **South (side) façade**, closest to Route US 1, has similar finishes as described for the front façade. The aluminum siding continues around the side wall. There is a very large white painted sign that tells of the products and services that Eastern Stair and Woodworking offer. There are three windows on this façade: Two near the west end of the two-story section of the building. Each window is a 1/1 double hung wood sash window. Also at this general end of the building is a matching single window on the first floor level. A security grille has been installed over this window. The windows are not configured to relate between the first and second floor levels. The yellow-brown brick veneer at the foundation level on the front of the building does not continue on this southern elevation.

There is a two story CMU block wall addition immediately adjacent to the west end of the frame portion of the building. The long wall of this façade is composed of 8 large bays, demarcated by low relief projections, also of CMU block construction. Each bay has at least one clerestory window, usually centrally located at the uppermost portions of the wall face. There appears to be a painted steel lintel along the top of each bay.

HO-824
FOUNCKE PROPERTY
HOWARD COUNTY
VIEW SOUTH FROADE
LOOKING WORTHWEST
