HO-836, Humphries-Clarkin House 6154 Rockburn Hill Road, Elkridge vicinity Howard County 1902 Private

# Maryland Historical Trust Maryland Inventory of Historic Properties Form

1. Name of	Property	(indicate preferred	I name)		
historic	Humphries	s-Clarkin House			
other					
2. Location					
street and number	6154 Rock	burn Hill Road		r	not for publication
city, town	Elkridge	Elkridge			vicinity
county	Howard

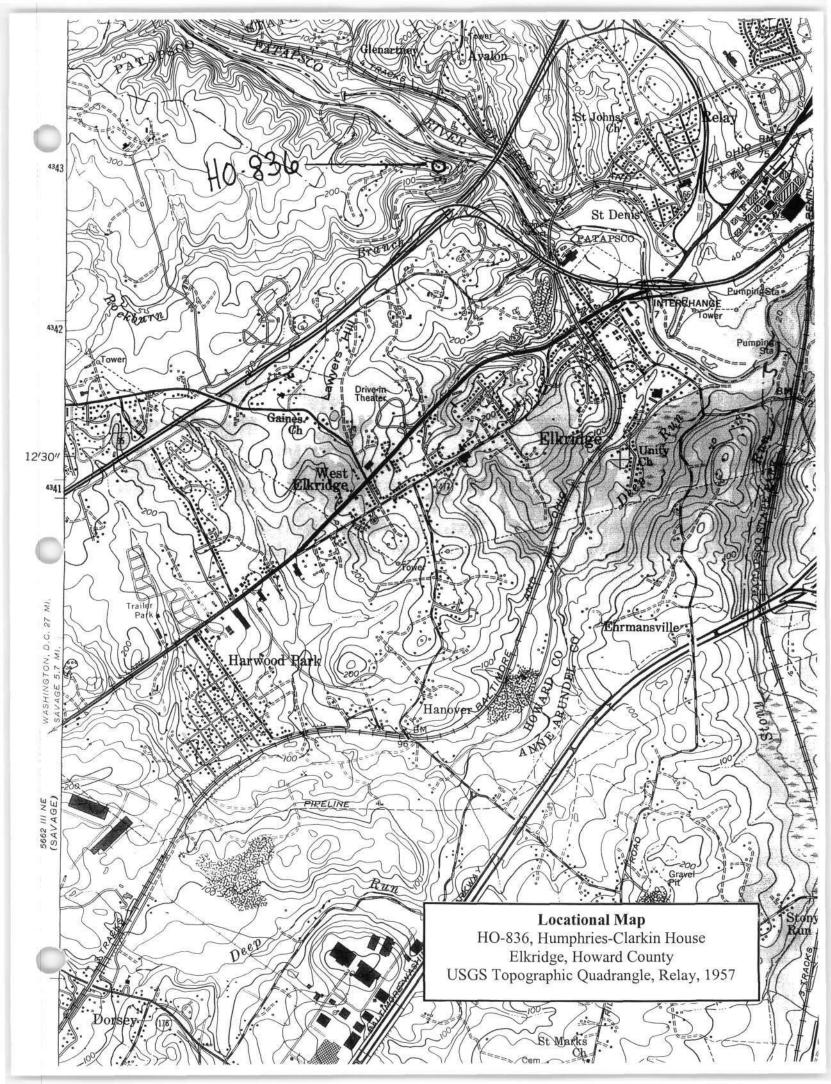
HO.836, Humphries-Clarkin House
6154 Rockburn Hill Road, Elknoge
Howard wanty Manyland
Knotin Hill 1/04 34 21+81 HHHHH 582
Negative at MOSHPO
SW elevation

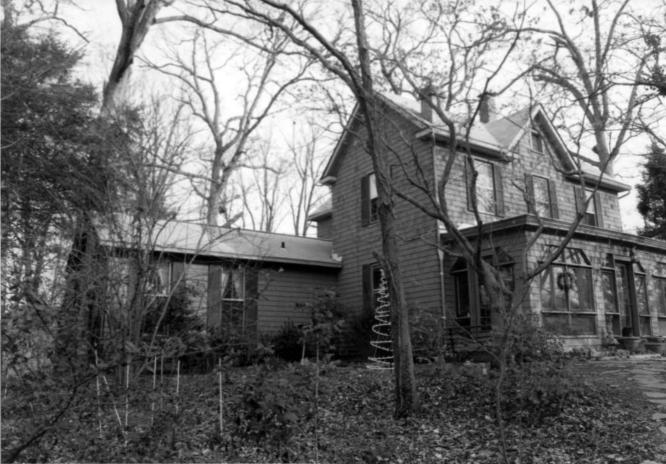
Ho. 836 Hamphnes Clarkin House 6154 Rockburn Hill Road, Elknoye Howard Lounty, Mayland Kristin Hill, 1/04 32 21+88 HINNH 625 Negative at MOSHPO SW elevation 2/11

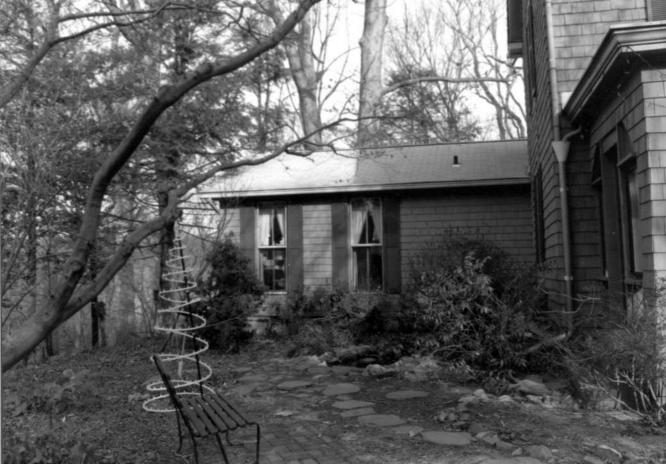
3/11

The west side façade of the house features two vertically aligned 2/2 double hung wood windows, one on each story, in the front section of the house and a substantial, single story addition extending from the west side of the rear wing. The addition is two bays wide and one room deep and has a side gabled roof. The floor-to-ceiling 2/2 windows that were removed from the front façade of the house were reinstalled on the front (south) façade of this addition.

16-836, Humphries-Clarkin House 6154 Rockburn Hill Road, Elkridge Howard Lounty, Maryland Knstm Hill, 1104 Negative at MOSHOU 32 21+01 5 elevation of 1970's addition showing reused 2/2 windows

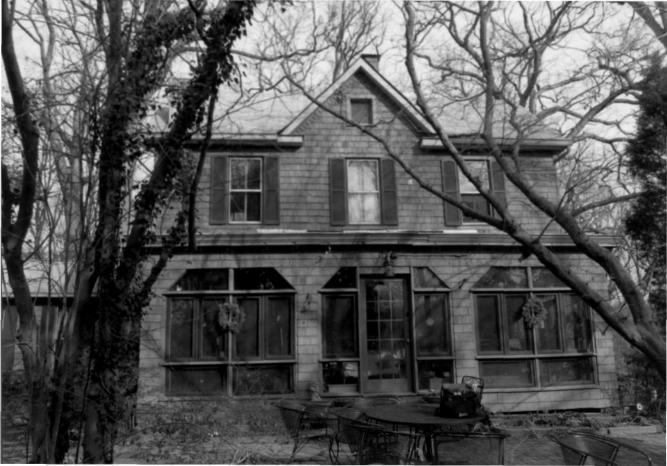
4/11

The front (south) façade is three bays wide with three 2/2 double hung wood windows across the second story. A square vent is located in the central cross gable. The first story is concealed behind a full width enclosed front porch. Originally, the house had a central entry flanked on each side by a tall, floor-to-ceiling 2/2 double hung window. The original porch had turned posts and Victorian-style scroll brackets. The porch was gradually enclosed during the 20th century, and a 1970's renovation removed the central entry and replaced it with a window and removed the two large 2/2 windows and placed French doors in both openings leading onto the enclosed porch. The 2/2 windows were reused in an addition built on the west façade of the rear wing. Two interior brick chimneys pierce the roof of the front section of the house. One is located on the front left slope of the roof while the other is located at the ridge just to the right of center. The one on the front slope was constructed in the 1970's; the one at the ridge is a heavily rebuilt version of an original chimney.

140-836, Humphnes-Clarkin House
16154 Rockburn Hill Road, Elknoge
140ward County, Mayland
Knstin Hill, 1/64
Negative at MOSHPO
Selevation

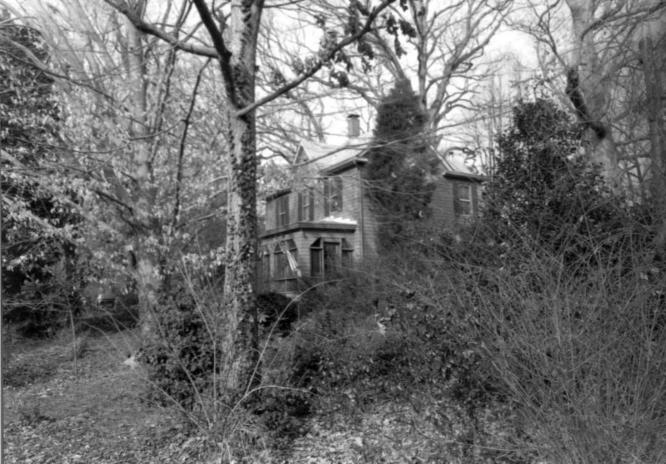
5/11

Ho. 836, Humphries - Clarkin House 6154 Rockburn Hill Road, Elknoge Howard Lounty, Maryland Knoth Hill, 1/04 Negative at MOSHPO 31 21+88 NHNHN 582 SE elevation

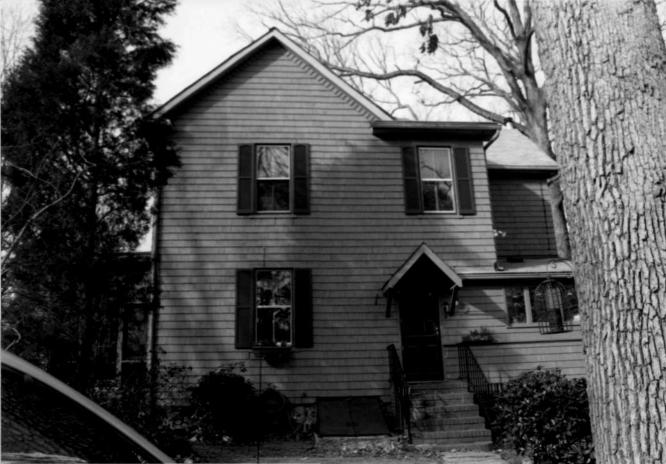
The east side façade features vertically aligned 2/2 double hung wood windows, one on each story, in the front section of the house, and a two story addition on the east side of the rear wing. The addition is actually an enclosed porch on the first story with a bathroom added directly above on the second story. There is a reused 2/2 double hung wood window on the second story of this addition and a door on the first story.

HO.836, Humphries: Clarkin House 6154 Rockburn Hill Road, Ellhridge Howard Lounty, Maryland Kn3th H.11 1/04 36 21+81 HAMMA 625 Negative at MOSHPO East elevetion 6/11

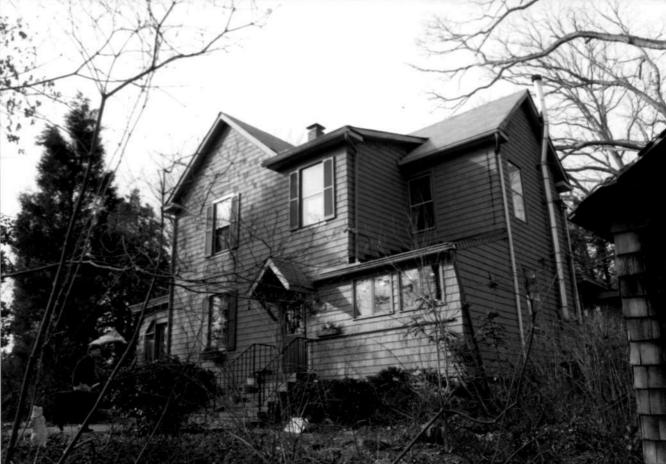
140.836, Humphnes Clarkin House
6154 Rockburn Hill Road, Elknoge
140ward County. Maryland
Kristin Hill 1104
Negative at MOSHPO
NE elevation

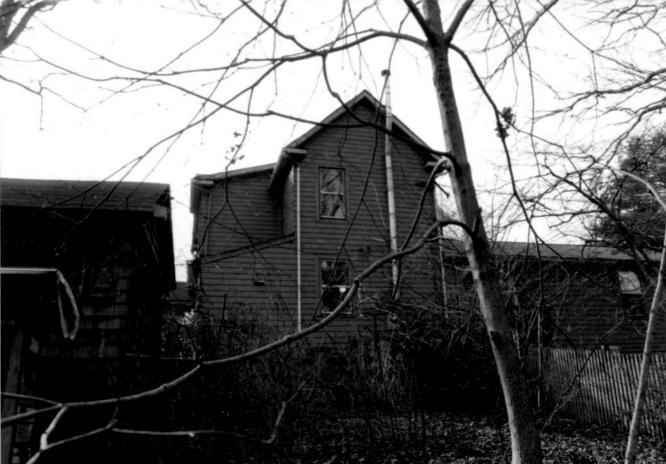
The rear façade of the rear cross gabled wing has two vertically aligned 2/2 double hung wood windows, one on each story, and an exterior metal stovepipe chimney. The rear of the front section of the house is visible to the right of the wing and features one 2/2 window on the second story. The first story is obscured behind a large addition extending from the west façade of the rear wing.

HO-836, Humphries - Clarkin House 6154 Rockburn Hill Road, ElKnoge Howard Lounty, Maryland Knstin Hill, 1/04 Negative at MDSHPD north (rear) devation 8/11

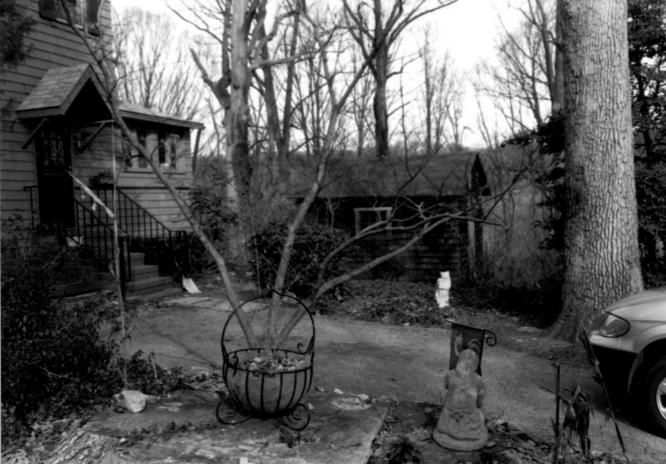
Ho. 836, Humphnes - Clarkin House 6154 Rockburn Hill Road Elknoge Howard Lounty, Mayland Knstin Hill 1/04 31 21+01 HMNNN 625 Negative at MDSHPO East elevation of house and south elevation of outbuilding

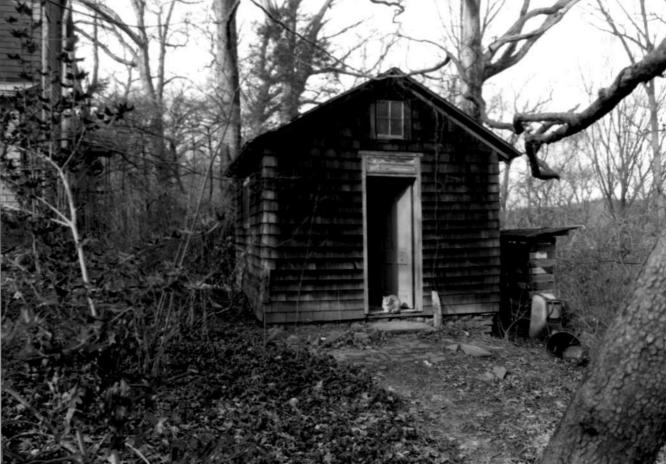
There are two frame outbuildings on the property. A single story frame outbuilding on a stone foundation located northeast of the house was probably constructed at the same time as the main dwelling and probably served some type of service function as storage space or a workshop. A single story frame garage on a cement block foundation located east of the original outbuilding was probably built sometime later in the 20th century, maybe as late as the 1970's renovation.

140-836, Humphries Clarkon House le154 Ralkburn Hill Road, Elknoge Howard County, Maryland Knstin Hill 1/04 Negative at MDSHPO 33 21+01 HHNHH 625 trame outbuilding, east elevation 10/11

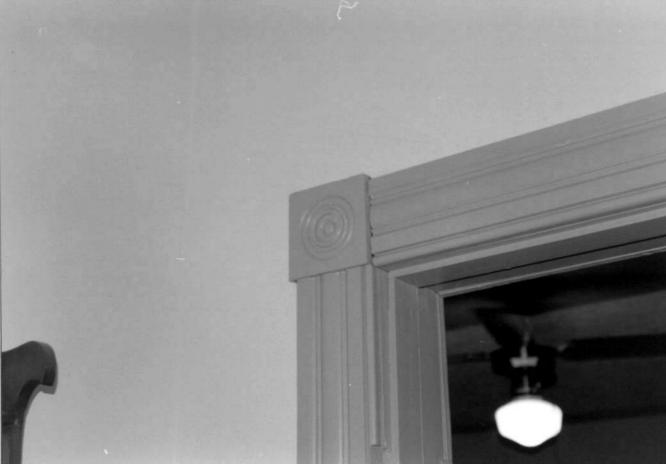
10.836, Humphnes-Clarkin House 6154 Rockburn Hill Road, Elknoge Howard Lounty, Mayland KnSth Hill 1/04 35 21-01 HNNH 582 Negative at MDSHPO original interest trim 11/1/
