HO-843, House 10109 & 10111 Frederick Road, Ellicott City Howard County Ca. 1925 Private

Maryland Historical Trust Maryland Inventory of Historic Properties Form

HO-843

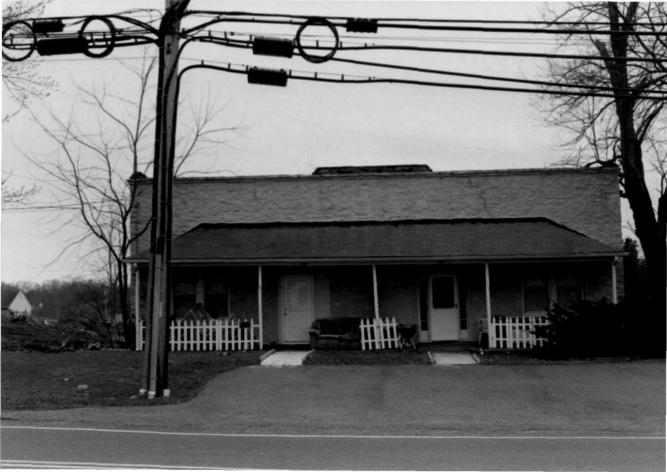
Ho.843, House 10109 + 10111 Frederick Rd. Howard Lourty, Maryland Knoth Hill 3/04 Negative at MOSHPO Foont (north) elevation 1 of 5

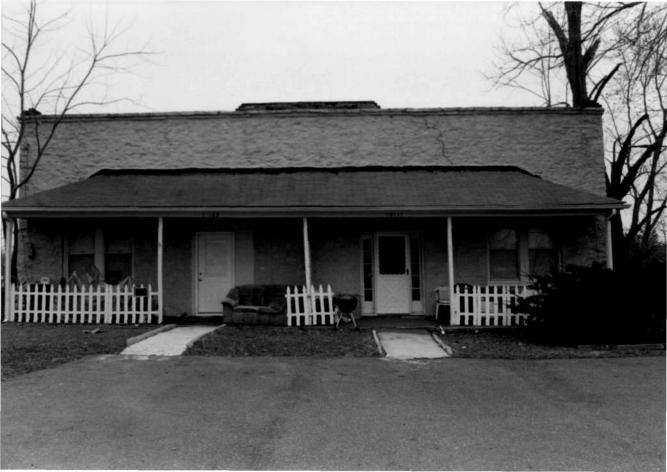
Ho. 843, House
10109 + 10111 Frederick Rd.
Howard County. Maryland
Knoth Hill, 3/04
Negative at MDSHPO 23 21+88 NNNNN 158
Front (north) facade

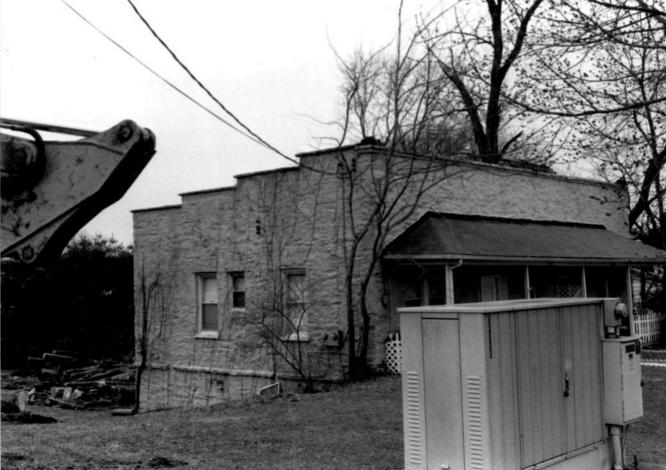
Ho.843, Honse
10109 + 10111 Frederick Rd.
Howard Lounty, Mayland
Knstin H.II, 3/04
Negutive at MOSHPO 22 21+88 HINNIN 158
NE elevation
3 of 5

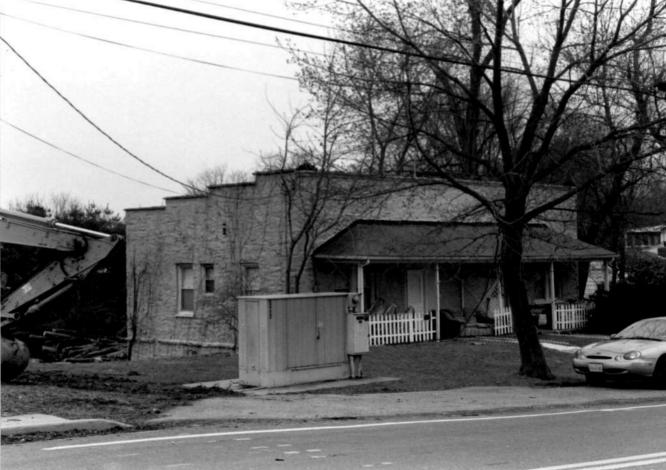
Ho.843 House
10109 + 10111 Frederick Rd.
Howard County, Maryland
Knoth Hill, 3/04
Negative at Mostpo
NE elevation
4 of 5

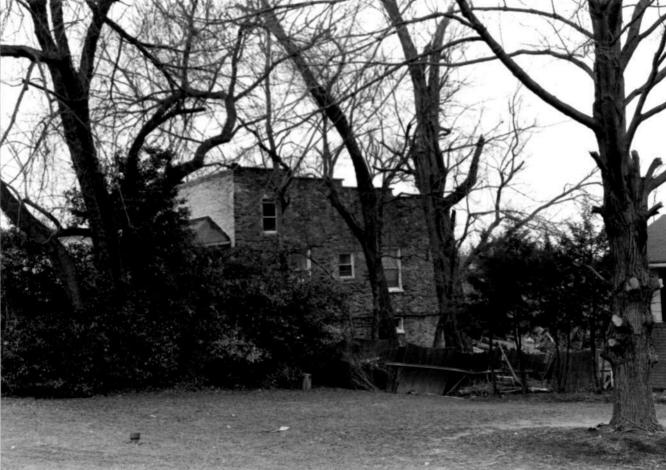
HO-843, House 10109 + 10111 Frederick Rd. Howard Lounty, Mayland Knstin Hill. 3/04 Negative at MOSHPO West elevation 5 8 5
