HO-920 "Wheatland" ("Bleakwood") 12570 Hall Shop Road Howard County, Maryland

National Register of Historic Places Registration Form

"Wheatland" HO-920

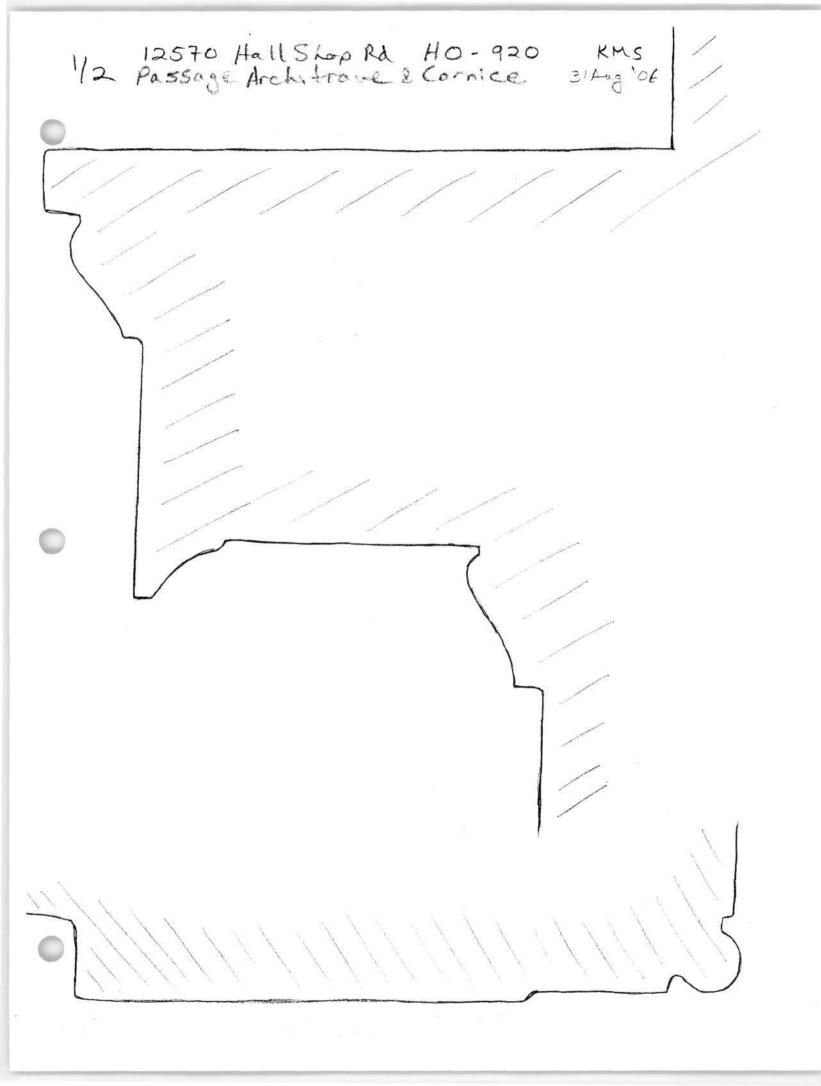
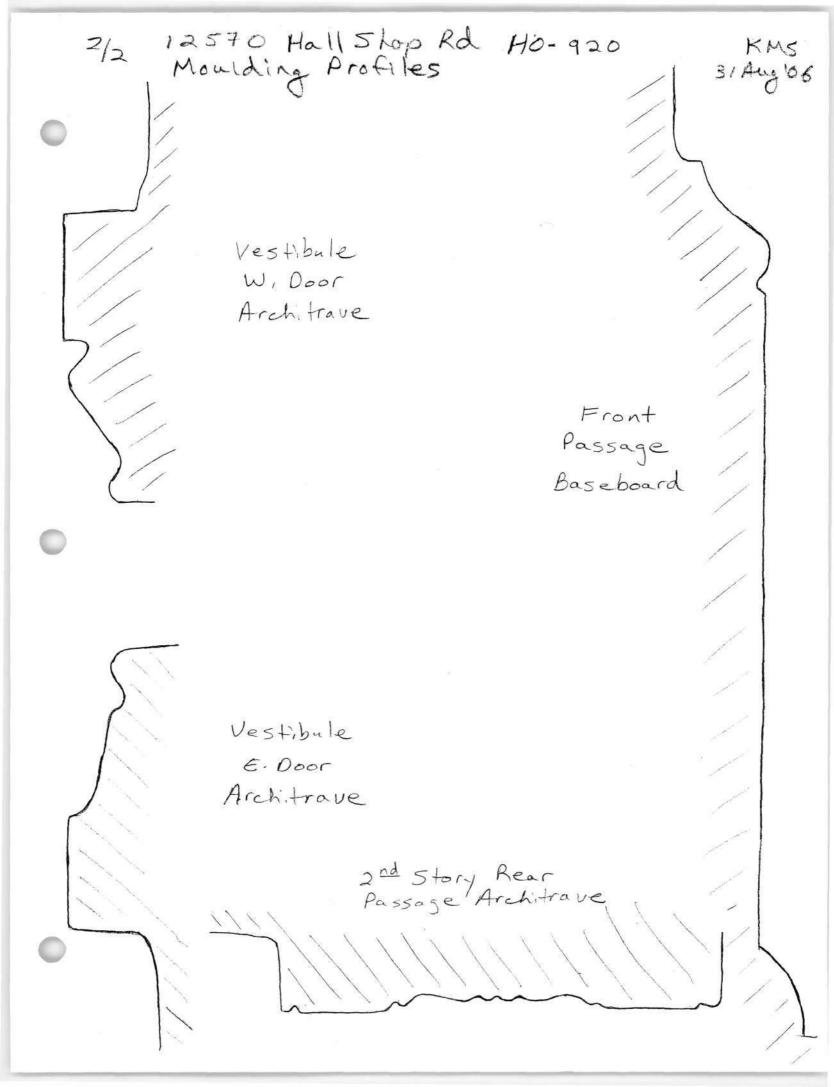
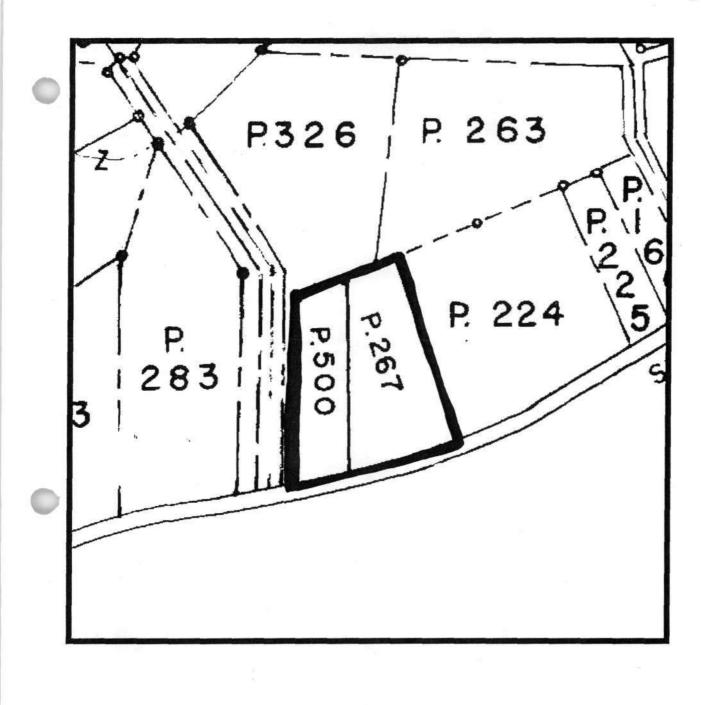
FIRST FLOOR PLAN - MEASURED BY KEN SHORT & LAURA DORSEY - DRAWN BY KEN SHORT - FEBRUARY 2007

Β. 0 0 2 O DN O C. 0 0 D NOTES: A. MODERN PORCH ENCLOSURE NOT SHOWN. STEPS ARE MODERN STONE. B. MODERN DECK NOT SHOWN. C. MODERN STONE STEPS. 10 20 FT D. FLAGSTONE PAVING. HO-920 "WHEATLAND" 12570 HALL SHOP ROAD

The house was originally a center-passage, single-pile plan with an ell. The re-entrant angle was then filled with an addition that added a passage and a roof on the back. The front passage has 2 1/4inch oak flooring that runs east-west. The baseboard has a quirked ogee on top. The architrave has a broken field with a beaded interior edge, and there is a cornice above each opening architrave that has a quirked Greek ogee bed mould, and a quirked Greek ogee on the cornice. The front door has quirked ogee-and-bevel panel moulds. It has cast-iron butt hinges with two knuckles, and a new mortise lock. There is a cornice above the transom and one panel under each sidelight that matches the door. The east room door has four panels with sunken fields and quirked ogee-and-bevel moulds. It is mortised and tenoned and pinned at the corners and has cast-iron butt hinges with two knuckles. There is a mortise lock that is original, but has circa 1920s escutcheons and new brass knobs. The west room door is missing. There is a straight run of stairs on the west wall, that descends to a landing at the north end, then returns on the east wall to the south. It has a large turned newel post that appears to be natural pine, with turned balusters and a trapezoidal handrail. The stair has a plain stringer and the stairs are curved at the landing, with no newel posts, and the handrail is not ramped. There are five vertical panels below the stairs, with sunken fields and quirked ogeeand-bevel panel moulds. There is also a door beneath the stairway leading to the cellar. It has four panels with sunken fields and no panel moulds, has cast-iron butt hinges with two knuckles, and has a plain cast-iron rim lock. The rear or north door in the passage has been removed, and the architrave does not have any cornice above it because it is set beneath the landing.

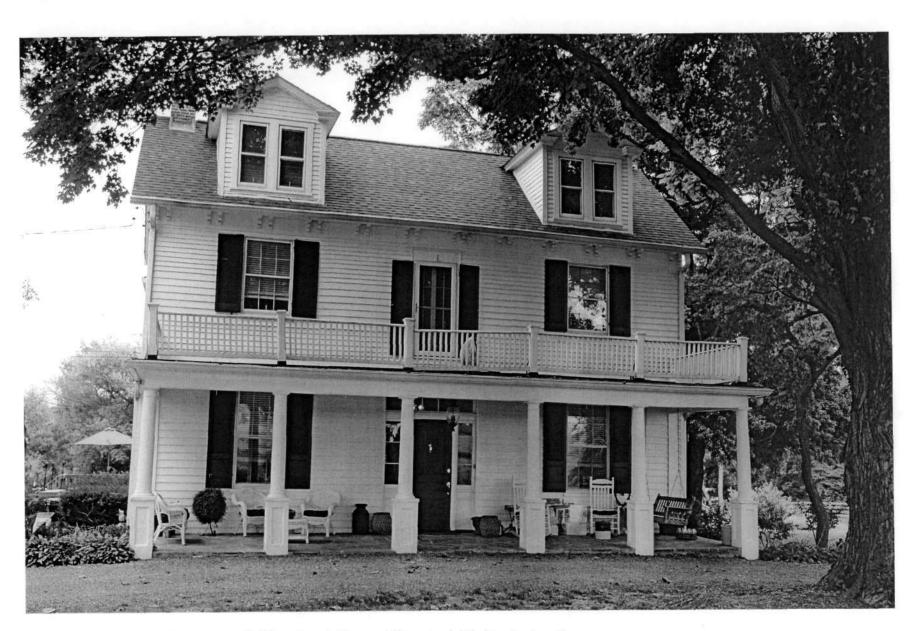
HO-920 "Wheatland," 12570 Hall Shop Road, Howard County, MD South elevation Ken Short, September 2006 1/14

On the south elevation, the first story has a door in the center bay that has six panels with the frieze panels set in the center. The panels have sunken fields and quirked Greek ogee and bevel panel moulds. There are sidelights with three lights over one panel, and the panels match those in the door. The doorway has a beaded-interior-edge mitered frame, and there is a five-light transom, with a transom bar that has a large Greek ovolo at the top. On each side of the doorway is a single six-over-six sash in a frame that matches the frame of the door. The windows have blinds with one panel at the bottom of each, and these panels match the door. The blinds are hung on cast-iron butt hinges with two knuckles. There is a one-story, three-bay porch across the front. It has a flagstone

deck, six wood Doric columns set on top of paneled plinths that are painted but appear to be cast concrete, and has a beaded-edge-and-center board soffit. The porch has a plain frieze and a flat roof with a balustrade on it. This has square chamfered newel posts and square balusters. The second story has French doors in the center that have eight lights each, and have blinds. There are six-oversix sash with blinds to each side of the doors, and these are smaller than the first story sash. The cornice has paired, sawn brackets, and is not boxed, but rather follows the profile of the rafters. The end bays of the roof have dormer windows with a pair of one-over-one double-hung sash in each, weatherboards on the sides, and a gable roof with north-south ridge and a cornice with returns. There is an interior brick chimney on both the east and west gable ends.

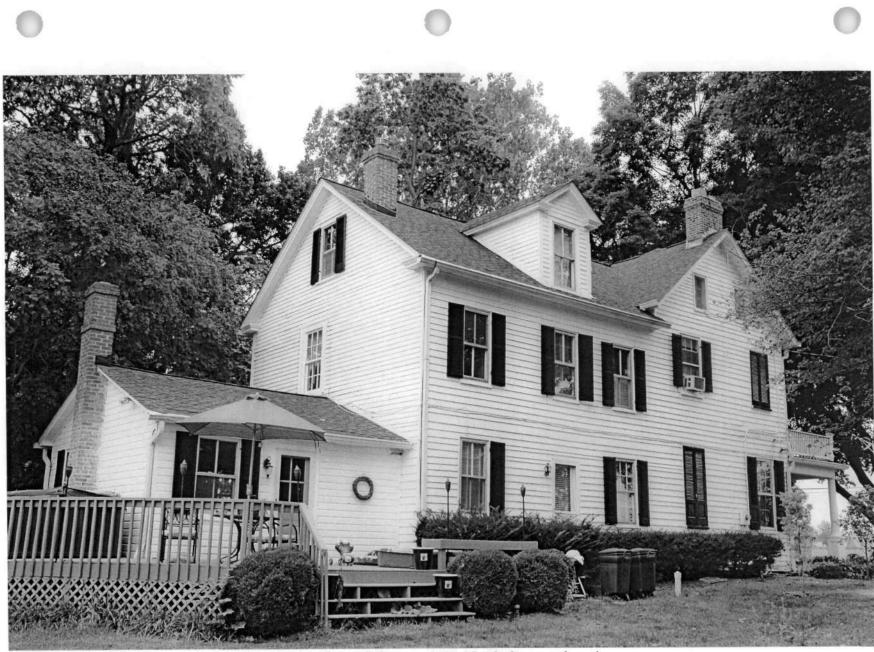
HO-920 "Wheatland," 12570 Hall Shop Road, Howard County, MD North & west elevations Ken Short, September 2006 2/14

The west elevation of the main block has two one-light sash in the foundation. The first story north bay has typical blinds with panels at the bottom, and these are fixed shut. The south bay has a typical first-story six-over-six sash with blinds that have panels. The second story north bay has a typical six-over-six sash with typical blinds, and the south bay has typical blinds that are fixed shut. The gable end has two six-light casement windows. The raking eave has plain board soffit. The west elevation of the ell has a door in the center of the first story that has one light over two panels and has a beaded-interior-edge mitered frame. There is a two-over-two sash with one blind set to the north in a typical frame, and a typical first-story six-over-six sash with blinds, but the window frames cannot be examined closely. There is a wood box cornice with returns, and a dormer in the center that has weatherboards, a two-over-two double-hung sash with head-cut trim, and a gable roof with a cornice that has returns, like that on the south elevation. There is an interior brick chimney on the north ridge.

The west elevation of the addition has a door in the center with four lights over three lying panels, and has a two-over-two sash to the north of it, with blinds. The north elevation of the addition has an exterior brick chimney in the center and a two-over-two sash with blinds to the east of it. The east elevation of the addition has a center door with four lights over three lying panels, and to the south of it is a two-over-two sash with blinds. The north elevation of the ell is covered by the addition on the first story, for the most part, but has some German siding exposed. The second story is cantilevered about six inches, with a sawn bracket at the northeast corner, beneath the cantilever. There is a new six-over-six sash in the center of the second story, in an altered opening. The gable end has a two-over-two sash with blinds.

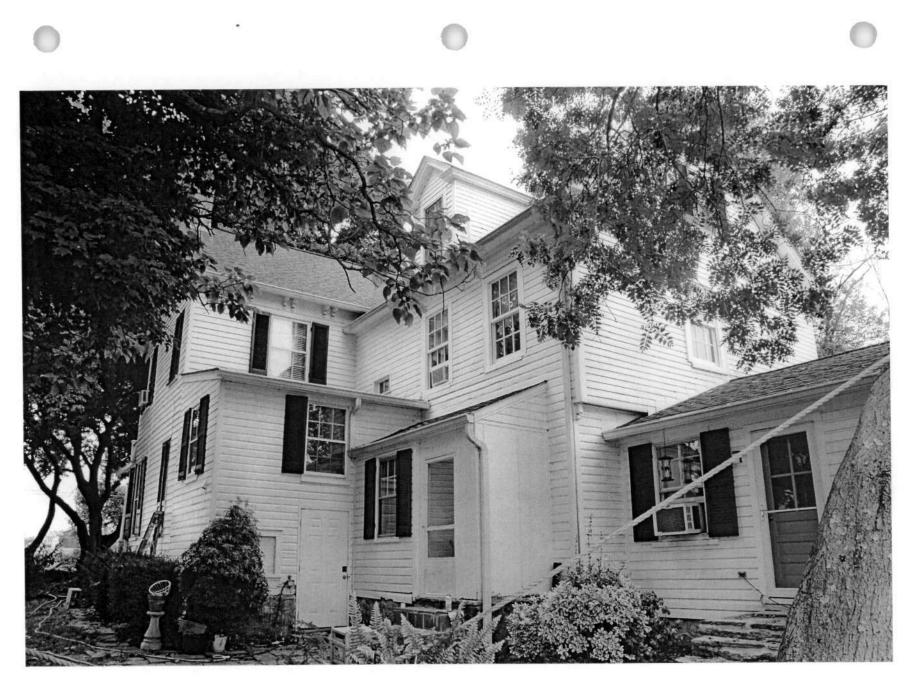
HO-920 "Wheatland," 12570 Hall Shop Road, Howard County, MD East & north elevations Ken Short, September 2006 3/14

On the east elevation of the ell, the first story has two one-story shed-roofed additions with German siding. There is an addition against the north wall of the main block, and the roof slopes down to the north. This has a six-over-six sash with blinds on the east elevation and another on the first story of the north elevation, set high on the wall. Below this window is a new six-panel door in an old opening that leads to the basement. There is a boarded-up window opening to the east of this door,

and it has head-cut trim. The other addition is on the east wall of the ell, with a roof that slopes down to the east. The east elevation of this addition has a six-over-six sash with blinds set to the south, and an enclosed porch to the north that has plywood with battens and a storm door. This addition also has German siding. The second story of the east elevation of the ell has a three-light sash in the south bay, set low on the wall. The center and north bays have new six-over-six sash. There is a gabled dormer that matches the west elevation. The north elevation of the main block, on the second story, has a typical six-over-six sash with blinds in the east bay. The bracket cornice matches the south elevation. The east elevation of the main block, on the first story, has a six-oversix sash set to the south, with blinds that have panels. The north bay has closed blinds with panels. The second story matches the first story, with the sash being smaller. The gable end matches the west elevation.

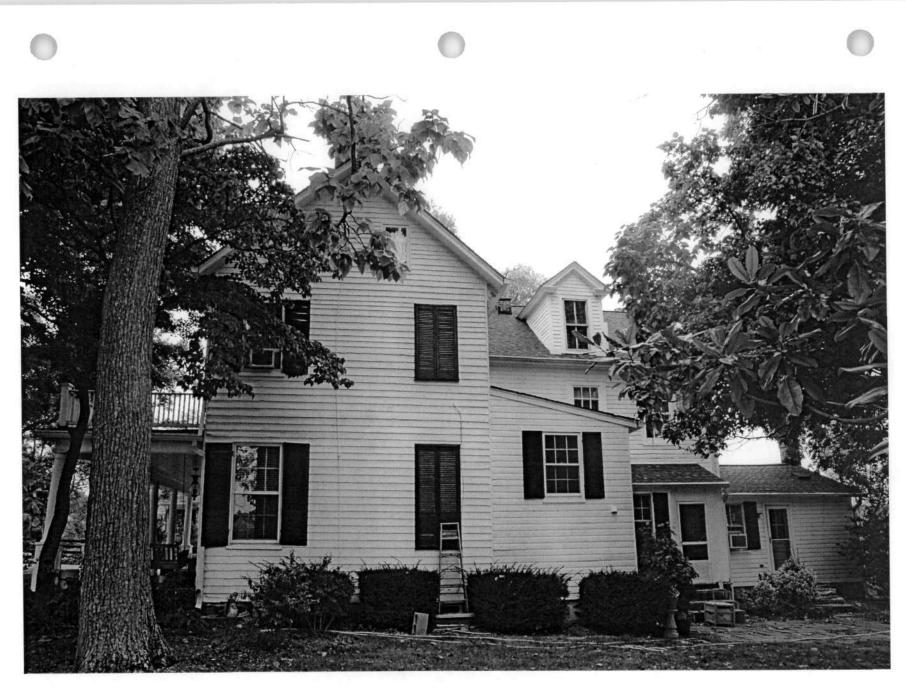
HO-920 "Wheatland," 12570 Hall Shop Road, Howard County, MD East elevation Ken Short, September 2006 4/14

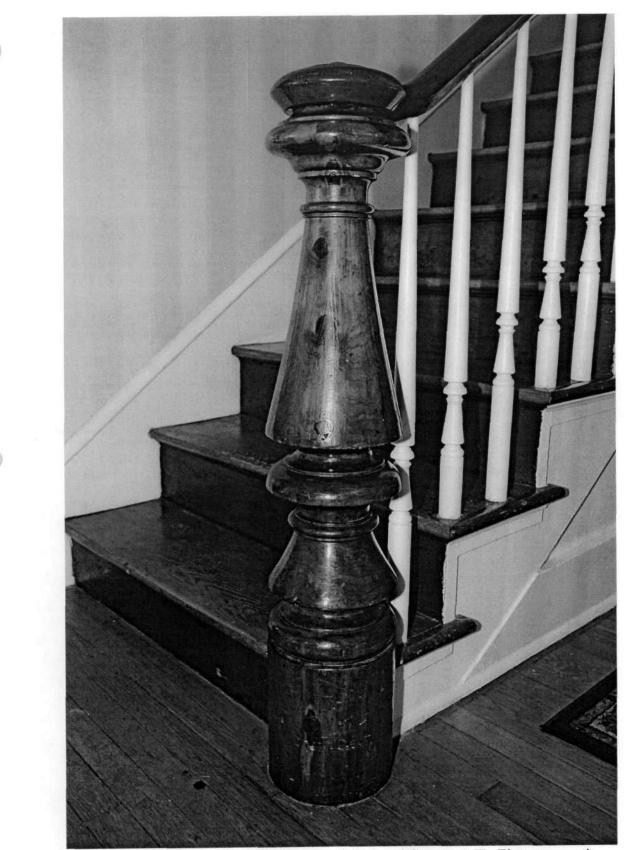
HO-920 "Wheatland," 12570 Hall Shop Road, Howard County, MD First story stair newel Ken Short, September 2006 5/14

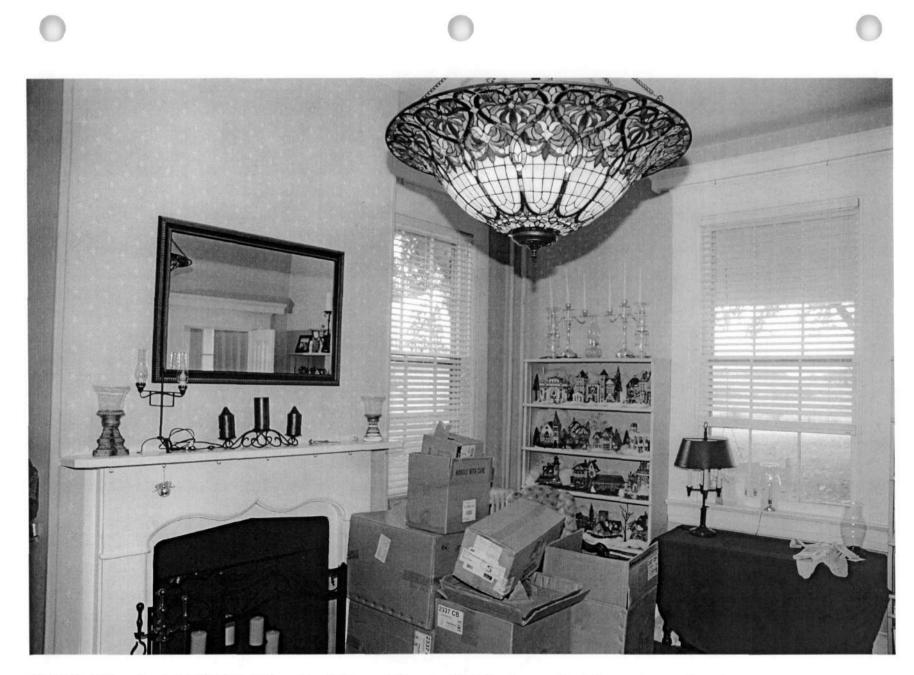
HO-920 "Wheatland," 12570 Hall Shop Road, Howard County, MD East room, first story, view southeast Ken Short, September 2006 7/14

The east room has random-width pine flooring that runs north-south and varies between 3-1/2 and 5 inches. The baseboard, architrave, and cornices are identical to the passage. The window sash have 12-inch by 15-inch lights, ovolo muntins, and parting beads with a check rail. They are mortised and tenoned and pinned only at the corners, it appears, and are hung on sash cords. The south sash has a brass tag with the number "14" on the west side of the sill. There is no definite evidence that a window opening existed on the north wall, but this wall is covered with wallpaper. There is a

fireplace centered on the east elevation with a brick hearth and splayed brick jambs. It has a wood mantel with plain, chamfered pilaster strips and has an ogee cut in the bottom of the frieze. It has a plain mantelshelf, and was originally painted black, according to the owner. There is physical evidence on the north side of the fireplace that a bookshelf had been built in in this location at some time.

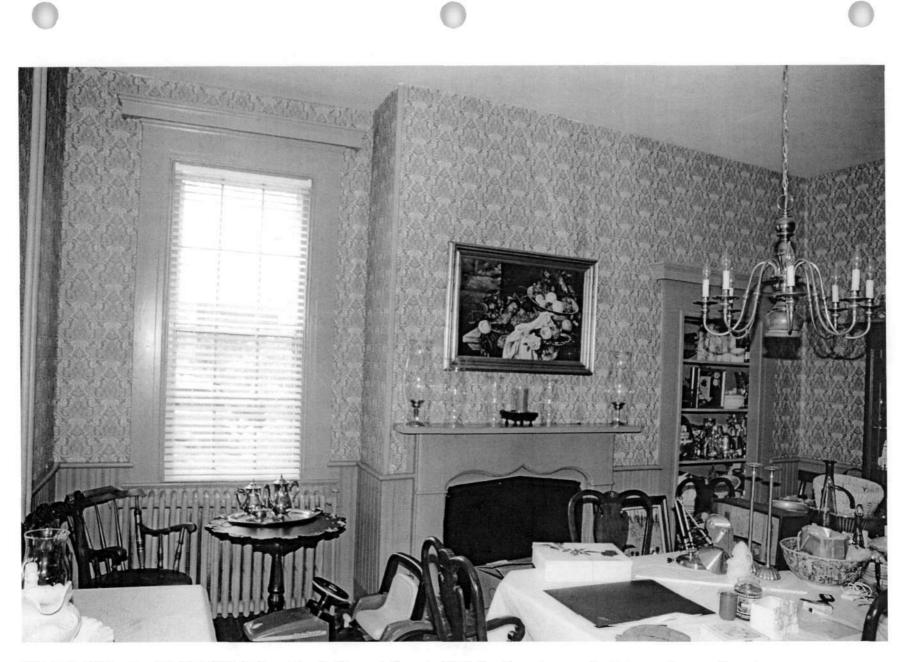
HO-920 "Wheatland," 12570 Hall Shop Road, Howard County, MD Southwest room, first story, view northwest Ken Short, September 2006 8/14

The west room has random-width flooring that runs east-west, is raised higher than the other flooring indicating it was added, and varies between 2-1/2 and 4-1/4 inches. The baseboard, architrave with cornices, and window sash match the east room. There is half wainscot consisting of vertical boards with three beads in the center and one on the edge. The sills appear to have brass numbers, but they are now painted and appear to be raised circles. The west elevation has a fireplace with a painted concrete hearth. The back wall of the firebox has been cut out and the hearth cut through to install a flue pipe for the furnace. The wood mantel matches that in the east room. To the north of the fireplace is a built-in closet that is missing its door but has typical architrave and cornice and appears to be original. There are four shelves inside the closet. On the north elevation, set to the east, is a typical four-panel door with a mortise lock that has circa 1920s escutcheons and new knobs. It also has typical two-knuckle butt hinges. This door leads to the vestibule.

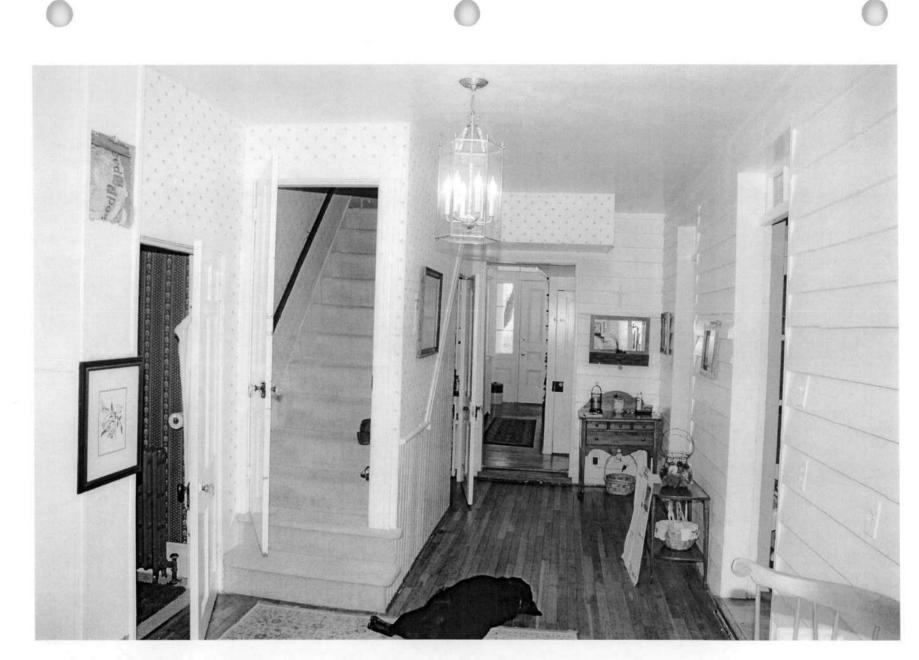
HO-920 "Wheatland," 12570 Hall Shop Road, Howard County, MD Rear passage, first story, view south Ken Short, September 2006 9/14

The rear passage floor is set lower than that of the main block and ell, and is 2 1/4-inch oak that runs north-south. The south and west walls are weatherboards that are face-nailed with cut nails, and have a 4 1/4- to 6 1/2-inch weather. There are two doorways with three-light transoms on the west, with a six-over-six double sash to the north. There is an enclosed straight run of stairs on the east wall, set to the south, and the stairs ascend to the south. The wall that encloses the stairway has three-bead wainscot like that in the west room at the north end, beaded-edge vertical boards in the center, and a 4-panel door to the south. This door has sunken fields, ogee-and-bevel panel moulds, and is painted white over a dark brown varnished layer that has no indication of graining. The door has one butt hinge with a ball finial and one newer butt hinge, and a plain cast-iron rim lock with glass knobs that replaces an earlier rim lock. This wall also has architrave set at an angle following the rise of the stairway; it has a broken field with a bead like the main block architrave. The door at the bottom of the stairs has four panels with sunken fields and ogee panel moulds. There is a plain cast-iron rim lock with glass knobs. The symmetrical architrave has two beads in the center flanked by an ogee, with a bead on the inner and outer edges. There are also bulls-eye corner blocks. There is a doorway on the north, but the door is gone. The architrave has a bead on the outer edge and a cavetto on the inner. The east wall has two doors with head-cut trim. The north door has been altered to have two lights over two panels, and has sunken fields with no panel moulds. It is hung on butt hinges with ball finials and has a cast-iron rim lock with a porcelain knob. It leads to an open vestibule. The south door has a modern six-panel door on butt hinges with ball finials, and has a cast-iron rim lock with glass knobs. It leads to a small modern bathroom that has an old six-over-six sash on the east. The sash has 9-inch by 12-inch lights, parting beads, and ovolo muntins. The sash is mortised, tenoned and pinned at the corners and is hung on tapes. The window has head-cut trim.

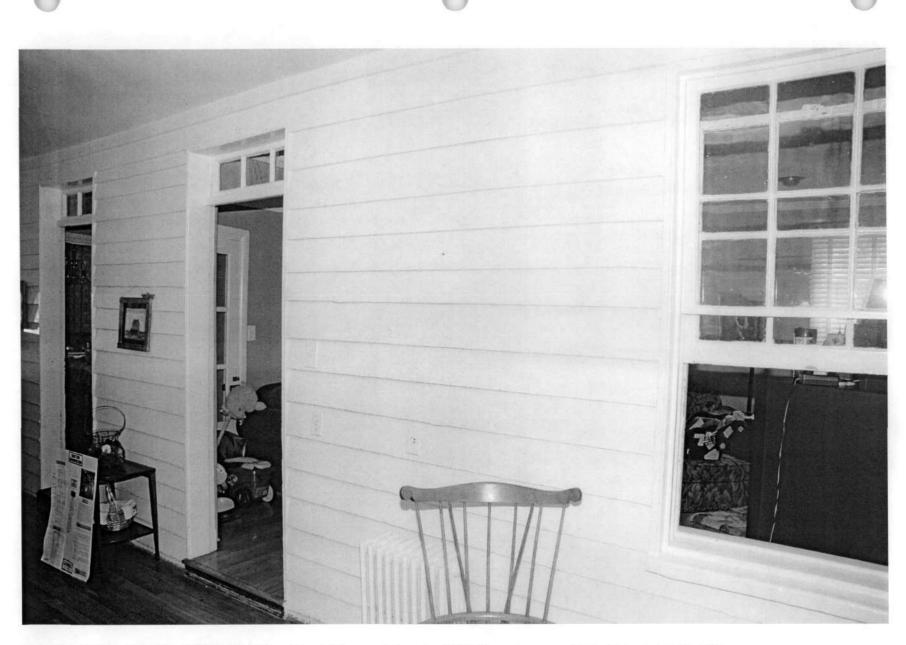
HO-920 "Wheatland," 12570 Hall Shop Road, Howard County, MD Rear passage, first story, west elevation Ken Short, September 2006 10/14

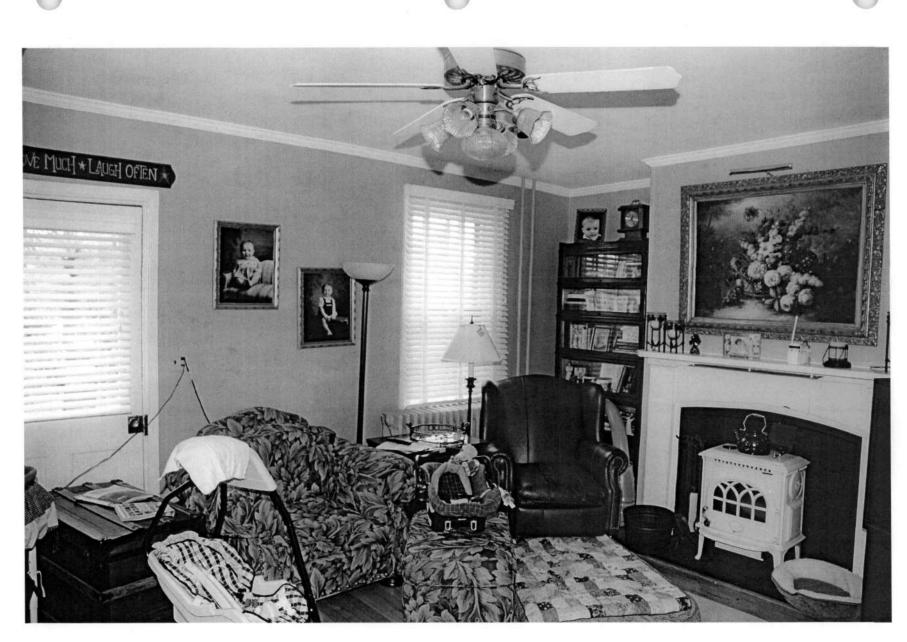
HO-920 "Wheatland," 12570 Hall Shop Road, Howard County, MD Ell north room, first story, view northwest Ken Short, September 2006 11/14

The north ell room has 2 1/2-inch oak flooring that runs east-west. The architrave has a plain ogee and bead, though the south door has a quirked ogee and bead like the vestibule. There is new crown moulding. There is a doorway on the east, set to the south, which is missing its door. It had butt hinges and a rim lock, and there is a three-light transom that is mortised and tenoned and pinned. On the north elevation is a fireplace that is segmentally-arched, and the hearth is painted and appears to

be concrete. The fireplace has splayed brick jambs and a parged surround. There is a wood mantel with plain pilasters and frieze that is arched on the bottom of the frieze. The bed mould has a small bevel at the bottom corner. The east elevation, to the north, has a window with 9-inch by 14-inch lights and ovolo muntins. The sash is mortised and tenoned and pinned at the corners, has parting beads and checkrail, and is hung on a tape on one side. The west elevation has a doorway set to the south, architrave that is similar but has a quirked ogee and bead on the south while the top and the north jambs have a small quirked ogee and bevel. There is a plain cast-iron rim lock and butt hinges with ball finials. The door has panels with sunken fields but no panel moulds. To the north of the door is a window with a two-light sash hung on tapes. The architrave matches that in the rest of the ell. The south side ceiling has a plumbing chase. The east end of the south wall is set at a slight angle to be just north of the east door, and appears that it was added later.

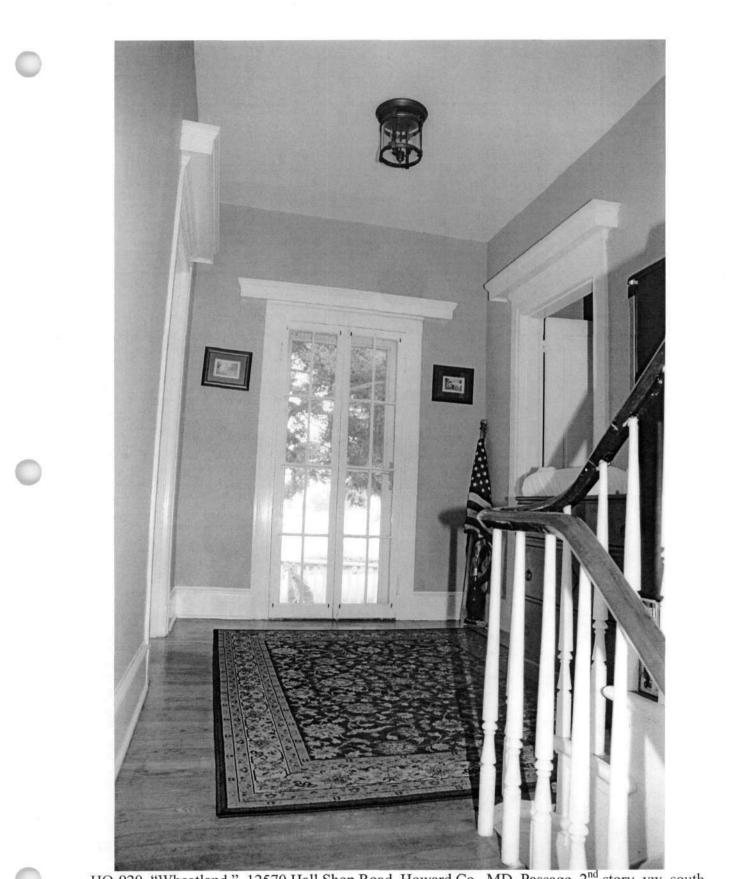
HO-920 "Wheatland," 12570 Hall Shop Road, Howard Co., MD Passage, 2nd story, vw. south Ken Short, September 2006 12/14

The second story of the main block matches the first story plan, while the second story of the ell has a passage with stairs in the southeast corner and two chambers on the west and one in the northeast. The passage landing has a door with typical architrave and cornice, and the door has four panels with sunken fields and ogee-and-bevel panel moulds. The door has butt hinges with two knuckles and a mortise lock with glass knobs. The cornice over the door has a different bed mould than those on the first story. The passage stairs continue up to the attic. The passage has 2 1/4-inch oak flooring that runs east-west, and the baseboard matches the first story. The east and west doors have typical architrave and cornice, and the doors have four panels with sunken fields and no panel moulds. There are butt hinges with two knuckles. The east door is missing its mortise lock, and the west door lock is new. The south door has a pair of eight-light French doors hung on butt hinges with ball finials. The surround has a sunken center field. The cornice above the door is too wide for the door, and has an ovolo bed mould. It appears that this was originally a window that was changed.

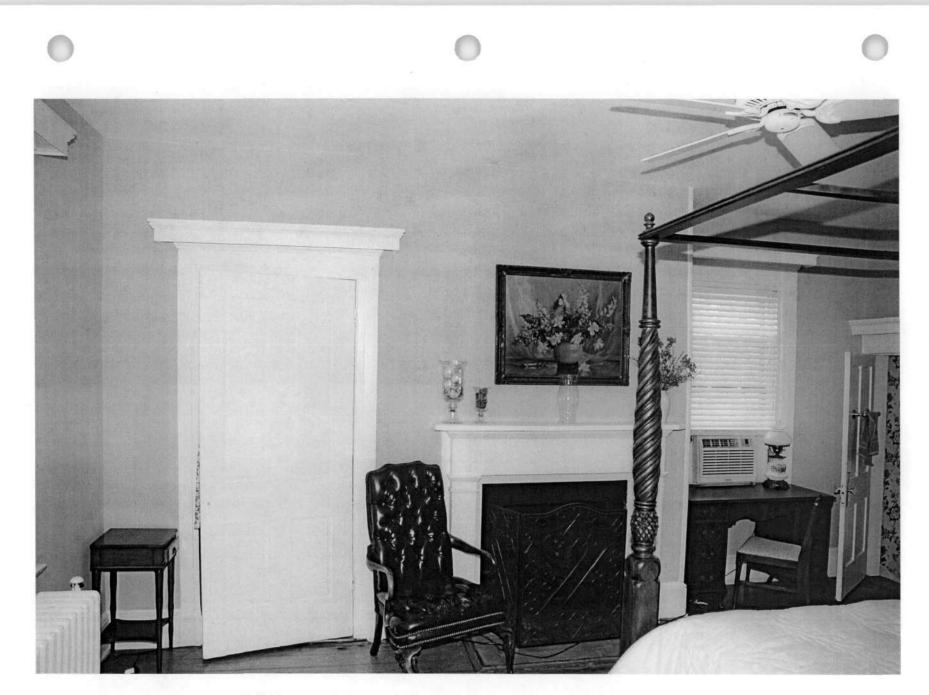
HO-920 "Wheatland," 12570 Hall Shop Road, Howard County, MD Southwest chamber, second story, view northwest Ken Short, September 2006 13/14

The west chamber has the same flooring, baseboard, architrave, and cornice as the east chamber. The east door is now missing its cornice, but has the bed mould. There is a fireplace on the west wall that has a re-laid brick hearth, splayed brick jambs, and a new firebox. The mantel matches that of the east chamber. To the south of the fireplace is a closet with a typical four-panel door that has no panel moulds. The door has a small cabinet lock on the interior. The south window has a brass number "25" on the sill. On the north elevation, set to the west, is a door with typical architrave and cornice. This doorway is set low and could be originally window trim that was lowered and moved here. The wall above is patched and could have the ghost of a cornice although this is not conclusive. The doorway has a typical four-panel door that has no panel moulds, has an old mortise lock with glass knobs, and has new escutcheons. The rear passage has a landing to the east with stairs down on the east wall. There is a three-light window on the east, with side-cut trim, and the sash has mortised-and-tenoned-and-pinned corners. There is a small, vertical board door on the west

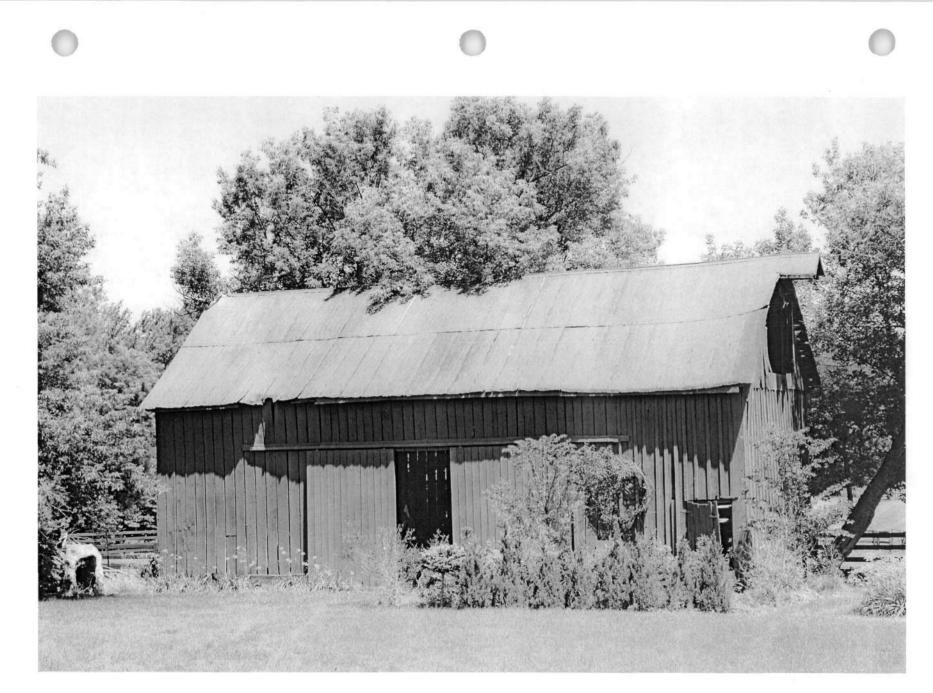
HO-920 "Wheatland," 12570 Hall Shop Road, Howard County, MD Barrack, south & east elevations Ken Short, September 2006 14/14

There is a barrack located about 100 feet from the house. It is a one-story, three-bay by one-bay frame structure set on rubble stone piers, with vertical-board siding that has battens on the north and south elevations of the east bay, and on the east elevation. There is a gable roof with an east-west ridge, corrugated metal roofing, and a cantilevered hood on the east end. The south elevation has center wagon doors hung on rollers, and a vertical board door at the east corner that is hung on butterfly hinges. The east elevation has no openings. The gable end has double doors beneath the

hood, made of vertical boards. These doors open in, and the hinges are not visible. The north elevation has a wagon door opening in the center that is boarded, with part of a roller track left in place. The west elevation has no openings. The building is constructed of a circular-sawn heavy timber frame that is nailed. It has a center wagon floor with a mow to the north and the south, and has a dirt floor. The bents have a single center post with braces. There is a partial board wall on the north mow that closes it off partly, and this could be an added feature. The rafters are 2 by 4s that are mitered and butted at the ridge and support board lath. There is a hay track with a fork hung along the ridge.
