HO-982

12705 Livestock Road  
West Friendship vicinity

## Maryland Inventory of Historic Properties Form

Inventory No. HO-982

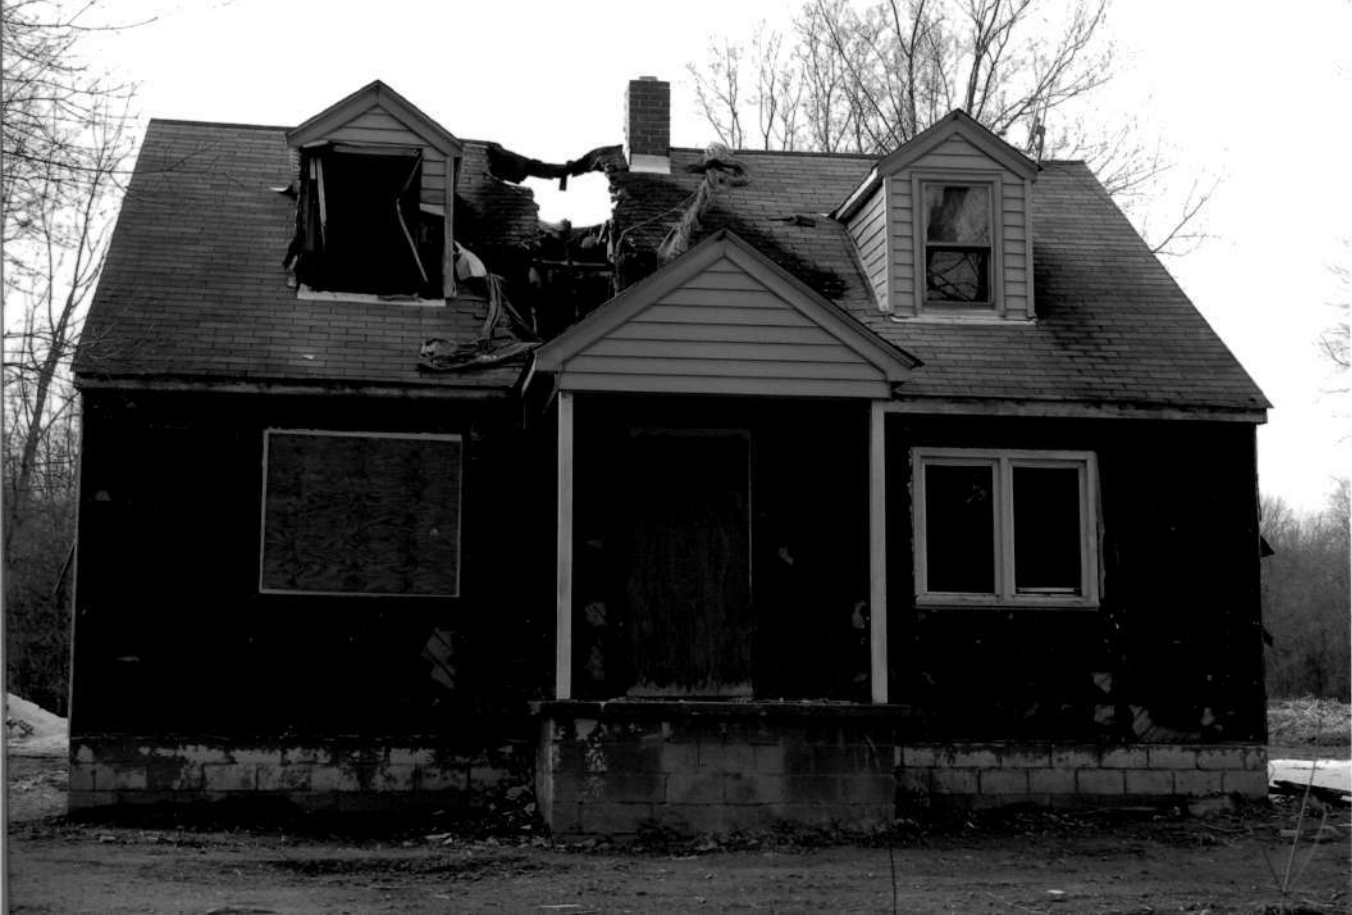
1 of 3

East elevation

The east elevation has a boarded-up doorway in the center, with a concrete porch that has a gable roof with an east-west ridge, supported by two square wood posts. The steps to the porch are missing, but the gable end retains aluminum siding. The north bay has paired windows, but the sash have been removed. The south bay is boarded up, but the opening seems to be of the same size as the north bay. The end bays each have a dormer window with a gable roof, aluminum siding, and the north dormer retains a one-over-one sash. There is a large hole in the center of the roof caused by fire, and the south dormer was likewise damaged.

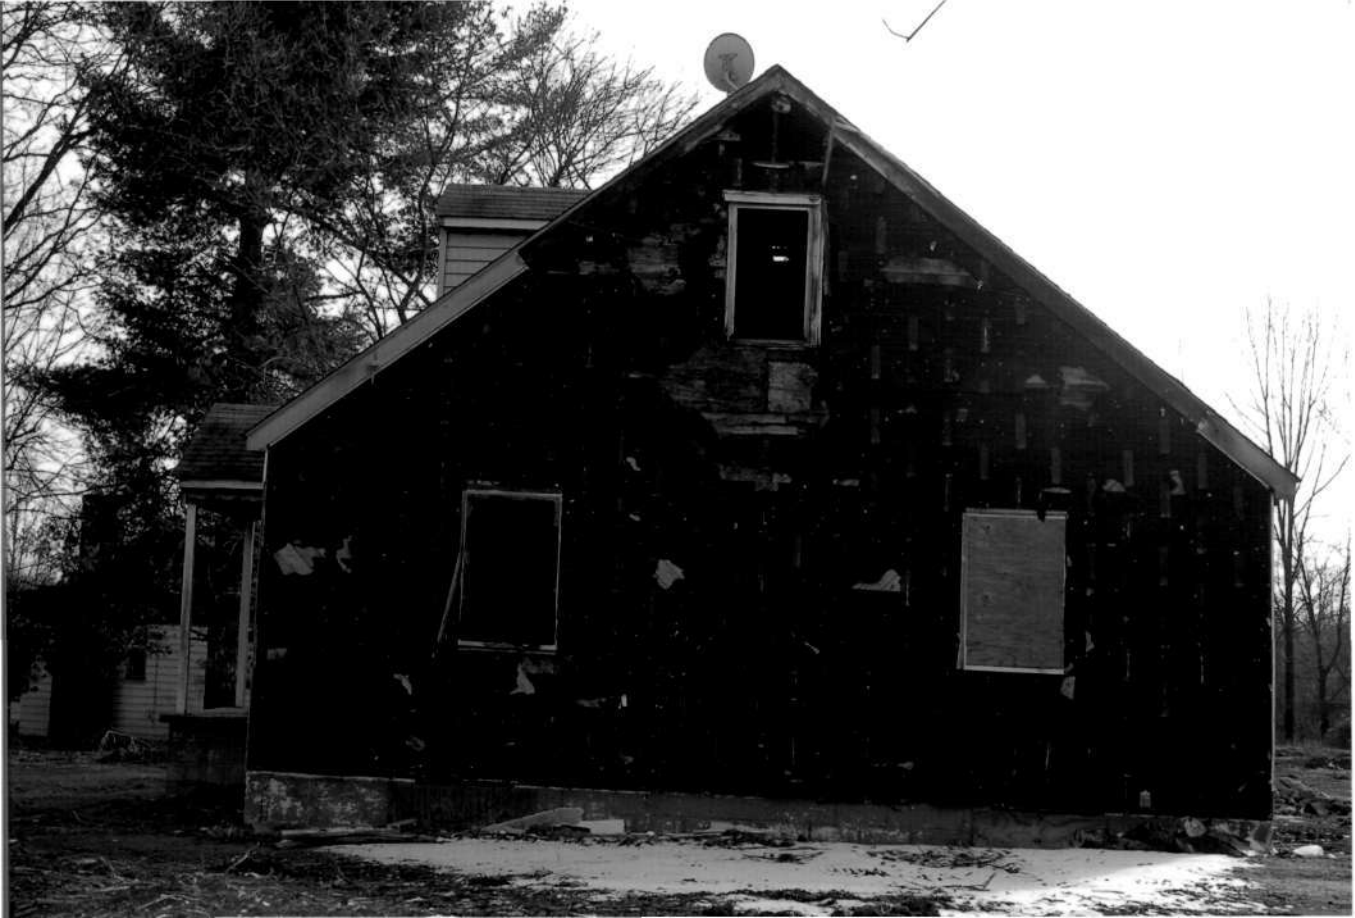
2 of 3

North elevation

The south elevation has paired one-over-one sash in the west bay and a boarded-up single opening in the east bay. The gable end has a broken-out window. The west elevation has a three-over-one sash in the north bay, a smaller three-over-one sash in the center, and a door with six lights over three lying panels in the south bay. There was a porch or shed-roofed addition on the south half of this elevation, but it has been removed. The north elevation has two boarded-up openings in the first story and a broken-out window in the gable end.

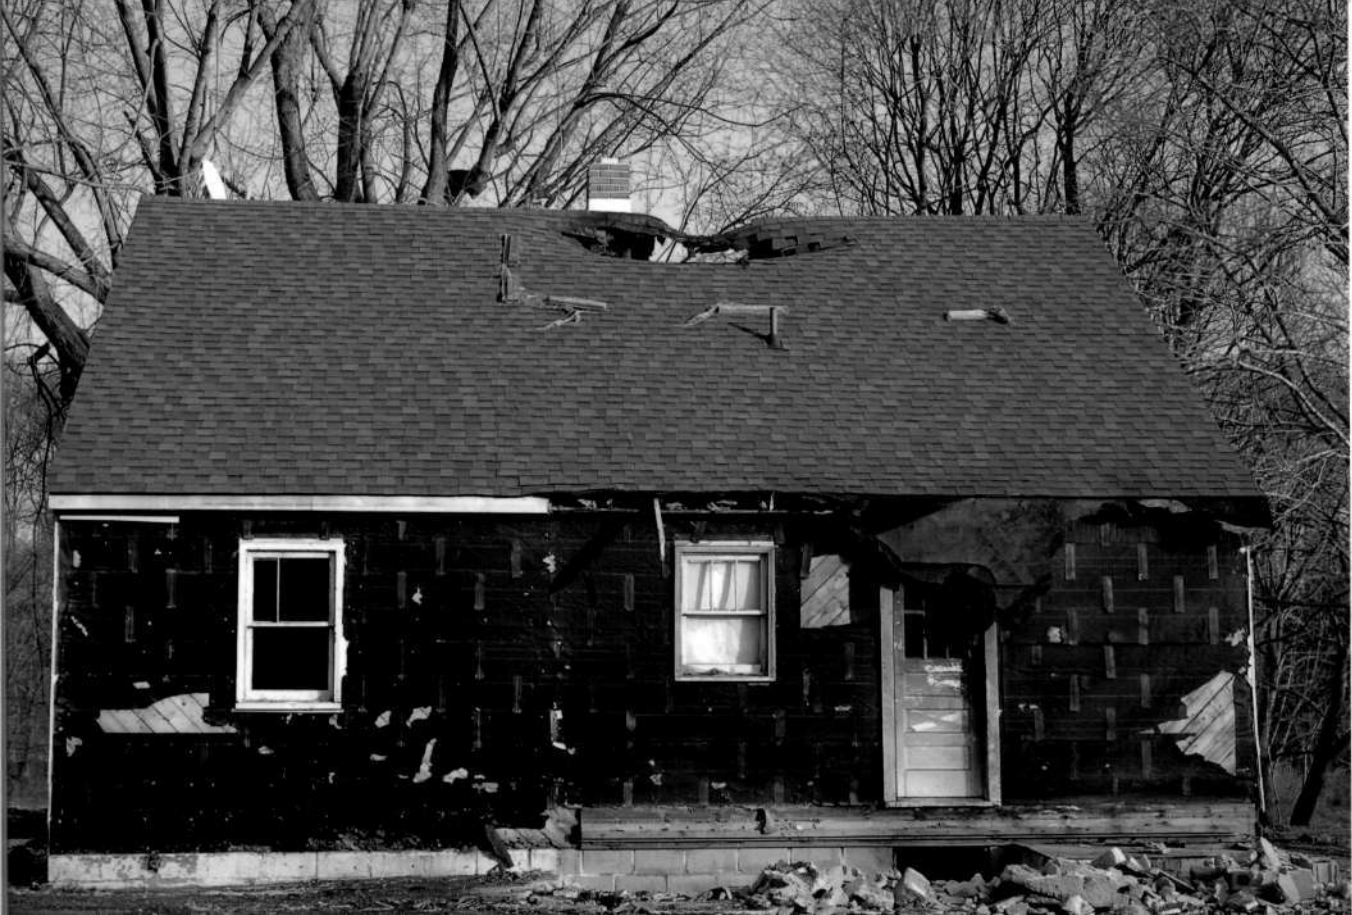
3 of 3

West elevation
