HO-985

Waters-Fulton Store and Post Office

11815 Lime Kiln Road, Fulton

Maryland Inventory of Historic Properties Form

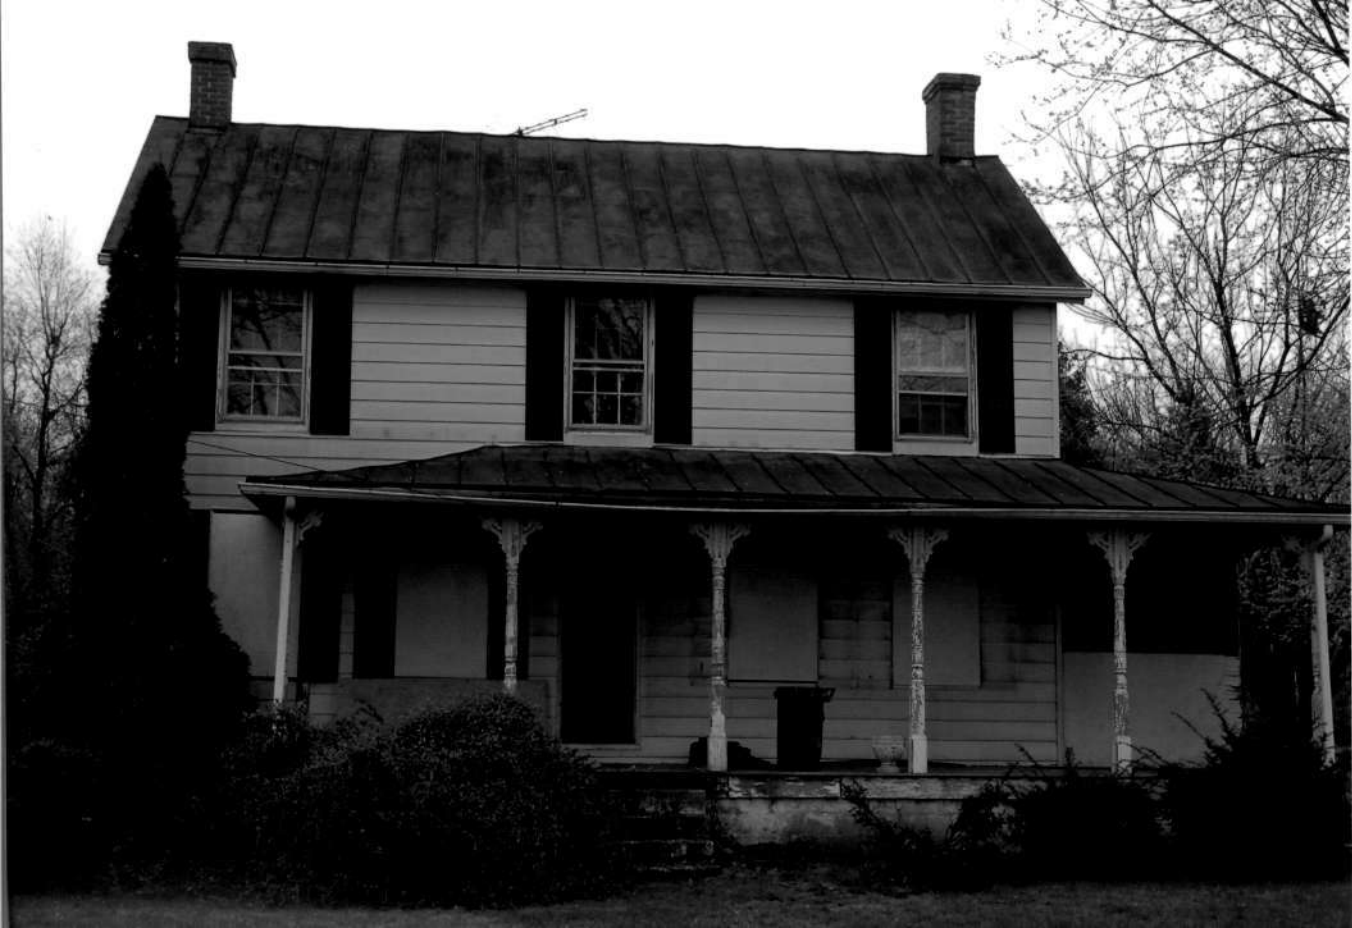
1 of 8

North elevation

On the north elevation, the first story has a center door with two six-over-six sash to each side. There is a five-bay porch, with the east bay of the house not covered by the porch, but the porch wraps around the west side. The porch covers both bays of the main block on the west elevation. The porch has CMU piers, new pressure-treated decking, and plywood on the soffit. There are six turned posts with jig-sawn brackets that are fastened with wire nails. The porch has a hip roof with standing-seam metal. The second story has three six-over-six double-hung sash. The eave is boarded, with the boards following the pitch of the rafters. The east elevation of the main block has two windows on the first story and none on the second story or gable end. On the south elevation, the first story of the main block has a six-over-six sash set hard against the ell wall. The second story has a two-over-two sash in the middle of the wall, in what is the east bay. The east elevation of the ell has a two-over-two sash in the north bay of both the first and second stories, with no openings in the south bay. The south elevation of the ell is

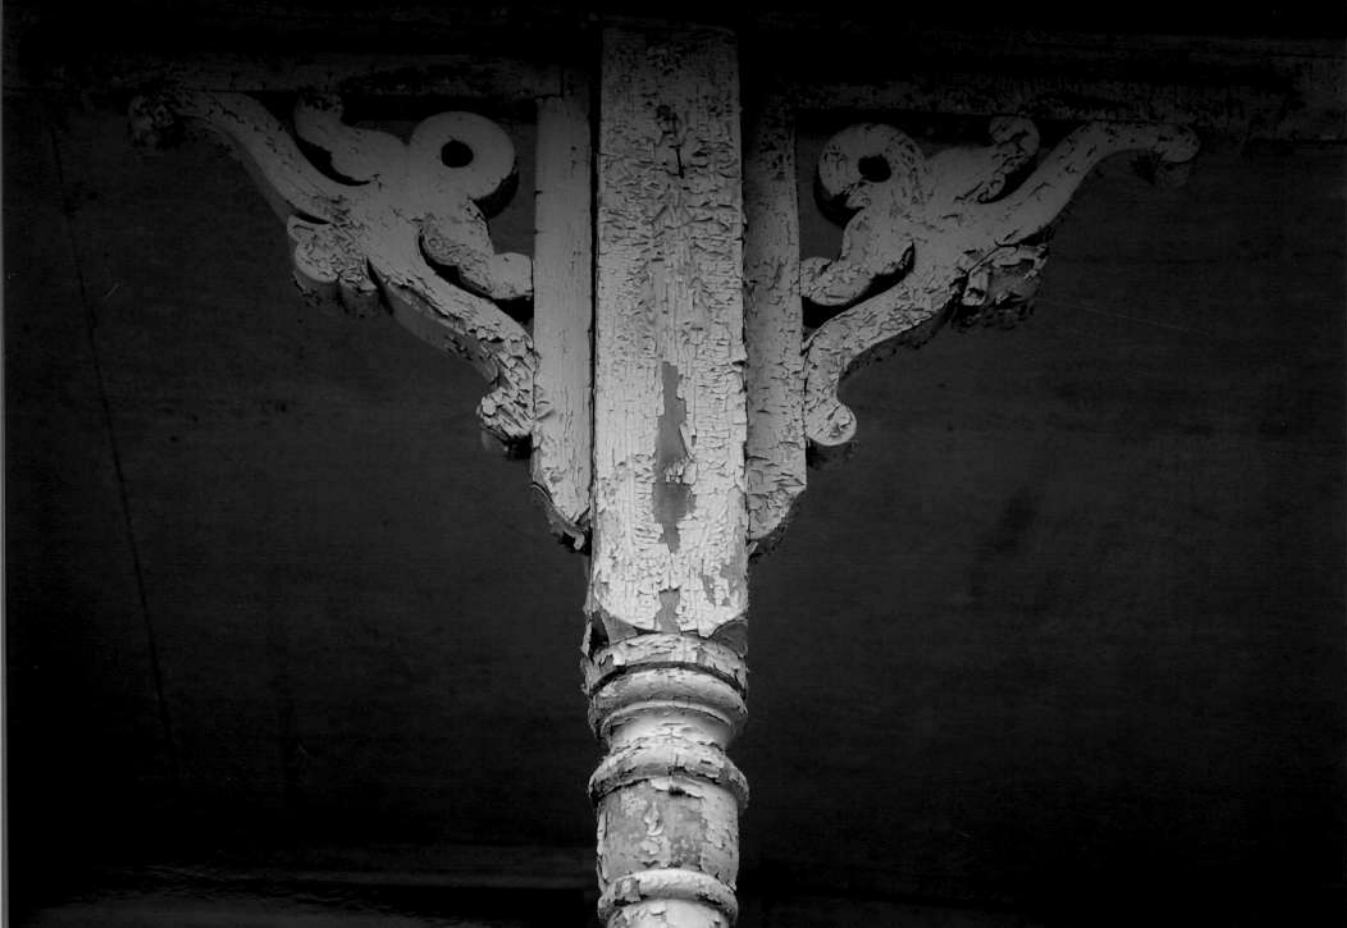
2 of 8

North elevation, porch bracket

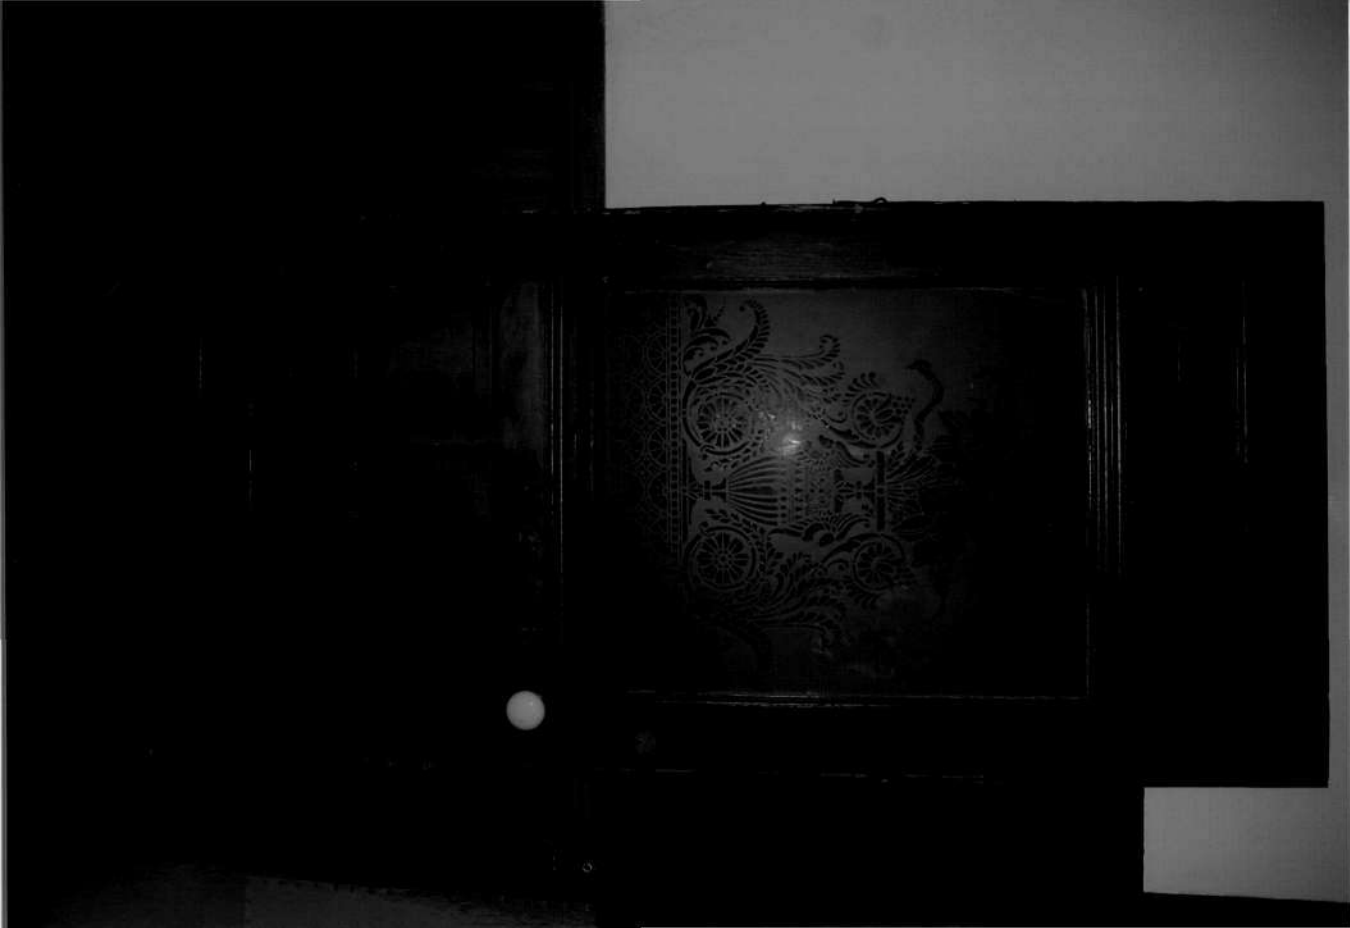
3 of 8

North elevation, front door

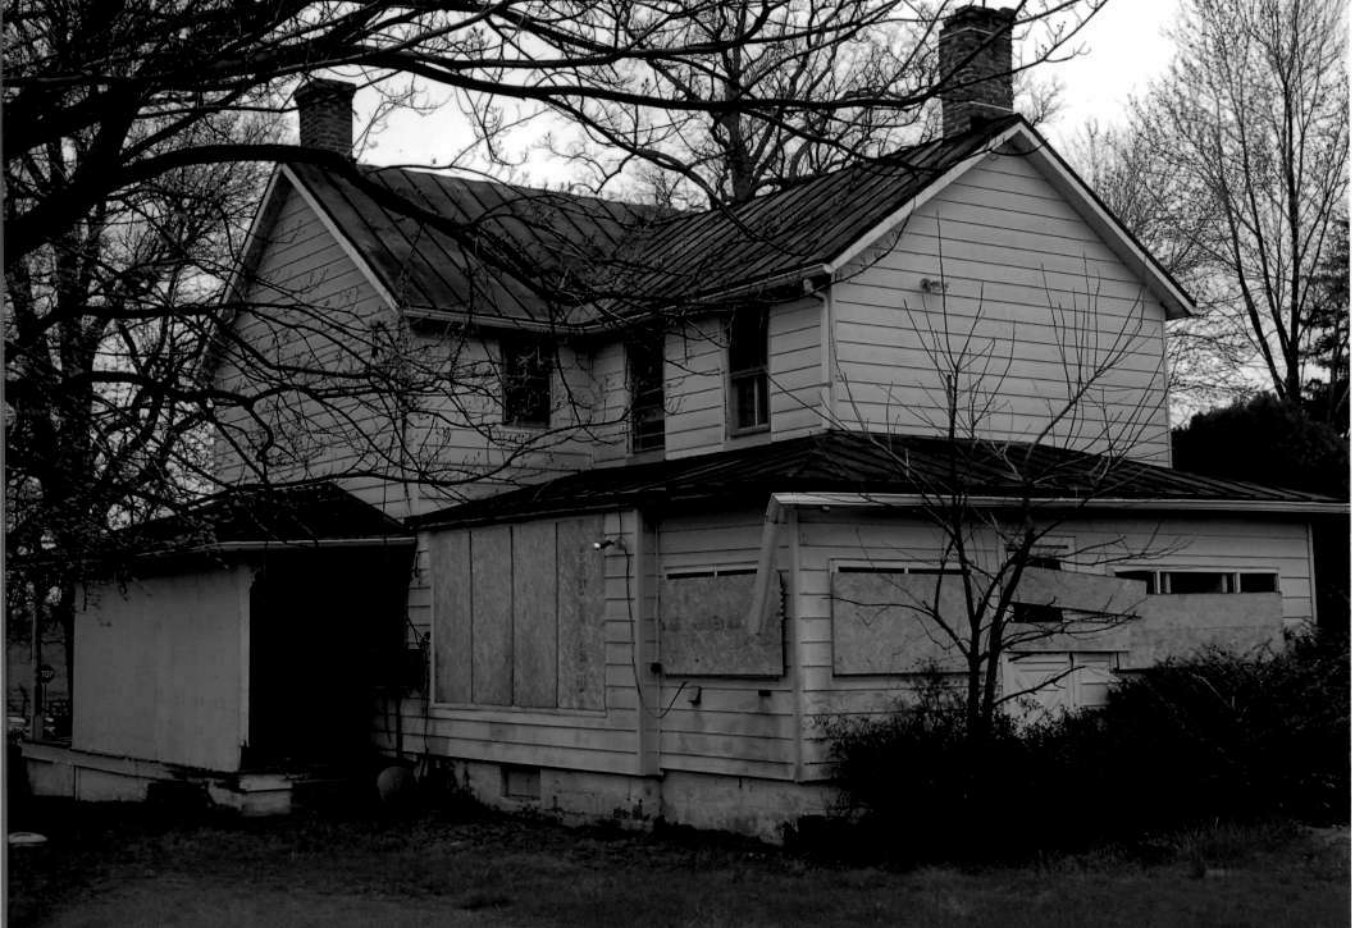
4 of 8

West & South elevations

covered on the first story by the hipped-roof addition that is modern and has standing-seam metal. The second story of the ell has no openings. The west elevation of the ell is also covered on the first story by the modern addition, while the second story has two two-over-two sash. The south elevation of the main block, in the west bay, is covered by the modern addition on the first story. The second story has a two-over-two sash in the center. The west elevation of the main block has the porch partially enclosed. The first story has a window in the south bay, and the second story and gable end have no openings. There is an interior brick chimney on the east, west, and south gable ends.

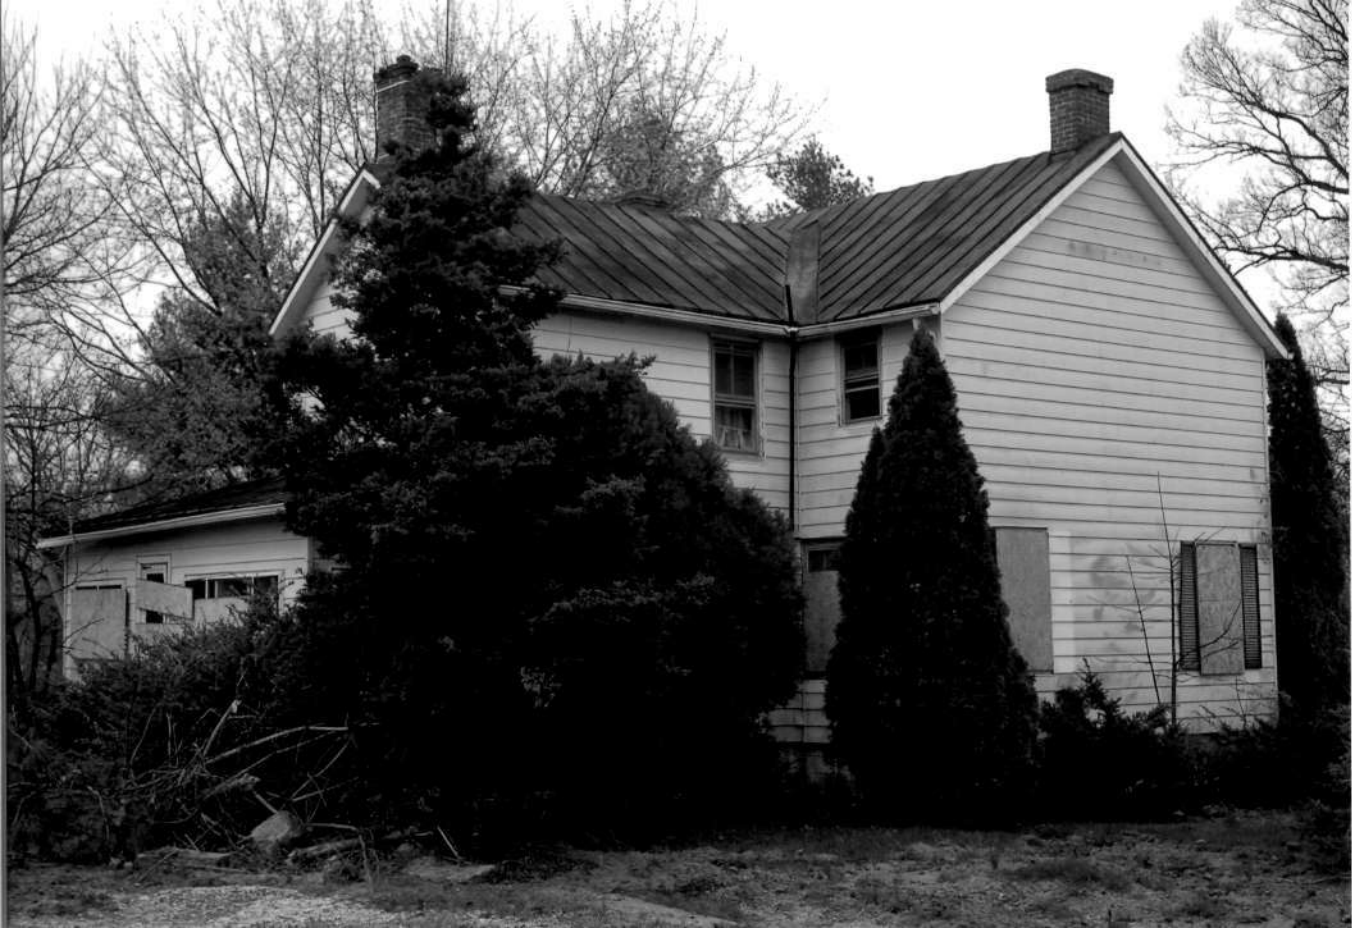
5 of 8

South & east elevations

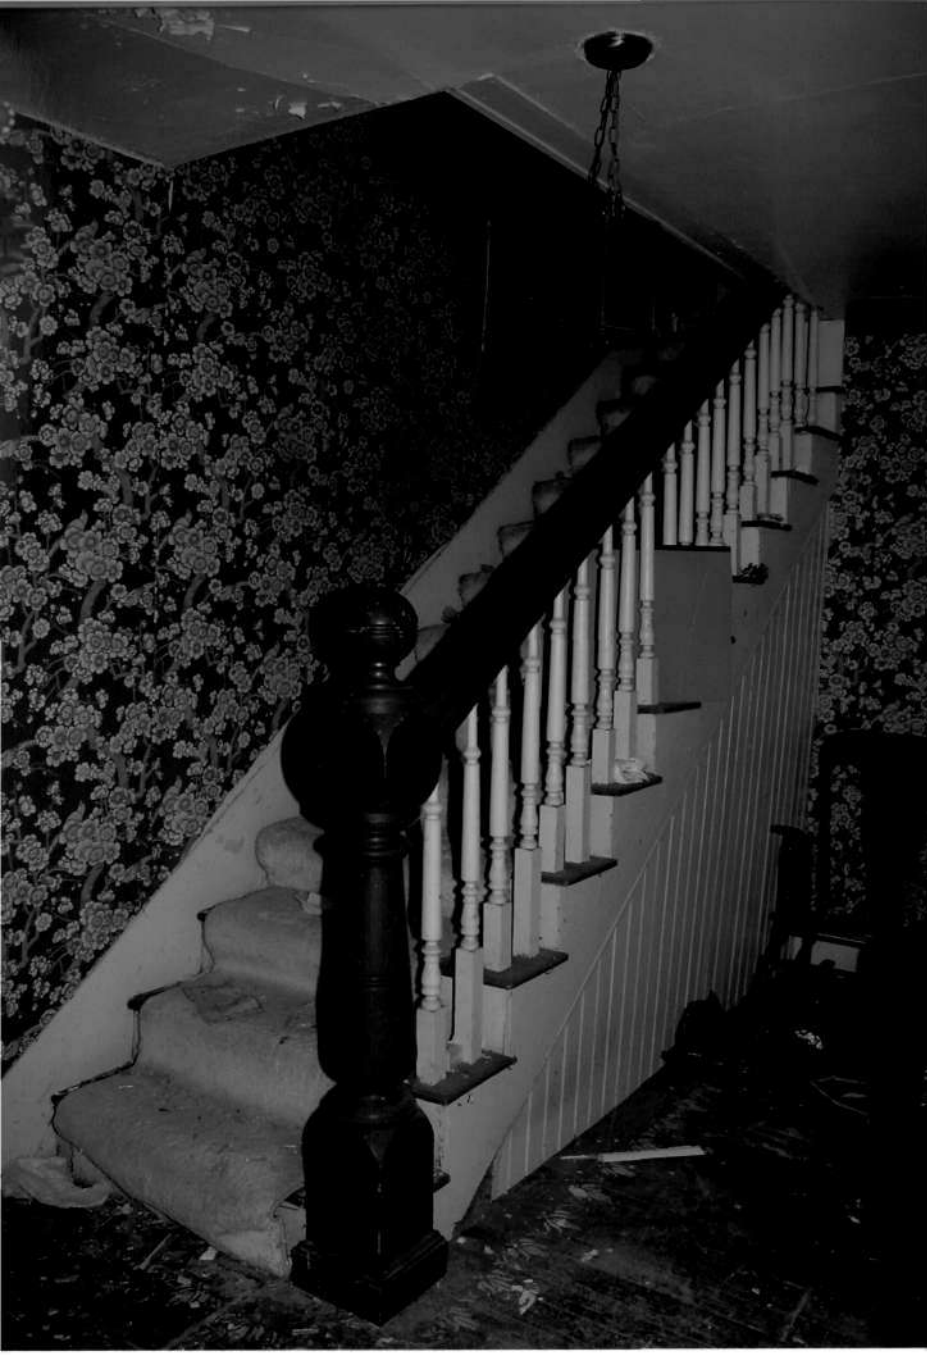
6 of 8

Center passage, view southeast

The interior has a center-passage, single-pile plan with a kitchen ell. There is 2 1/2-inch flooring that runs east-west throughout the main block. The flooring is termite-eaten, with numerous large holes in the floor rendering it unsafe. The passage is blocked off at the south end. There is a straight run of stairs along the east wall, with a plain open stringer and beaded vertical boards below the stringer. There is a large turned newel post of oak that is tapered in the center and has two annulets. The newel has a large block at the bottom and another near the top, with a round ball on the top that also has two annulets. The newel post is built up of eight three-quarter inch boards. The balusters are turned and tapered and the oak handrail is moulded with a bead between two fillets at the bottom on each side of the handrail. The newel post and balusters are wire-nailed, though the nails could be added to the newel post because the bottom is rotted. The passage is two bays wide, with the east-center bay window set in the passage across from the stairway. It appears that the stair is a later alteration or addition to the house. The front door has a large etched-glass light with a geometric band at the bottom of the light and two rows of fanlight motif, and a large urn with flowers and foliate scrolls on each side of it. There are two panels above the glazing and nine panels below it, all with sunken fields and ovolo and cavetto panel moulds. There is a cornice moulding above and below the light. The door is hung on cast iron

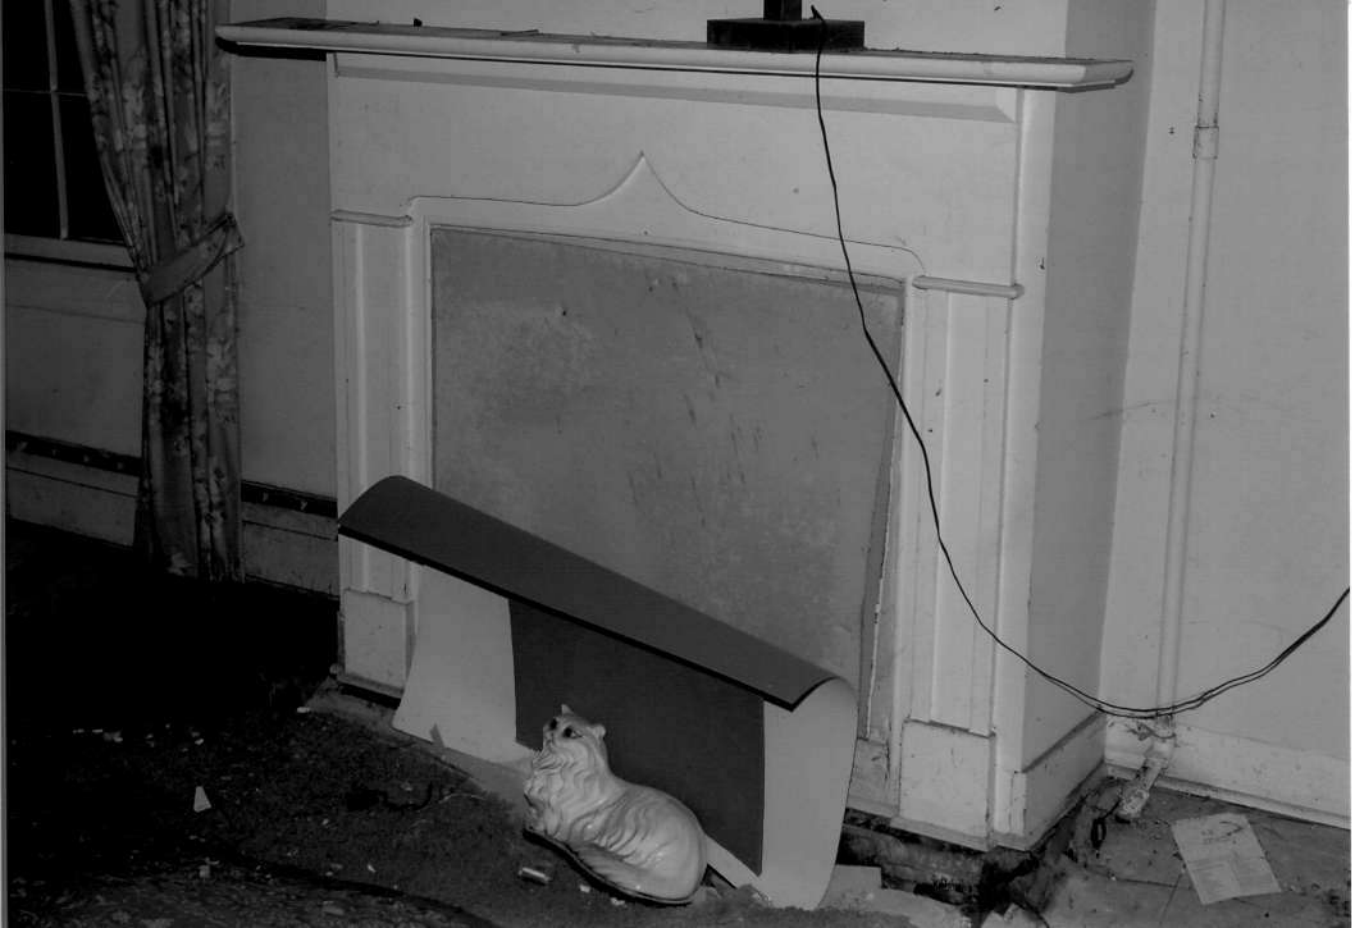
7 of 8

West room, mantel on west

The west room has a drop ceiling, drywall, architrave that matches the passage, and plain baseboard. There is a fireplace on the west wall that has been closed off, and the floor around it has collapsed. There is a wood mantel with wood pilasters that are sunken and flat, and the mantel has a plain frieze with a double ogee cut on the bottom of the frieze. The bed mould has a simple beveled bottom edge and sides, and is otherwise plain. The windows are six-over-six sash with ovolo muntins, plain meeting rails, no parting beads, and 10-inch by 14-inch lights. The sash are mortised and tenoned and pinned at the corners and one of the muntins is pinned at both the bottom and meeting rails. There is a door on the south elevation that leads to the ell, and this is a typical four-panel door. The floor in the ell has collapsed, and the room was not entered.

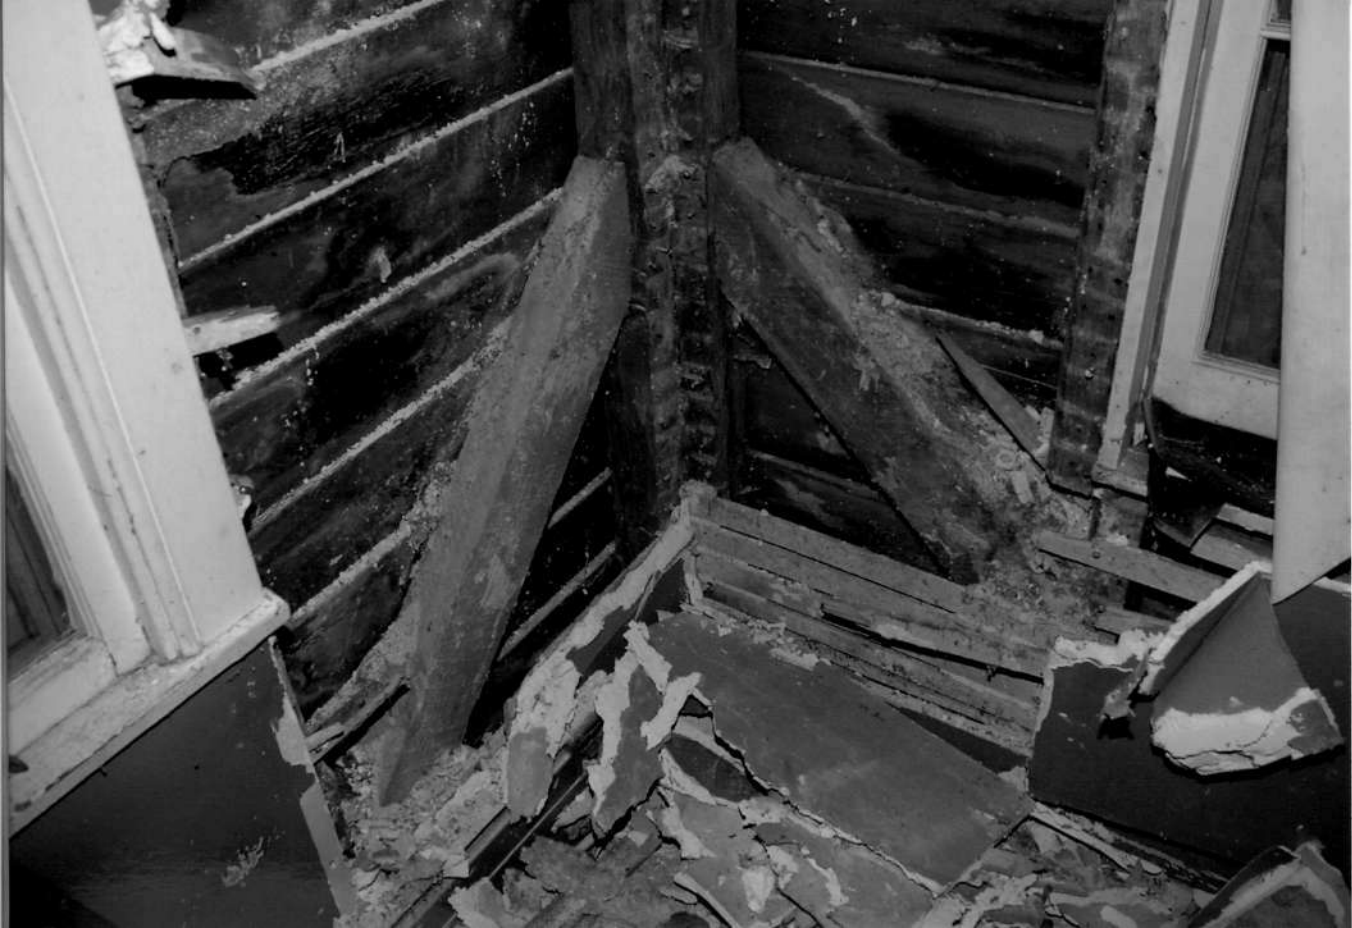
8 of 8

East room, northeast corner framing

The walls on the first story were partially opened up to examine the construction of the building. Beneath the wood siding is a heavy timber frame cavity wall, with the framing having broken-off cut nails from earlier siding that was removed when the existing wood siding was installed. The post of the east side of the west-center bay window is 3-1/2 inches deep by six inches wide, is hewn on the outer face, and is left in the round on the east side. All of the studs are hewn on their inner and outer faces and left in the round on the sides. The lath is circular-sawn and is fastened to the studs with cut nails. The northeast corner post is hewn and is guttered, with downbraces that are mortised and tenoned and pinned to it. The downbraces are set across from each other, not staggered, and are circular-sawn, are 3 inches by 5 inches and are set about two feet, nine inches above the floor. The corner post appears to be oak. Between pairs of studs are set thin nailers on which to fasten the lath. These nailers are circular-sawn, are one-half inch thick by 2-1/2 inches deep, and appear to run from the sill to the girt. The west-center bay window jamb has a wire nail in it that missed the post, but it is not clear if this is for the window or for the later storm window installation.
