# Maryland Historical Trust Maryland Inventory of Historic Properties Form

Inventory No. HO-987

historic Melvin and Katherine Brown Farm

street and number 2020 Long Corner Road \_\_ not for publication

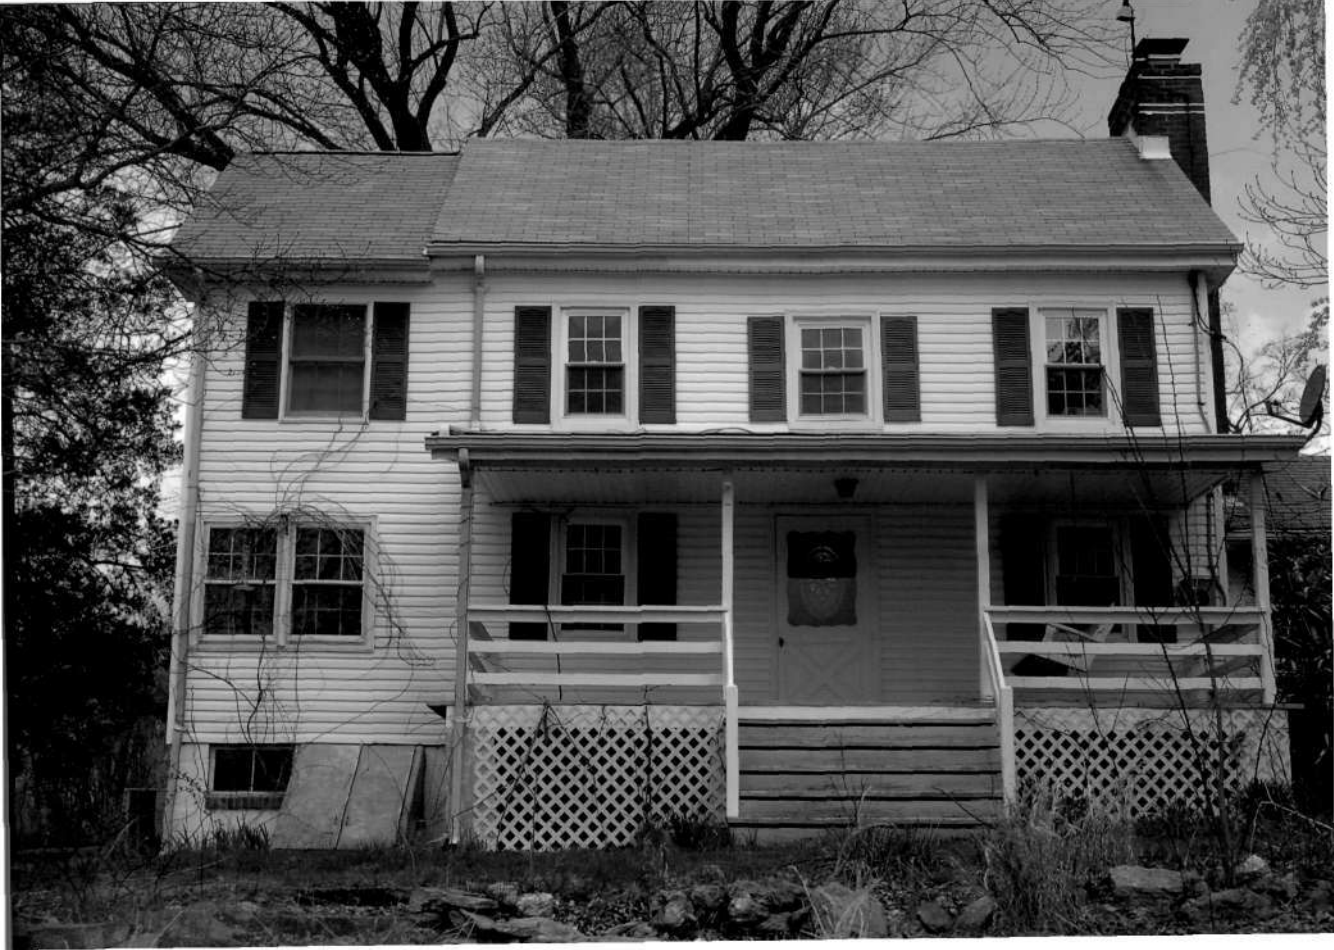
1 of 4

South elevation

The south elevation of the main block, on the first story, has a center door of modern oak and leaded glass. There is a new six-over-six sash with fake blinds to each side of the center door, and the second

story has three six-over-six fake blinds. There is a box cornice with returns. There is a one-story, three-bay porch over the entrance, with CMU piers, a rebuilt deck, four wood posts, and new railings. The soffit is now covered with vinyl, and there are five steps up to the porch. The east elevation of the main block has the first story covered by a breezeway, and the second story south bay has a new six-over-six sash. The north elevation of the north addition has a six-over-six wood sash in the east and center bays of the first story and a door in the west bay that has nine lights over a crossbuck; this door is of wood but is modern. The second story has three six-over-six sash, with the east one being wood. The east elevation of the north addition has the first story covered by the breezeway and has a new one-over-one sash on the second story. The west elevation of the north addition has the first story covered by the west addition and the second story has a new six-over-six sash. The west elevation of the main block is completely covered by the modern addition.

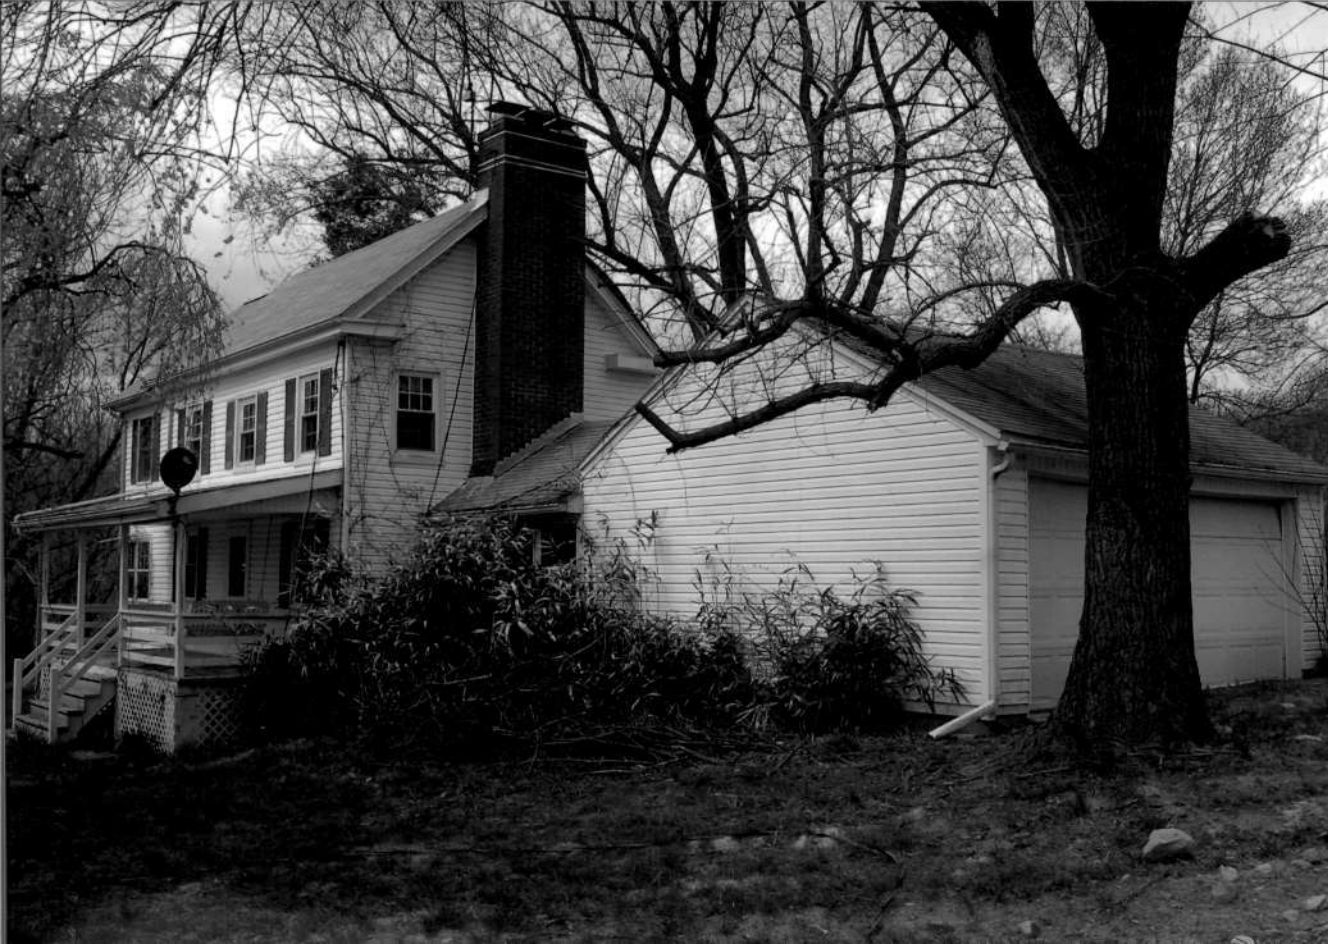
2 of 4

South and east elevations

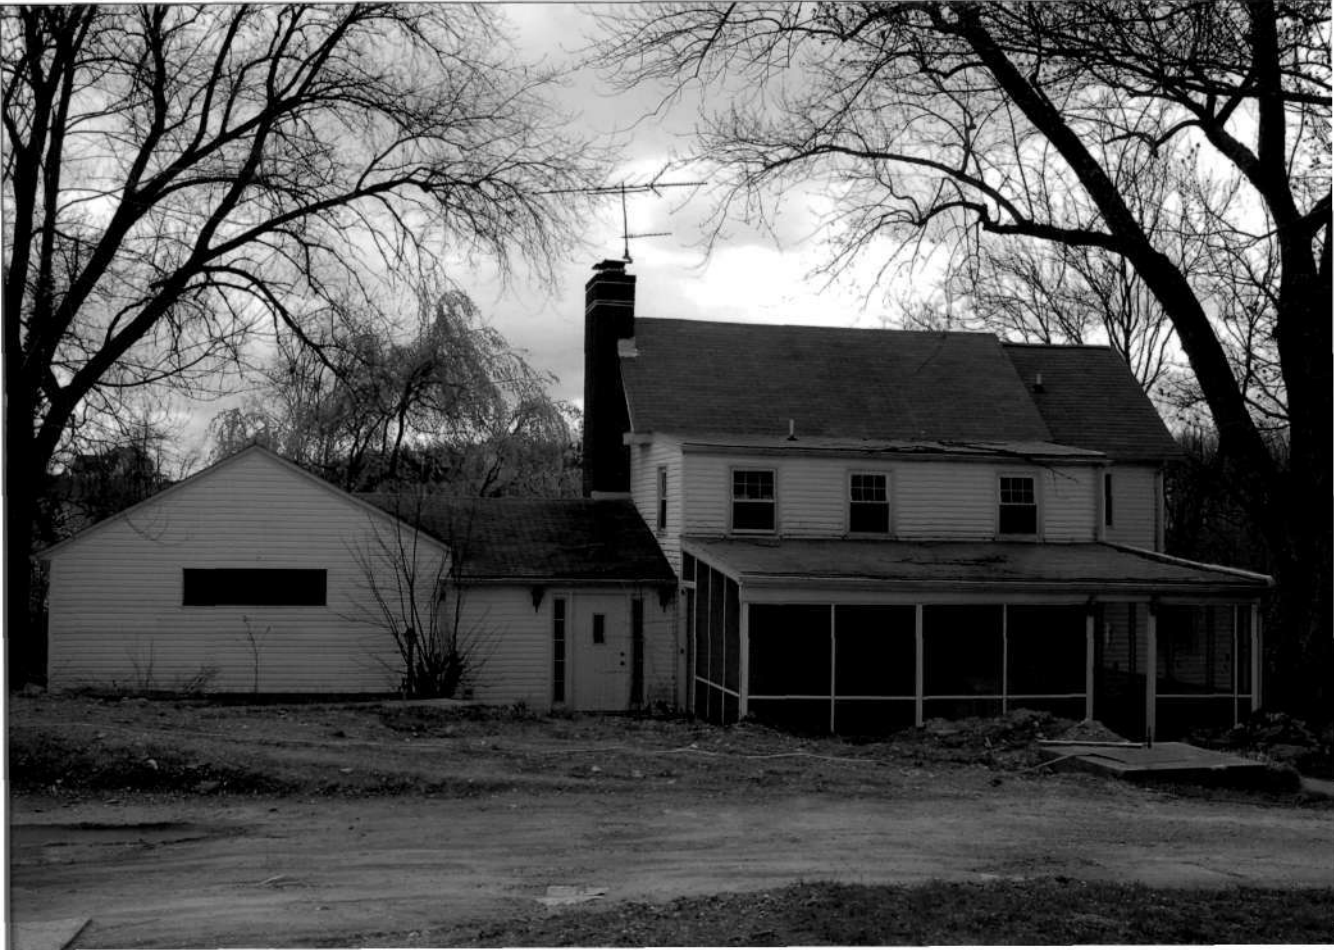
3 of 4

North elevation

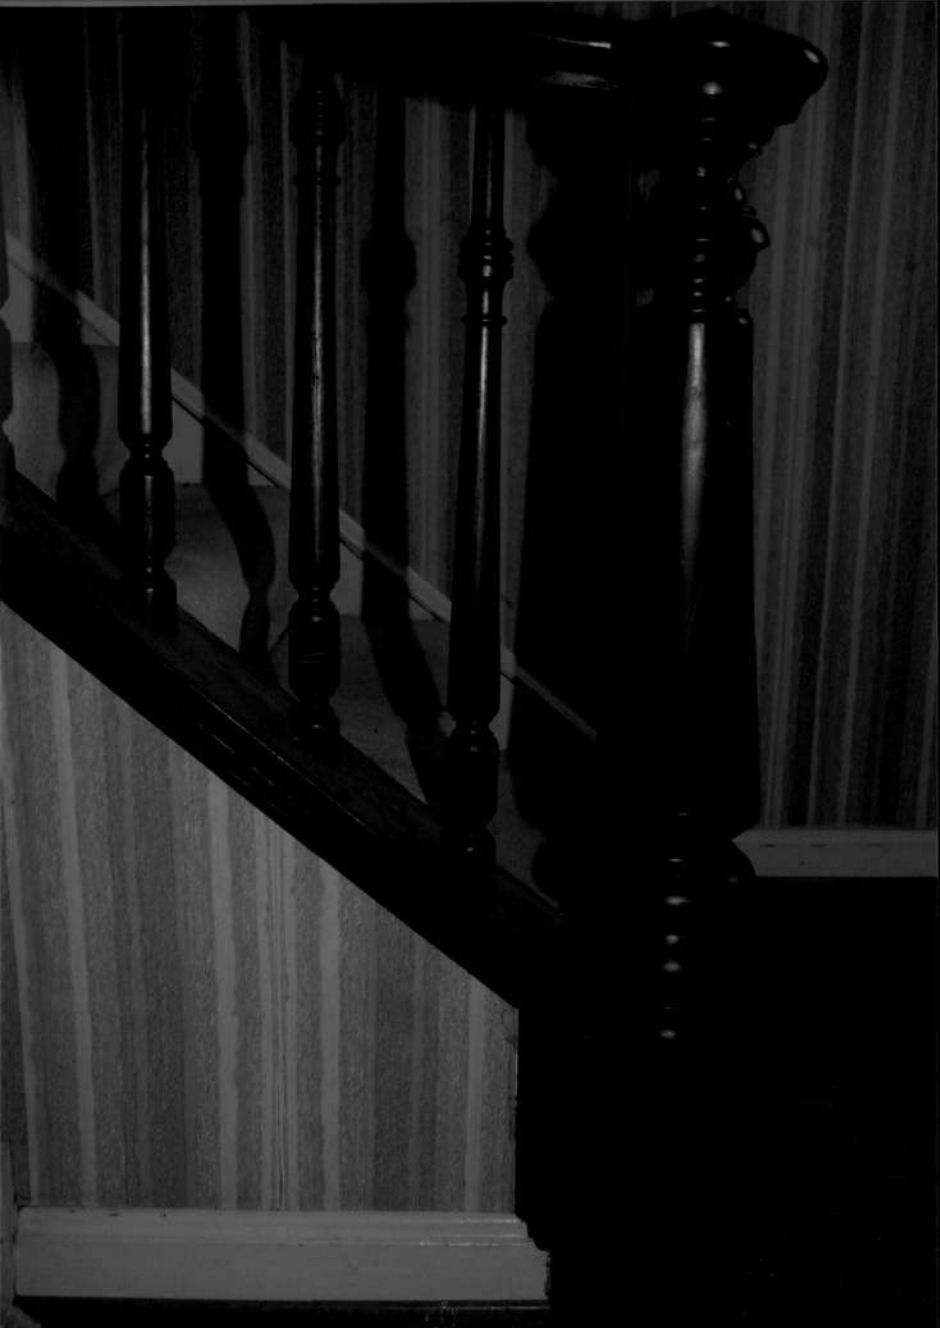
4 of 4

Stair newel

The first story of the house has a center lobby entrance with a straight run of stairs that ascends to the north; the stairway is enclosed to the east and is half enclosed to the west, with a railing to the bottom half of it. The house has a single-pile, two-room plan. The lobby entrance is open to the room on the west, and there is no door giving access to the east room. The flooring is 2 1/4-inch pine that runs north-south. The baseboard has an ogee on top, and the architrave is a modern broad, flat ogee and bead. The newel post is turned and tapered, appears to be walnut and does not have an urn profile. The balusters are turned oak and are slender, with one ringlet on the bottom. They appear to be late 19<sup>th</sup> century. The handrail is ovoid. The west wall of the west room has been opened up to the west addition. The northwest corner of the first story was opened up. The construction is 2 by 4s that are circular-sawn, with drywall, and they never had any lath or plaster on them. Beneath the stairway is a closet, and the door has modern architrave. There is a passage behind the stairs that leads to the north addition and the east room. The east room has typical flooring and a fireplace on the east with a raised stone hearth, a brick mantel, and knotty pine paneling and shelves on either side of the fireplace. The north addition has no historic features.
