**Figure 43 - Results of Stray Current Test #2 on Chancellor Ln**

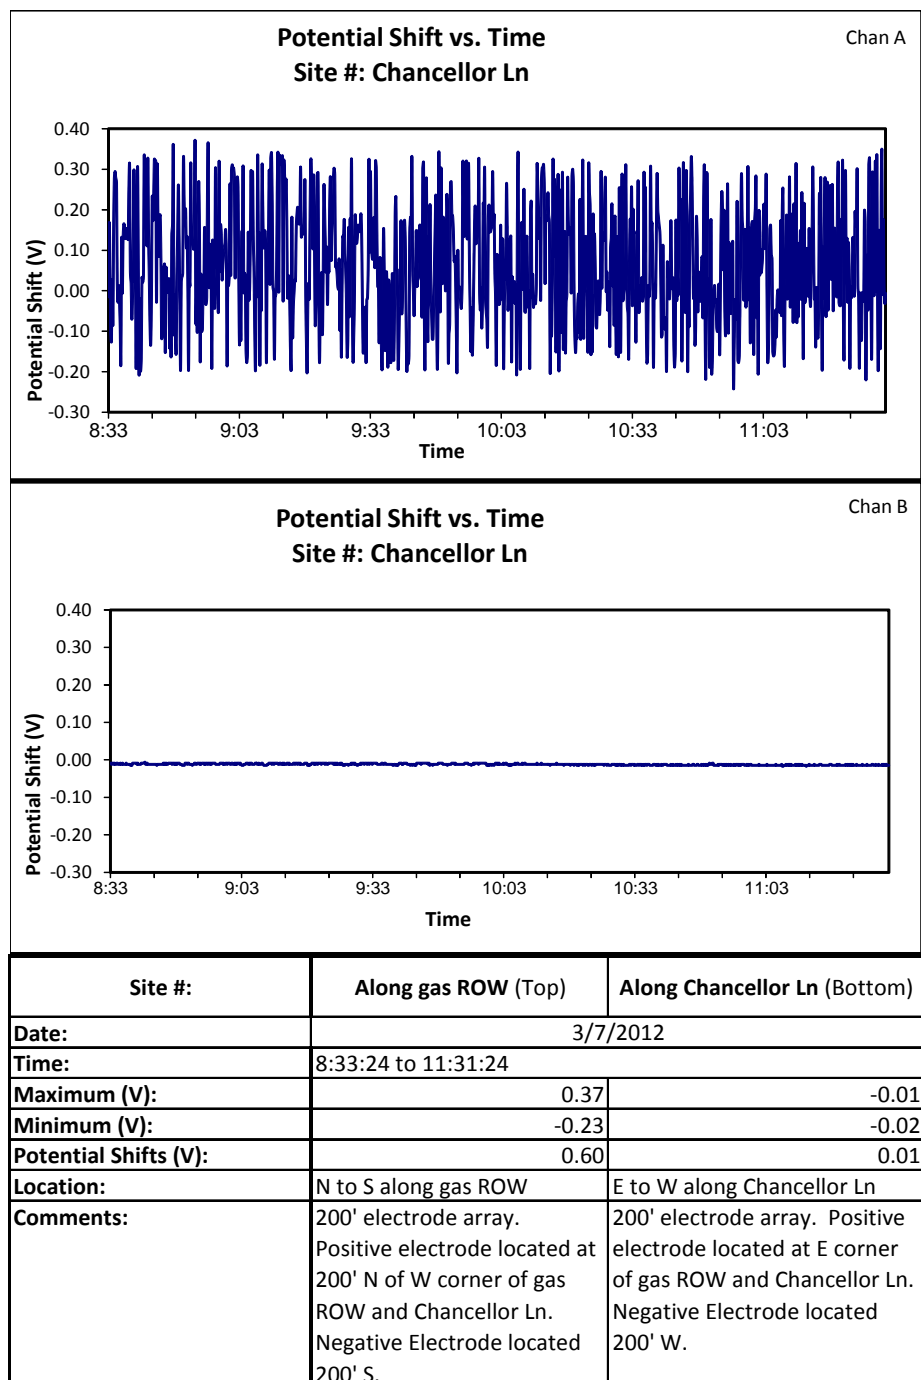
The graph for channel A displays readings that are predominantly greater than zero, indicating that there is an underlying steady state voltage gradient present in the area. The overall pattern of the data in the plot for the north / south electrode array (parallel to the gas pipeline) carries the typical signature of stray current gradients associated with operation of DC power.
