Pine Ridge

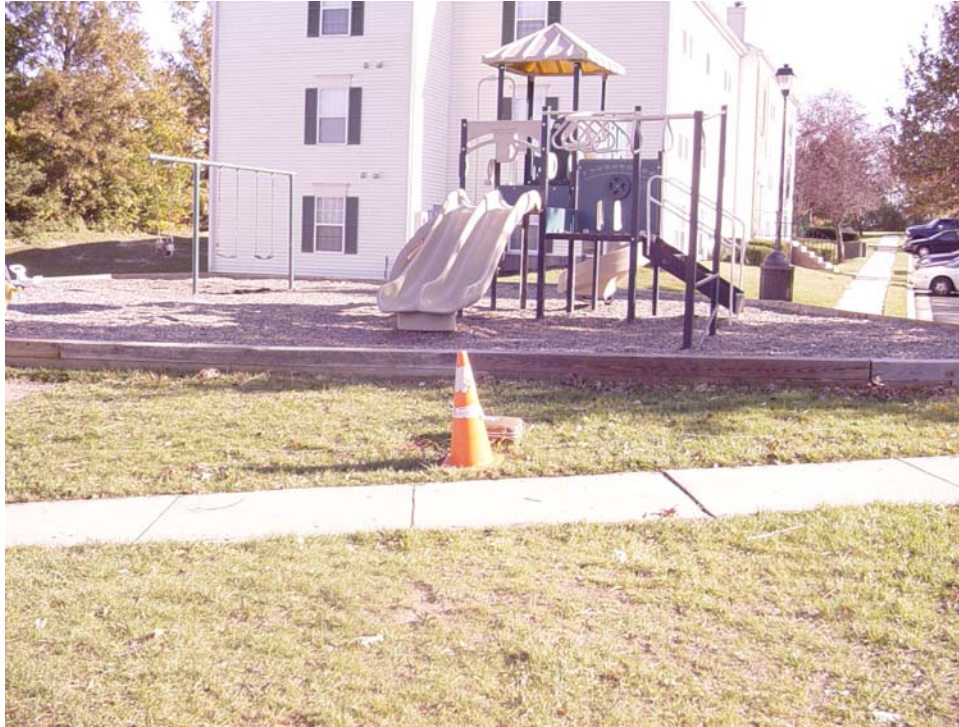
One (1) stray current measurement was taken in the Pine Ridge community, close to where the service pipe branches off, shown in Figure 36. The results are shown in Figure 37.

Figure 36 - Stray Current Testing in Pine Ridge Community

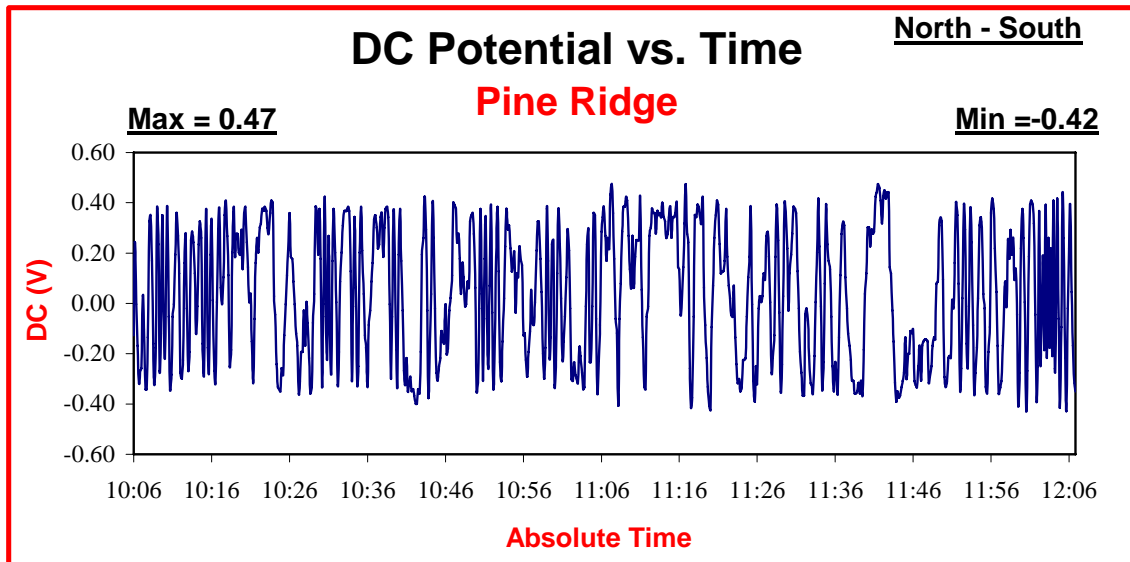
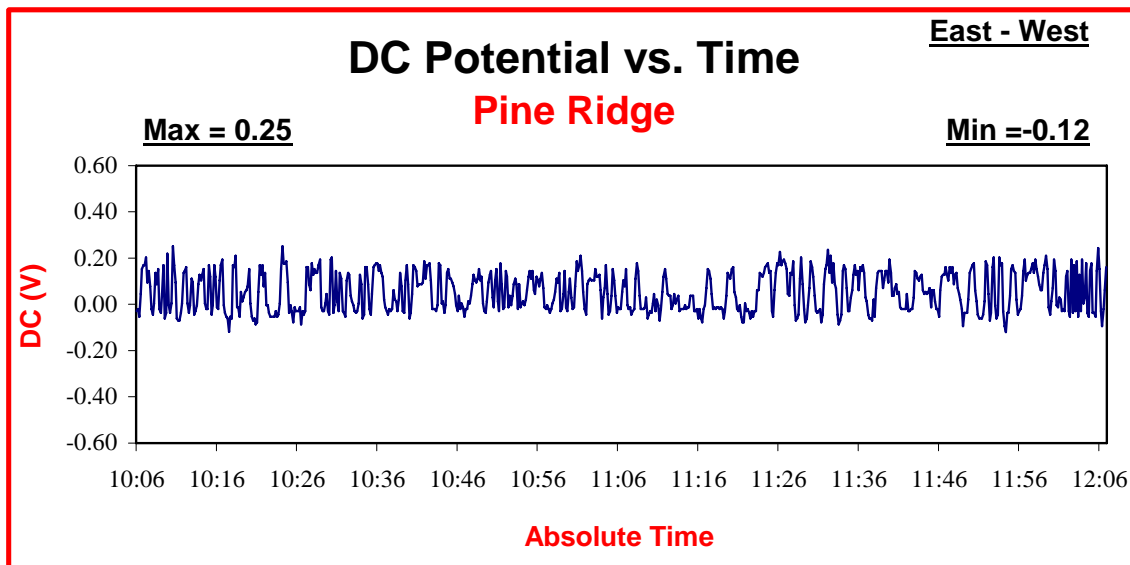
Location:	Pine Ridge Apartments	
GPS Location:	N 39° 11.854', W 76° 44.734'	
	North-South	East-West
Date:	10/25/2006	10/25/2006
Time:	10:06:02	10:06:02
Maximum (V):	0.47	0.25
Minimum (V):	-0.42	-0.12
DC Potential Shifts (V):	0.89	0.37

Figure 37 - Stray Current Result for Pine Ridge
