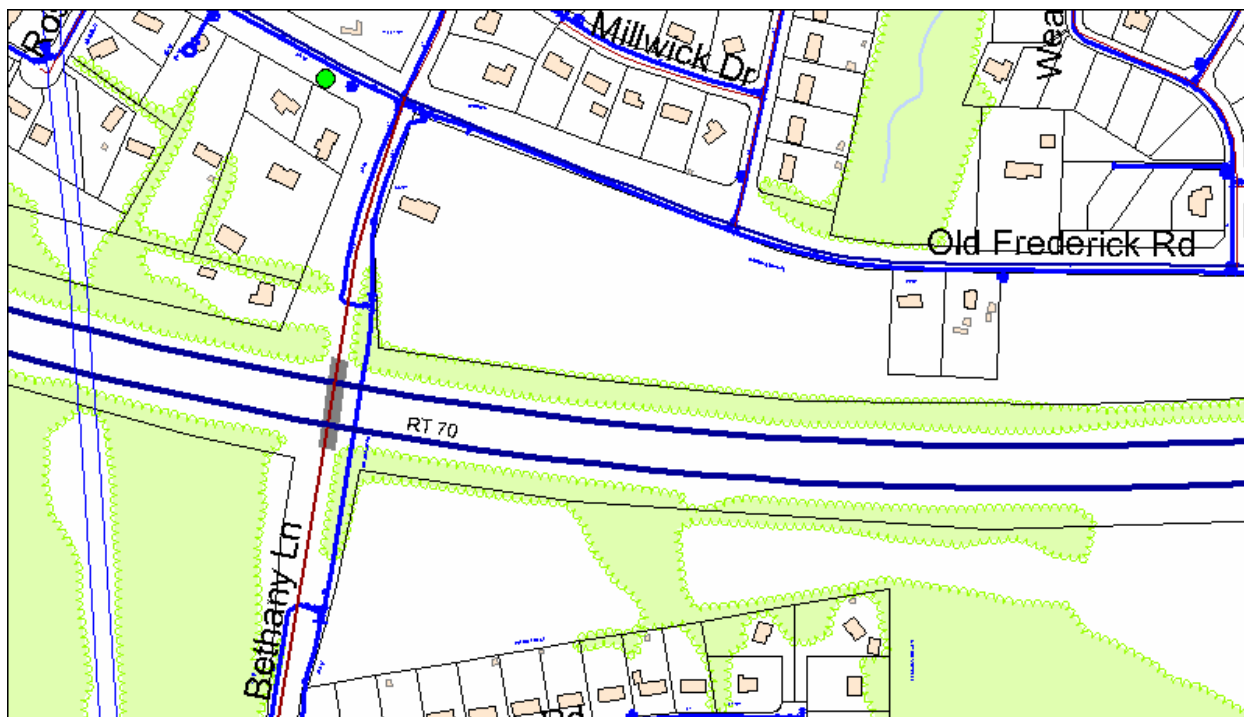
Figure 116 – Stray current location near Bethany Lane and Route 99

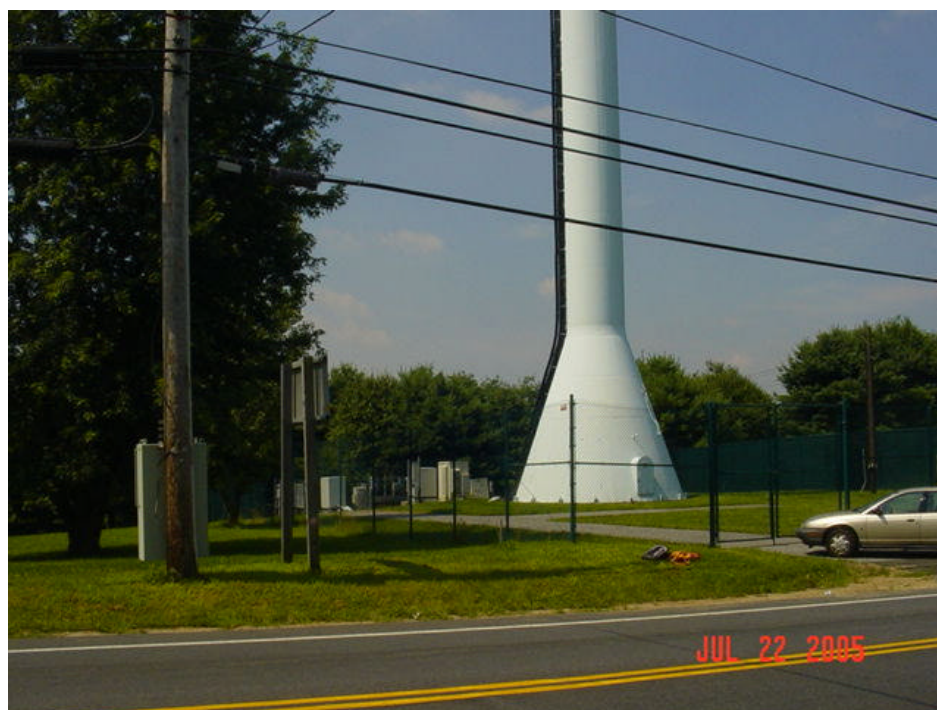
Figure 117 – Measuring stray currents near Bethany Lane and Route 99
