Section 1

Figure 42 – Results of Stray Current Test #1 on Rt 144

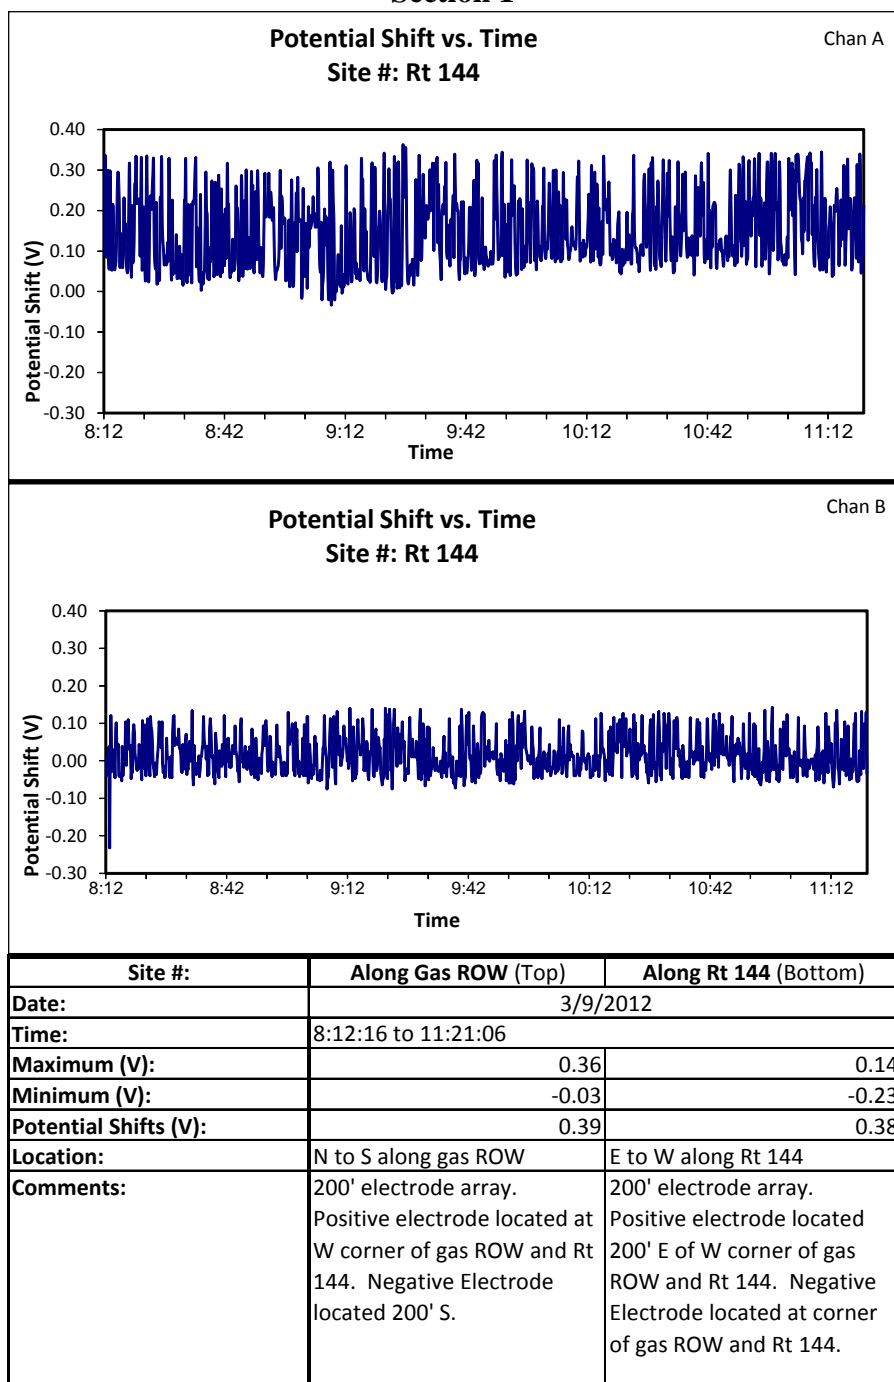
Both graphs display readings that are predominantly greater than zero, indicating that there is an underlying steady state voltage gradient present in the area. The overall pattern of the data in both plots carries the typical signature of stray current gradients associated with operation of DC power.
