Table 4. Data Summary of Stray Current Test for Site 3 - No Rectifier Cycling

DC STRAY CURRENT TESTING Alpha Ridge Water Project - Site 3

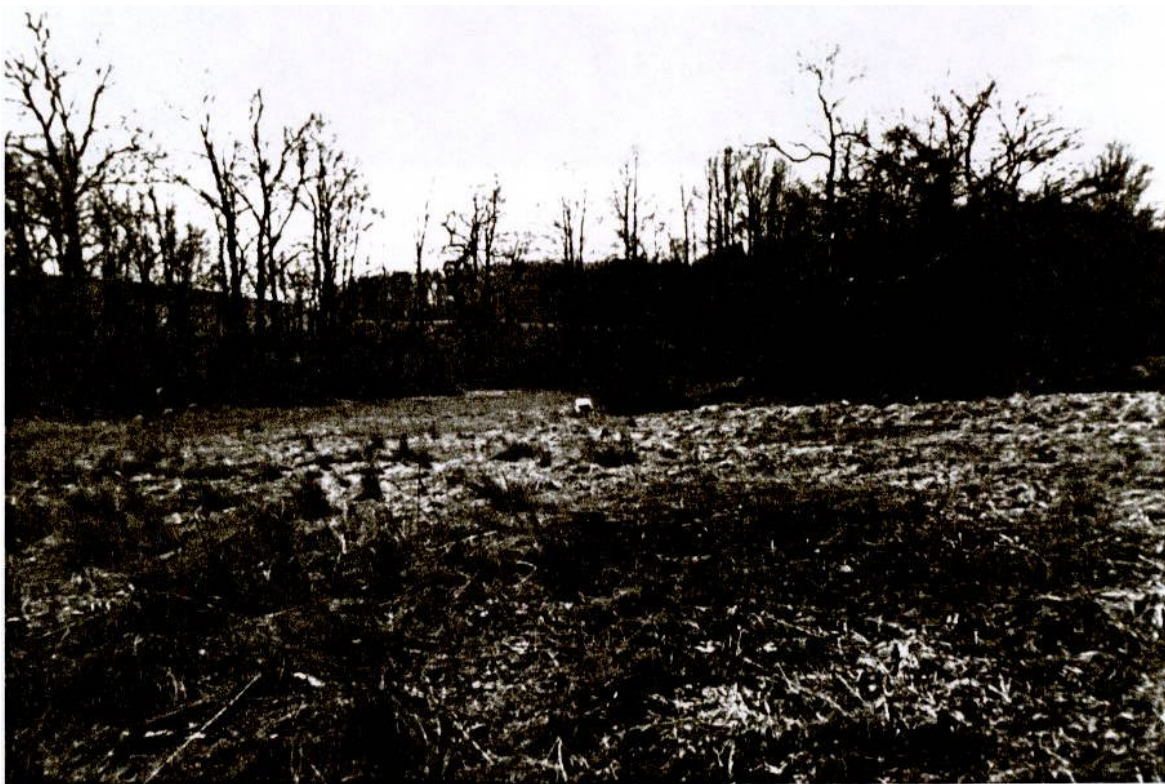
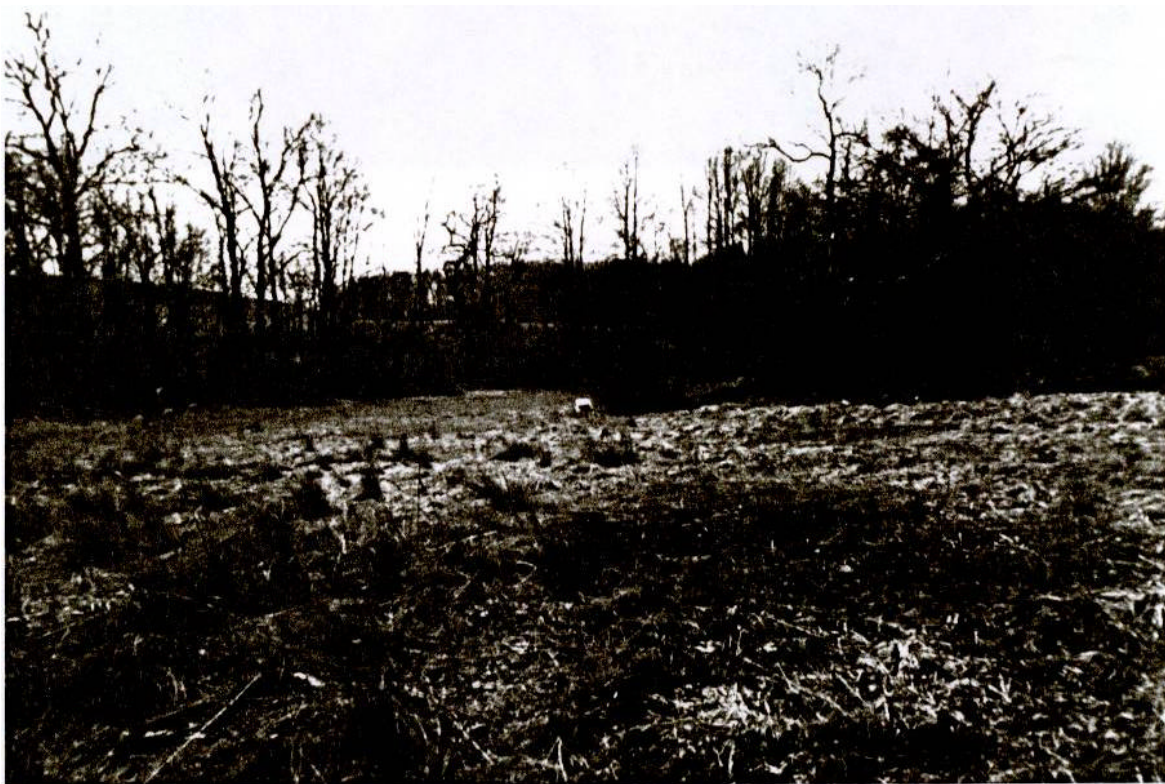
Figure 28. Location of Testing Site 3

Maximum DC (V)	Minimum DC (V)	Delta (V)	Circuit Resistance (Ohms)	Maximum Current (mA)	Maximum AC (V)	Minimum AC (V)
1.265	1.187	0.078	254.8	0.31	2	0
Start Time:	3/25/96 - 2:26 PM					
Stop Time:	3/26/96 - 11:00 AM					
Location:	Steel rod located in field south of Alpha Ridge Community Park. The groundbed used was the baseball outfield fence, approximately 435' northeast of the steel rod. The remote Cu/CuSO ₄ electrode was located approximately 175' southwest of the steel rod near a stream. Wet soil conditions.
