## HOWARD COUNTY DEPARTMENT OF PUBLIC WORKS CORROSION CONTROL TEST STATION FIELD DATA SURVEY FORM

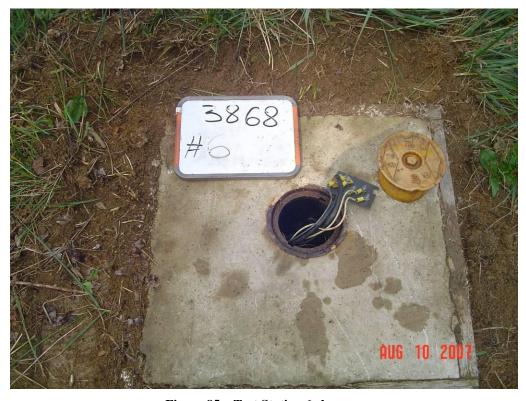
Figure 85 – Test Station 6 close up

Location:	01+77 (N	1)		Date Surveyed: 0			/2007		
	E. of Rt.29N ramp			Surveyed by:			AS/MJ		
T/S #:	06						8868		
T/S Type:	CS w/An	odes		Pipe Size: 16					
Was the T/S located? YES / NO			YES						
TEST STATION CONDITION									
Test Box: Good									
Terminal Board: Goo		ood							
Wires: Good		ood							
Other:									
SURVEY DATA									
Test Wire			P/Cu-CuSO₄ (V)			P/Zn (V)		Anode	
Size/Description		Color		On""Off"		"Oı	On""Off" (mA)

6.									
7.									
8.									
P/Cu-CuSO <sub>4</sub> = Pipe to Copper-Copper Sulfate Reference Electrode									
P/Zn = Pipe to Zinc Reference Electrode									
"On"			= Reading with Anode(s) connected						
"Off" = Reading with Anode(s) disconnected									
Anode = Current output Anode(s)									
TESTING THE EFFECTIVENESS OF INSULATING JOINTS									
Groundbed:	_								
Connected to (B/W):			Voltore (V)				Resistance (ohms)		
ON:		urrent (A)	0.63	<b>Voltage (V)</b> 2.45			Resistant	<b>se (onms)</b> 3.57	
OFF:			0.00			0.200		3.37	
DELTA:			0.63						
TESTING IR DROP  IR Drop Between Resistance									
Calibrations	i (A	) F (	nV)	K =	Δl (ı	mA)	Terminals	(ohms)	
INITIAL		· · · · · · · · · · · · · · · · · · ·	117)	Ν		mV)	Terminais	(Ollilis)	
FINAL					∆ <b>∟ (</b>				
DELTA			D	irection:					
REPAIRS MADE  Test Box:									
Test Box.  Terminal Bo									
Wires:									
Other:									
Comments/Recommendations: Casing test confirms the isolation between the casing and the pipe
