**HOWARD COUNTY DEPARTMENT OF PUBLIC
CORROSION CONTROL TEST
FIELD DATA SURVEY**

Location: Lincoln Dr. & Cedar Ave. **Date Surveyed:** 3/22/2005
T/S #: 02 **Surveyed by:** AC/MJ
T/S Type: IJ **Contract #:** 24-3811
Pipe Size: 8"

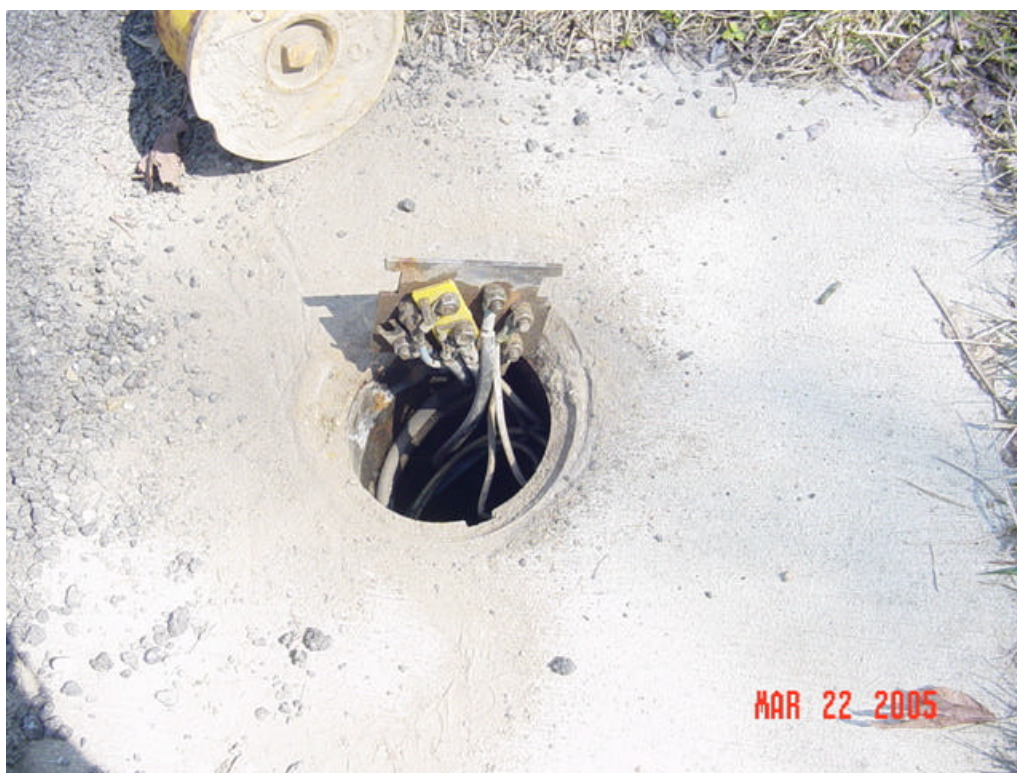
Figure 200 - Test Station 3811-2 close-up

Test Box : Good
Terminal Board : Good
Wires : Good
Other : _____

Test Box: _____
Terminal Board: _____
Wires: _____
Other: _____
Additional Comments/Recommendations: IJ test confirms the electrical isolation between the two pipeline sections.
