HOWARD COUNTY DEPARTMENT OF PUBLIC WORKS CORROSION CONTROL TEST STATION FIELD DATA SURVEY FORM

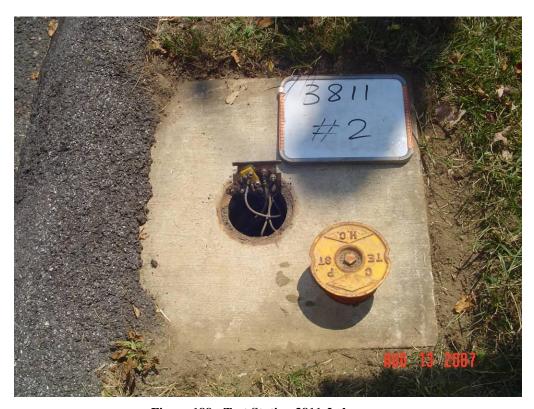
Figure 188 - Test Station 3811-2 close-up

Other:													
Comments/	Recom	menda	tions:	IJ test co	onfirm	s the electr	ical is	olation b	etwe	en the tw	o pipelin	e	
Comments/Recommendations: IJ test confirms the electrical isolation between the two pipeline sections													
			_
