Howard County Traffic Signal Inspection Summary Report:

Signal Number: 021

Location: Little Patuxent Parkway at Gov. Warfield Pkwy. & Banneker Rd.

Inspection Date: April 11, 2018

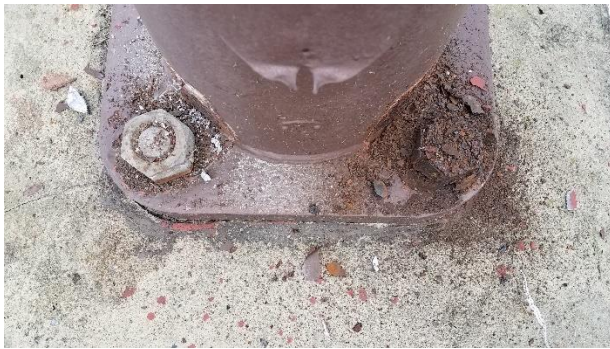
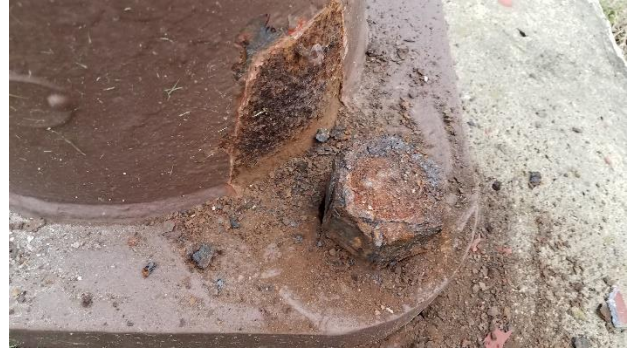
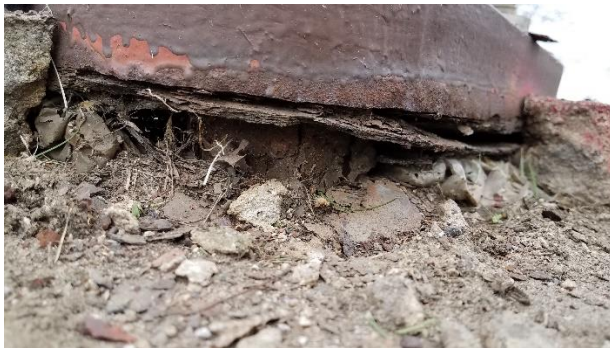
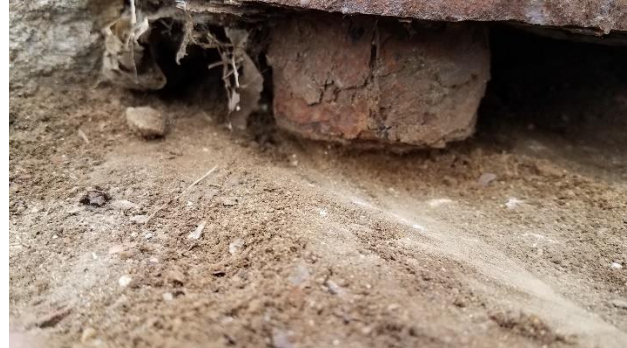
Poles in overall fair condition. Both north and south median structures have rusting and deterioration around the base plate area, anchor bolts, and tightening nuts. Structural evaluation was completed, and media blasting, prime, and re-paint was recommended.
